FINAL REPORT

**HOSPITAL CREEK
FISH AND FISH HABITAT
ASSESSMENT**

Project No. #153-01-01

January 2003

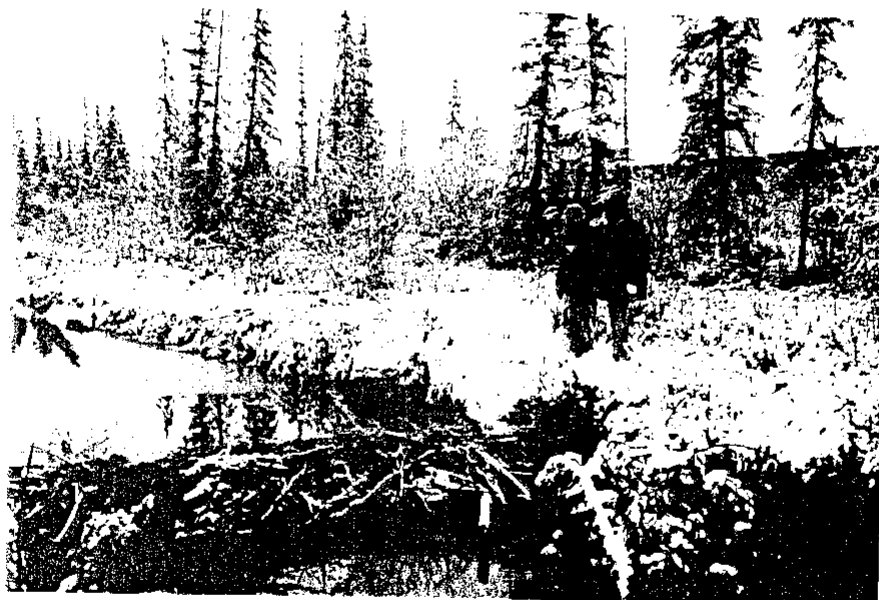
Photograph 2. Second beaver dam upstream of mouth of Hospital Creek.

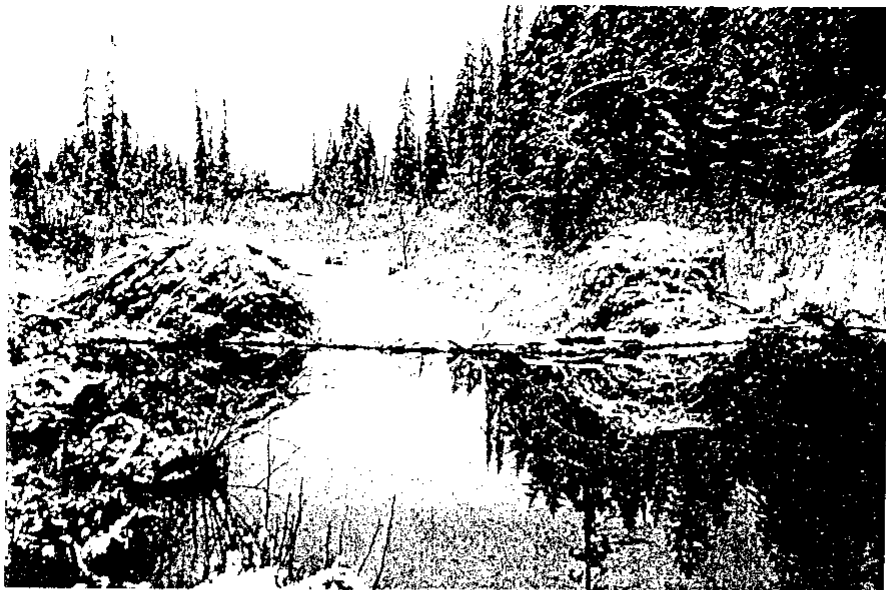
Photograph 3. Third beaver dam upstream of the mouth of Hospital Creek.

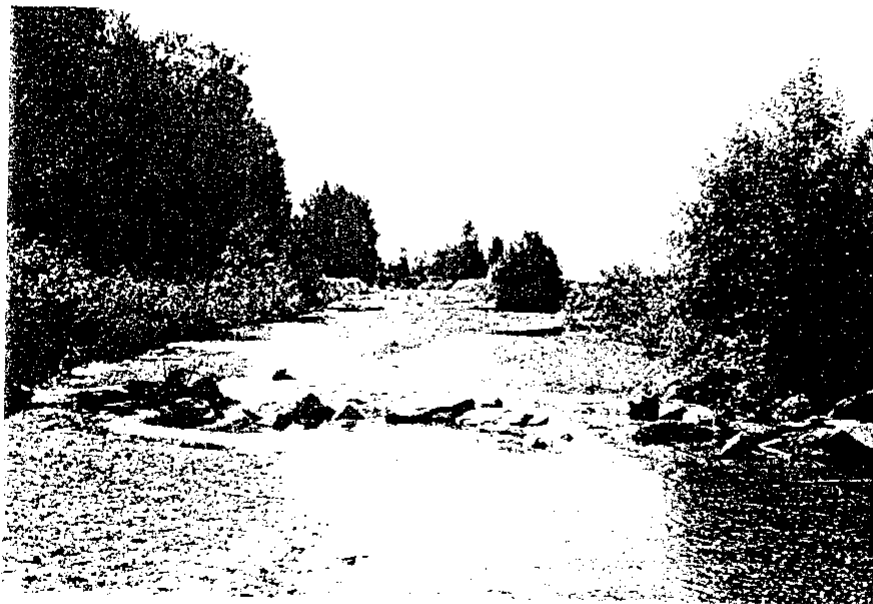
Approximately 1000 m upstream of Anderson Road, the stream had several constructed rock weirs with a total length of about 150 m (Photograph 6). Below the weirs were some of the only pools identified in Hospital Creek. The lowest pool, and the largest, was 95 cm deep and contained several juvenile salmonids – three appeared to be mountain whitefish and one likely a rainbow trout. The substrate was silty and the lower part of the pool had collected some woody debris, of both natural and manufactured origin.

Photograph 6. Weir in Hospital Creek Section 3

This section appears to have had some enhancement completed. The weirs were producing some of the best habitat observed within Hospital Creek. However, the weirs may be impounding gravel upstream. Some riparian planting would provide additional cover.

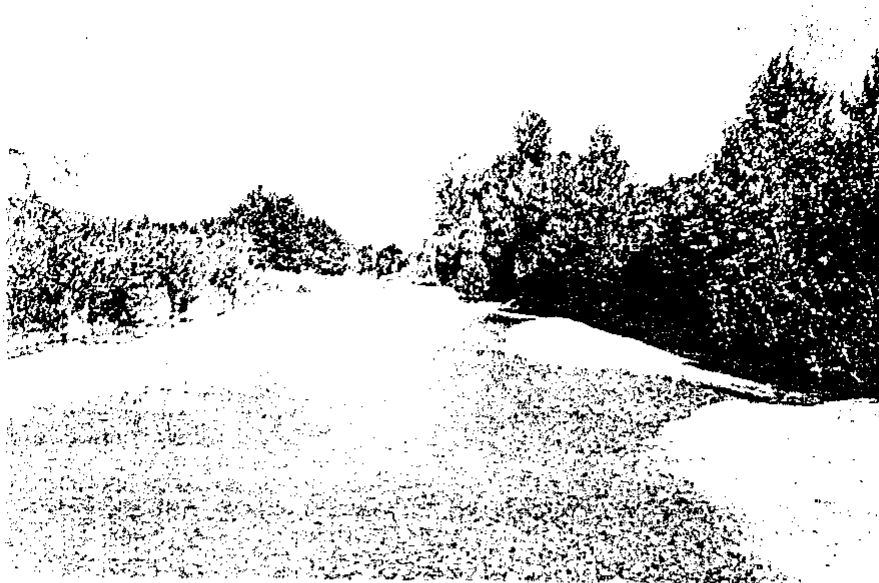
Photograph 7. Gravel accumulation in Section 4 of Hospital Creek.

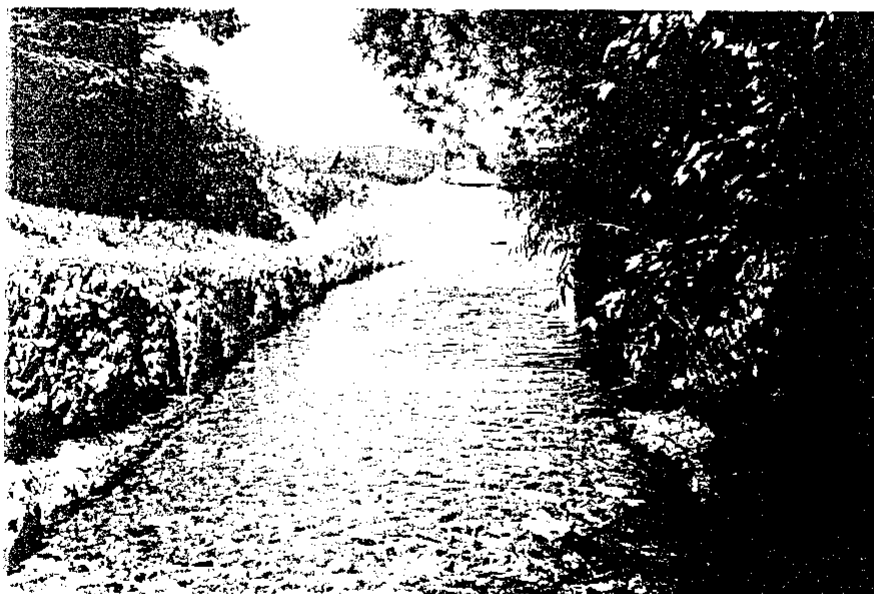
Photograph 8. Gabion walls in Hospital Creek Section 5.

This area was heavily disturbed and would benefit from the stream being forced into one channel and allowed to meander between the dykes. However, to excavate a channel would be quite expensive and if the observed channel resulted from aggradation, this type of constructed channel likely will not survive the next high flow event that results in substantial bedload movement – frequency is unknown at present. Adding vegetation may help stabilize one channel, and may help. If this section remains passable for fish it is not a high priority. Further investigation that determines whether the disturbance resulted from aggradation of bedload, gravel extraction or other human activities may alter the level of risk associated with restoration of this area. This area may require assessment by a hydrologist to determine options for dealing with the aggraded sediments and risks to downstream habitat from aggrading sediments.

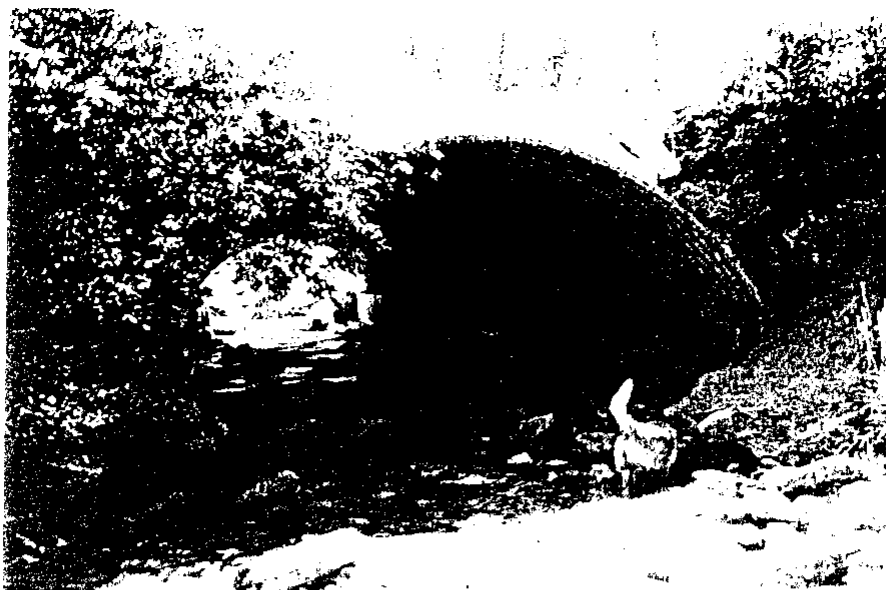
Photograph 9. Pipe arch culvert in Section 6 of Hospital Creek.

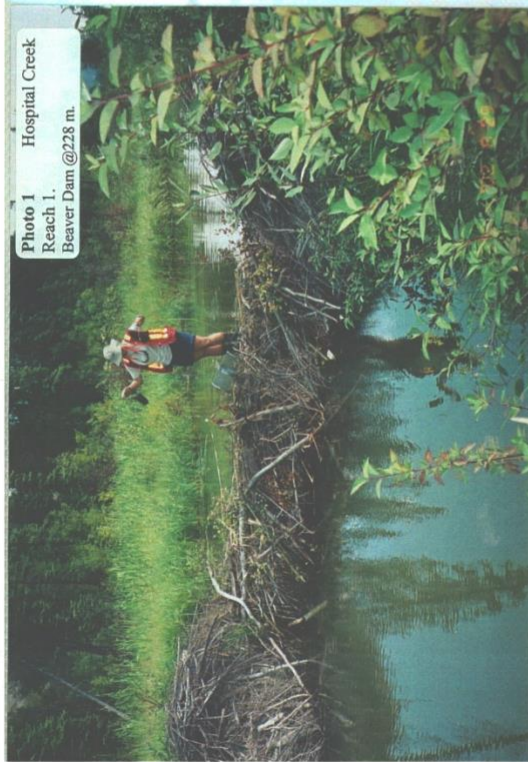
Photo 1 Hospital Creek
Reach 1.
Beaver Dam @228 m.

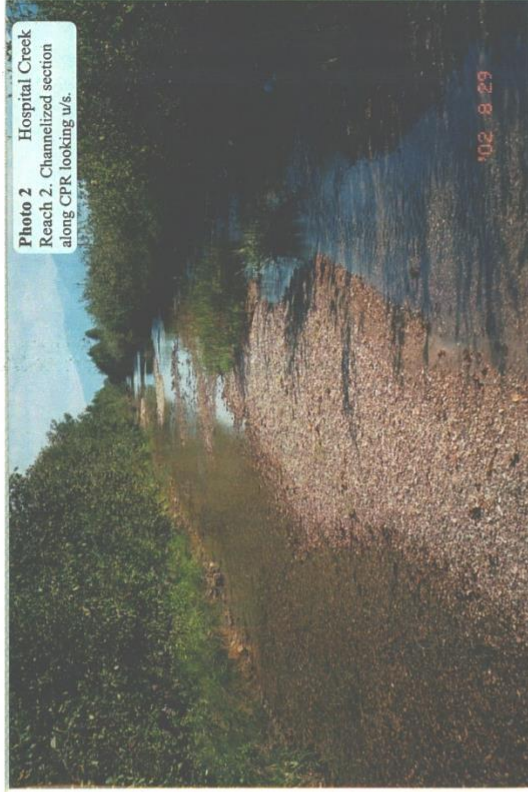
Photo 2 Hospital Creek
Reach 2. Channelized section
along CPR looking u/s.

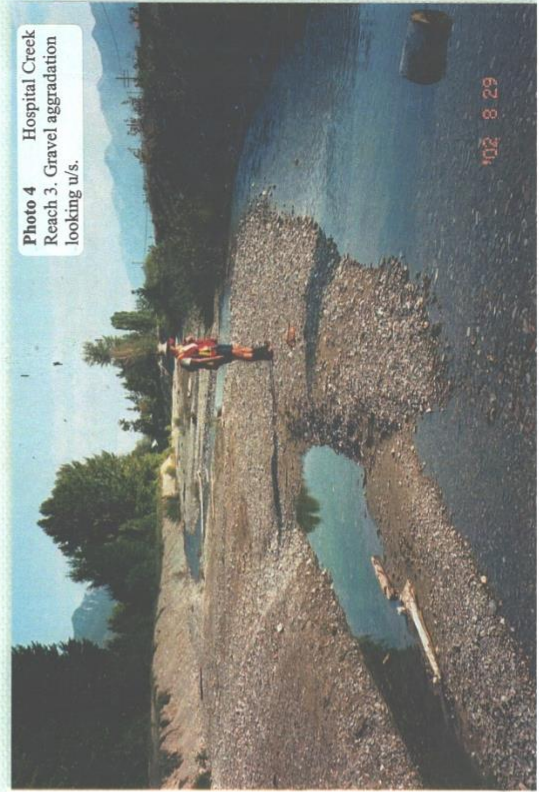
Photo 4 Hospital Creek
Reach 3. Gravel aggradation
looking u/s.

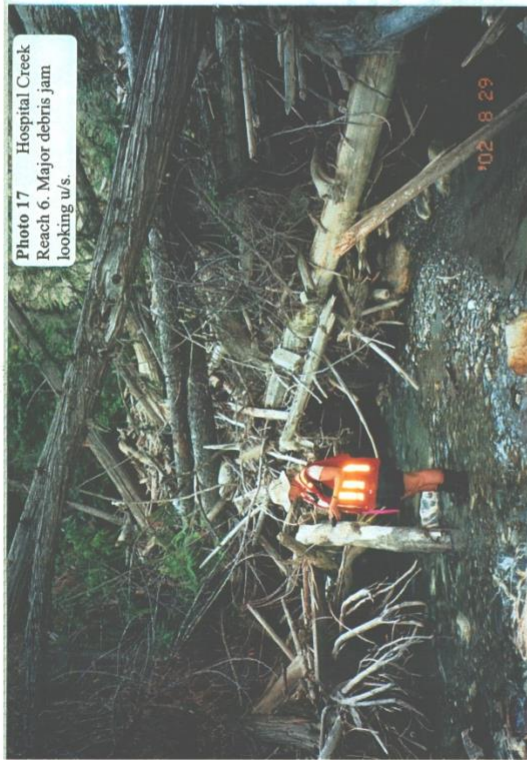
The large debris jam in the Hospital Creek Canyon is holding back a substantial amount of material and also prevents fish from accessing approximately 250 m of stream up to the falls. If the jam breaks loose in a high flow event, the resulting debris flow could pose a threat to downstream property as well as damage any downstream instream restoration work that is undertaken and cause fish mortality.

Photo 17 Hospital Creek
Reach 6. Major debris jam
looking u/s.

The large debris jam in the canyon is holding back a large amount of material as well as blocking fish passage. The risk and consequences to human life and property of catastrophic failure of this jam, as well as feasibility of removing or dismantling the jam, should be assessed by a fluvial geomorphologist or water resources engineer. Catastrophic jam failure resulting in a debris flow could also have serious impacts on fish and fish habitat, including any instream restoration work that is undertaken.

There may be some urgency to investigation of the debris jam. If risk and consequence of failure are high, it may be desirable to dismantle the debris jam in spring prior to freshet to utilize high flows to distribute the stored material to downstream areas. A work crew equipped with chainsaws and chainsaw winches would probably be able to strategically weaken the debris jam so that it will be gradually removed by freshet flows.

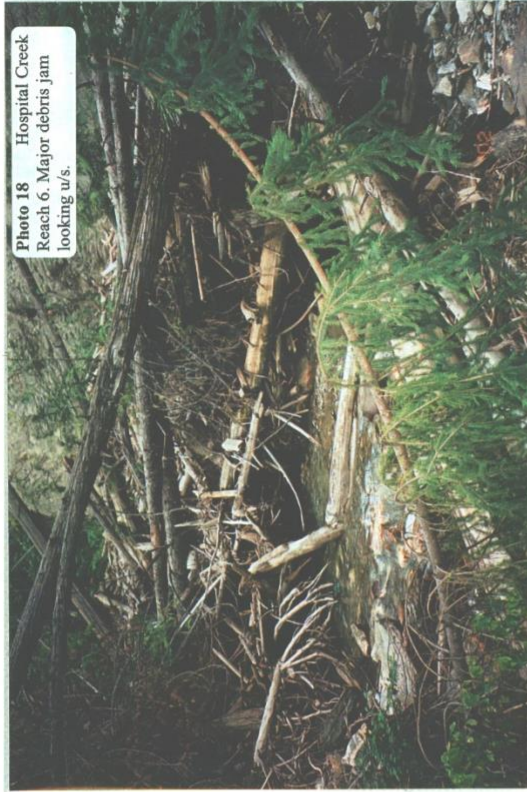
Photo 18 Hospital Creek
Reach 6. Major debris jam
looking u/s.

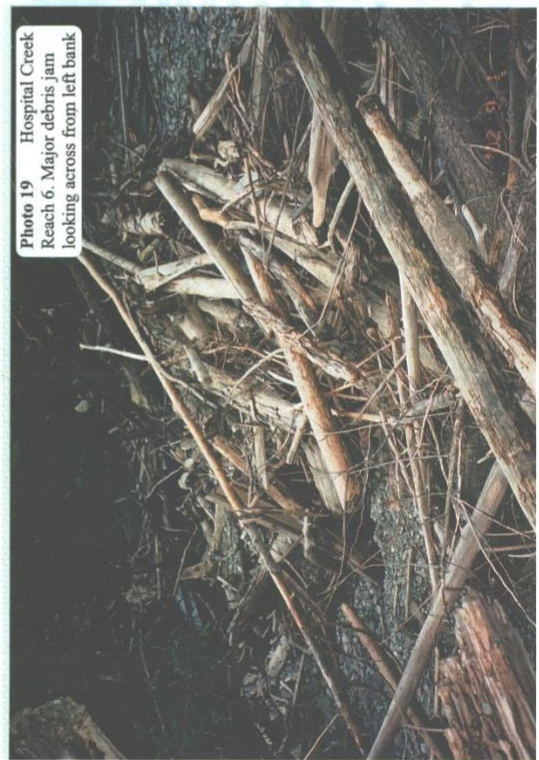
Photo 19 Hospital Creek
Reach 6. Major debris jam
looking across from left bank

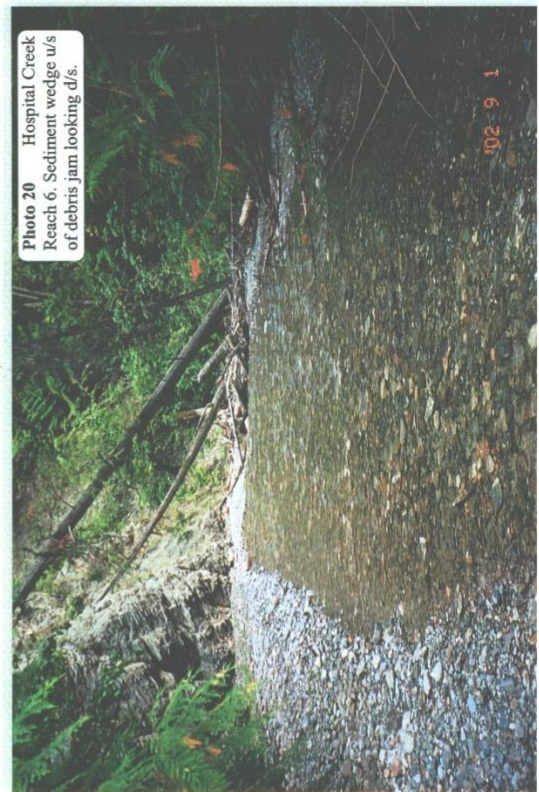
Photo 20 Hospital Creek
Reach 6. Sediment wedge u/s
of debris jam looking d/s.
