# TOWN OF GOLDEN FLOOD RISK MAPPING ASSESSMENT

**SUBJECT: Town of Golden, Kicking Horse River Flood Risk Assessment  
Draft Report**

# **TOWN OF GOLDEN FLOOD RISK MAPPING ASSESSMENT**

March 2004

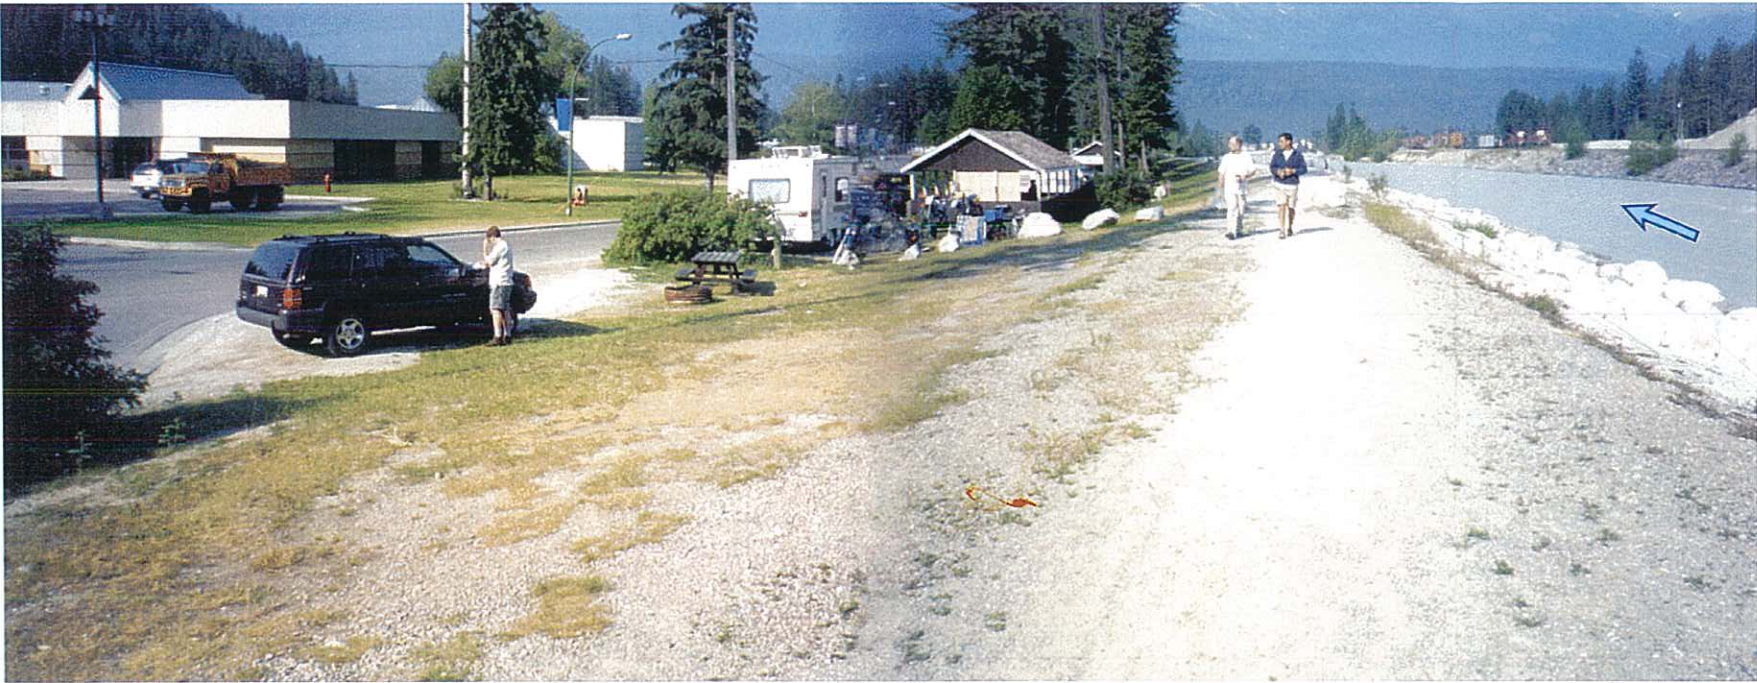
1. Entrance to campground looking downstream. The dyke crest is 4 m wide at the top with a 1.6 m drop to the ground level beside the road. Potential breach area to evaluate.

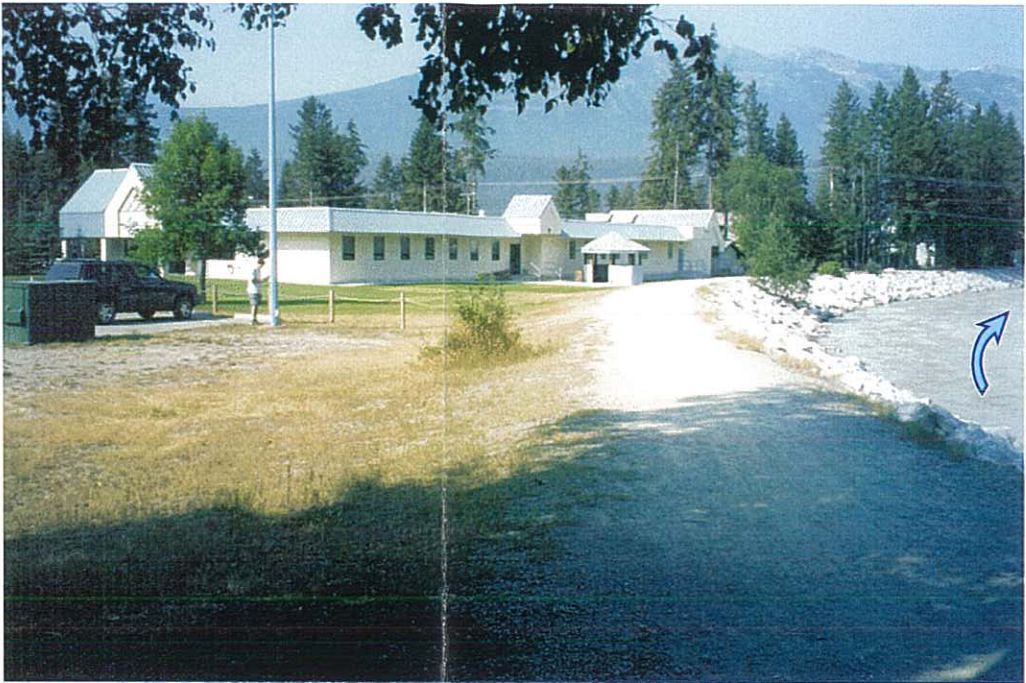
2. Looking downstream at College of the Rockies property. The dyke crest is 0.66 m above the natural ground and 4 m wide at the crest. Minimal risk of major dyke breaching here, although on outside bend of river and freeboard is low.

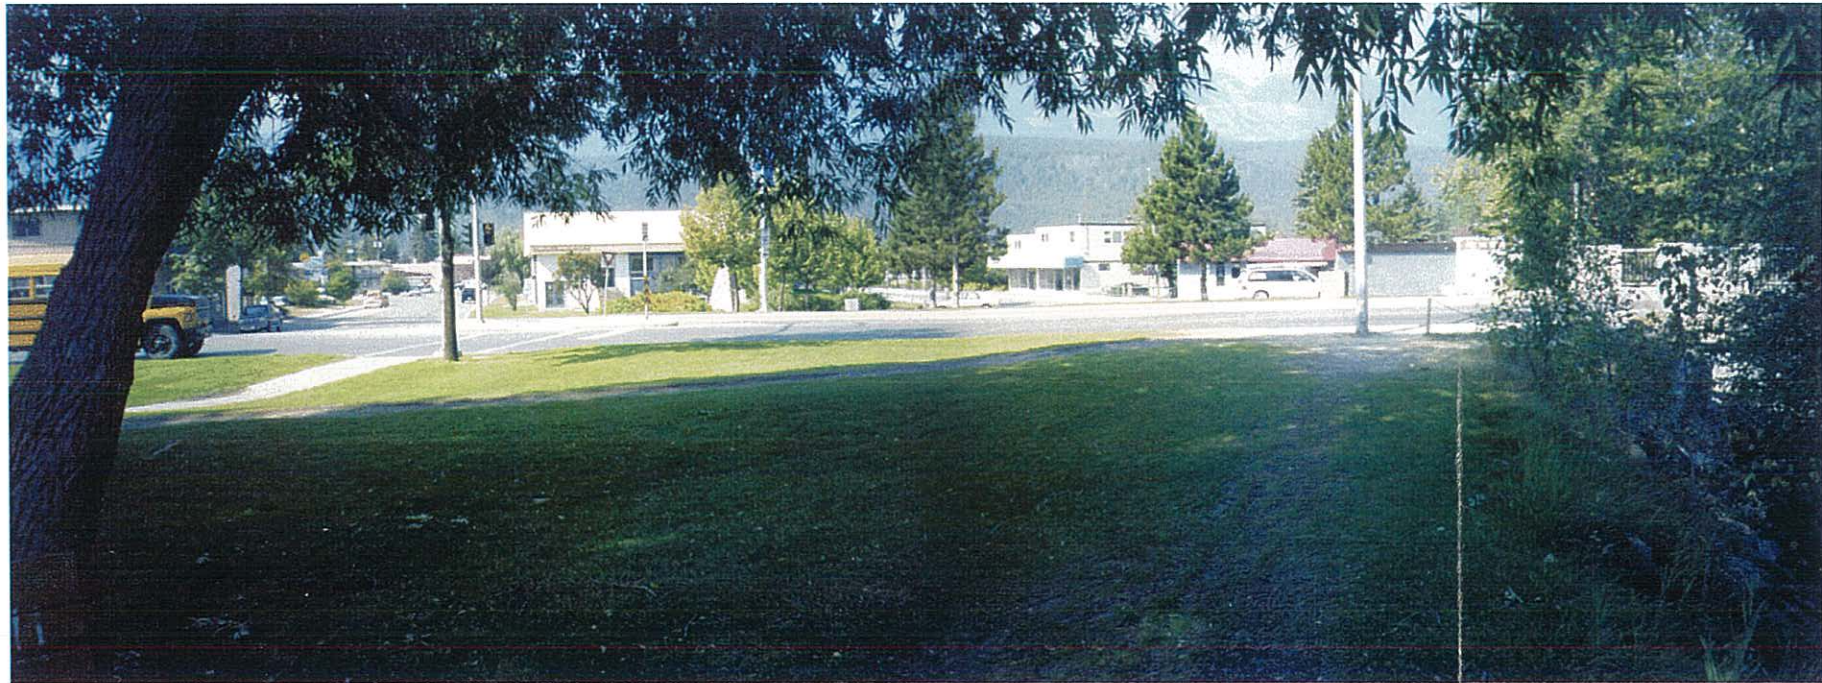
3. Looking downstream on south side of the Highway 95 bridge. This area has a significant elevation drop of 1.5 m from the dyke to the road level at the intersection with 11th Avenue South (just left of the photo).

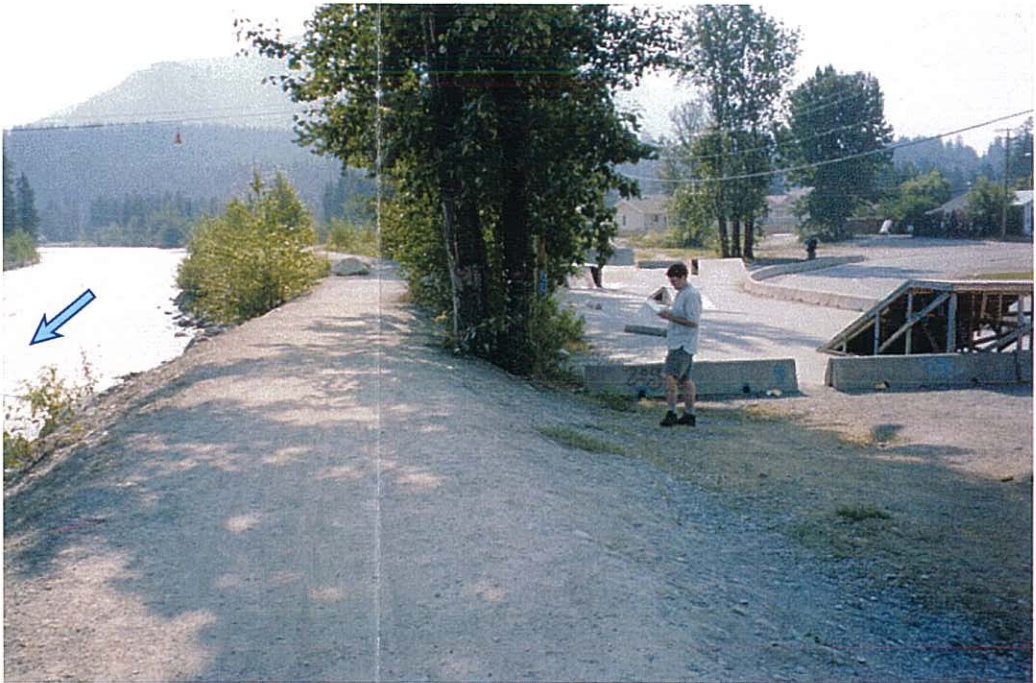
4. Skateboard Park looking upstream. The dyke crest is 0.96 m above the ground in the park area and 1.4 m above the road with a crest width of 3 m. The river side of the dyke is slightly steep at 55%. Potential breach area to evaluate.

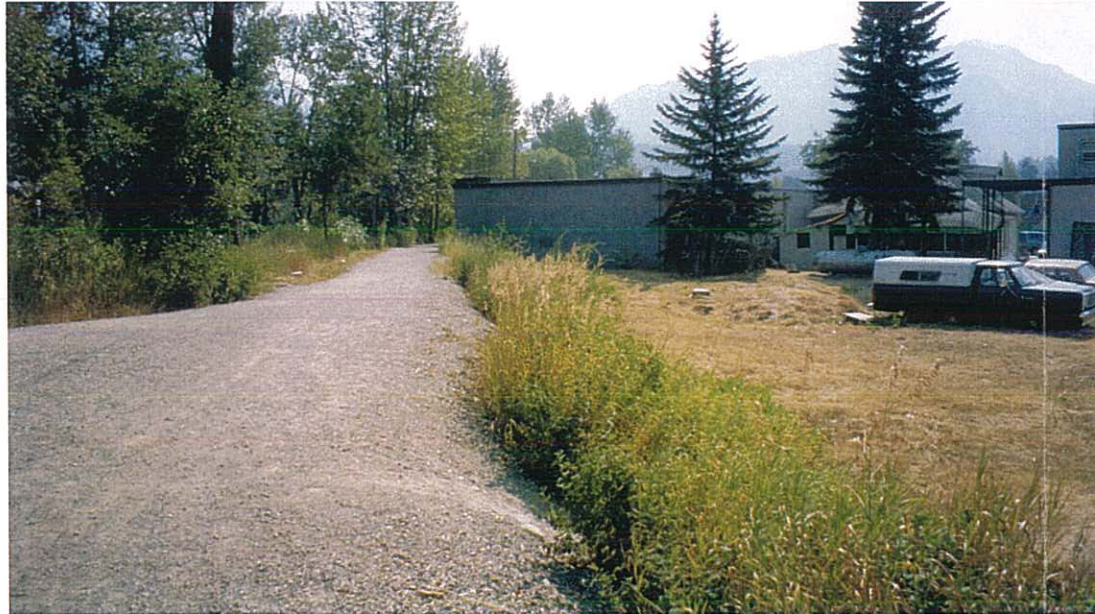
5. Looking upstream along dyke beside sub-channel downstream of Highway 95 bridge. Significant drop to natural ground of approximately 1.5 m.

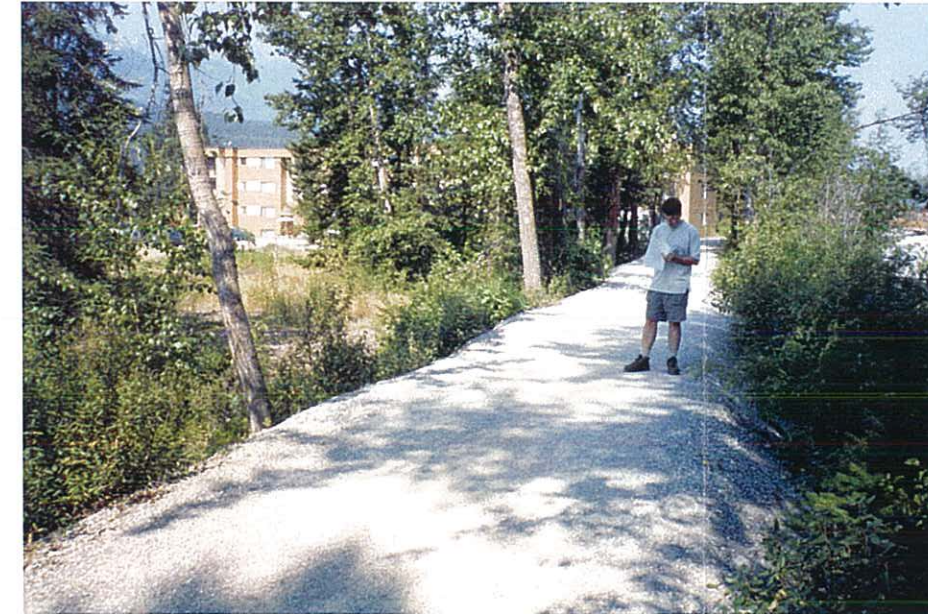
6. Looking downstream from location of Photo 5. The narrow 3 m wide dyke crest is 1.8 m above the natural ground level. The landward slope of the dyke is oversteep at 62%. Dyke upgrading is planned along this sub-channel reach in September - October, 2003.

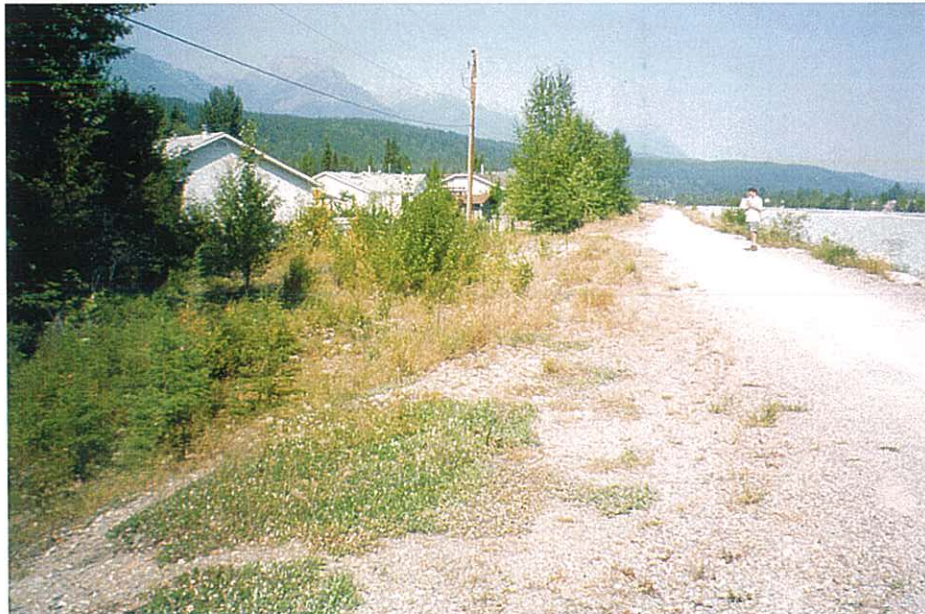
7. Photo taken from near Section K6 looking downstream. The 6 m wide dyke crest is 1.7 m above the natural ground on the left. The natural ground on the left is a local depression. Residential area ground level is about 1 m below the dyke crest.

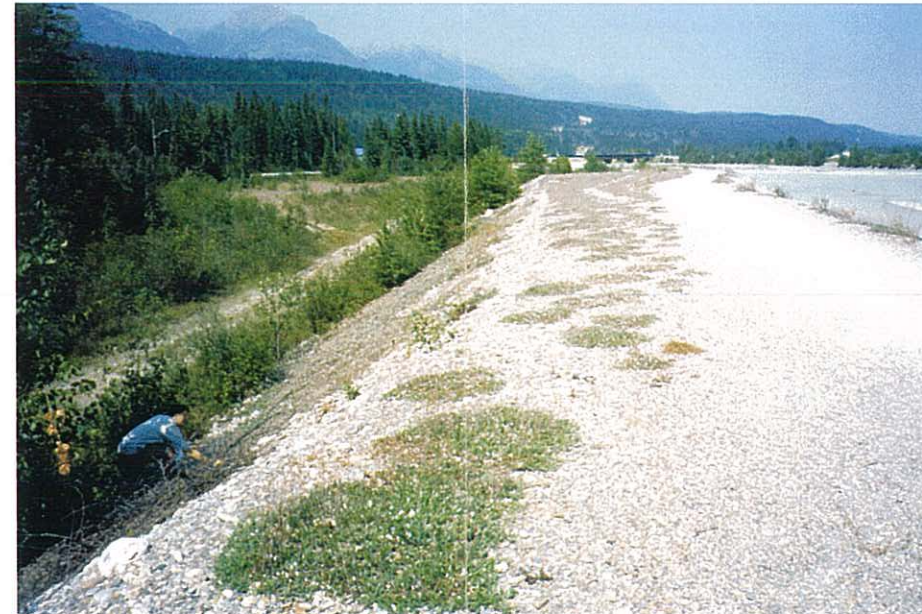
8. Photo taken from near Section K7 looking downstream. The 6 m wide dyke crest is 3.4 m above the natural ground on the left.

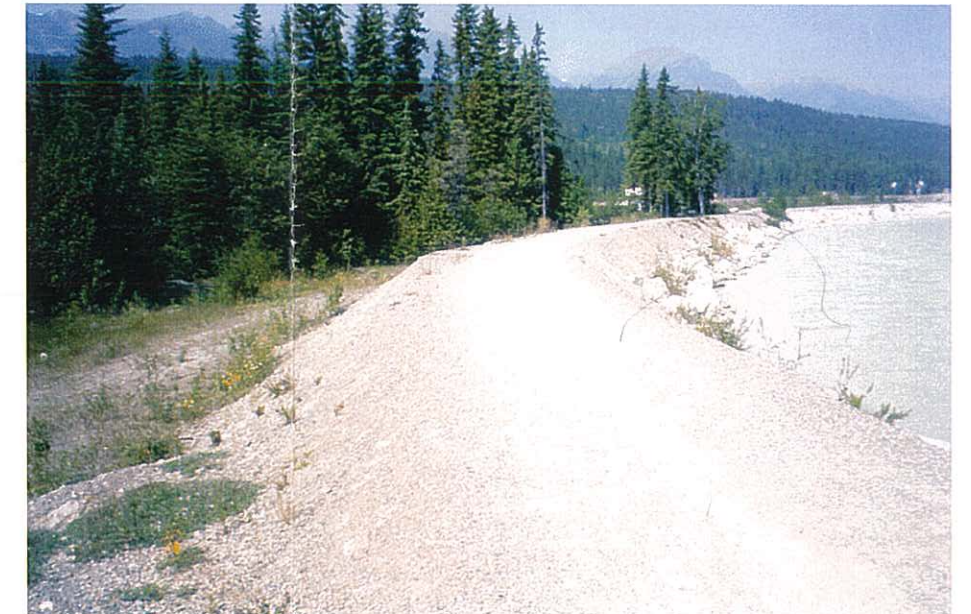
9. Photo taken halfway between Section K7a and K7b looking downstream. The 5 m wide dyke crest is approximately 3 m above natural ground level.

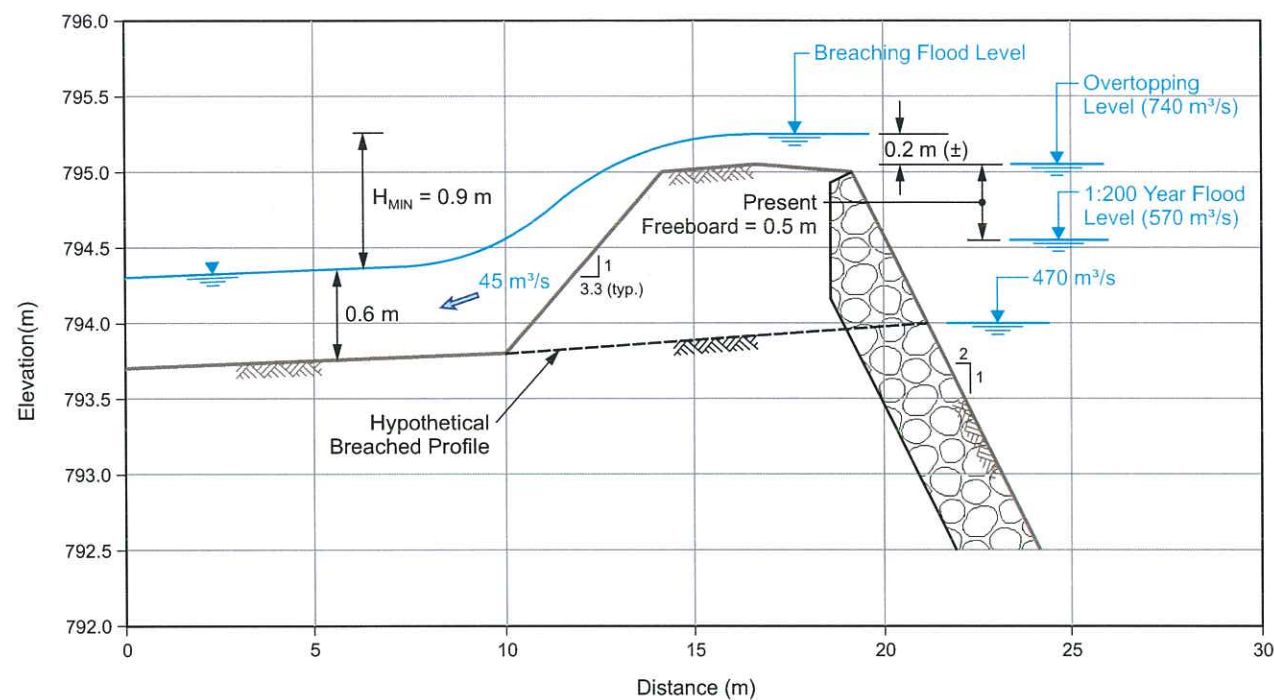
**Dyke Section (K52) at Campground**

For assessment purposes, a maximum 30 m wide, rectangular shaped breach was evaluated at the most upstream site at the campground, as illustrated in Figure 9. This is about the widest breach width that might be expected to develop given that the maximum length of initial overtopping is about 100 m. Initial hydraulic analyses applying a weir flow equation compute a peak flow in the order of 75 m<sup>3</sup>/s in such a breach without considering any downstream backwater conditions to limit the breakout flow. Incorporating backwater conditions with a minimum downstream flood depth of 0.6 m in the campground area and assuming the river flood level remains at 0.2 m above the dike crest, the maximum breakout flow is estimated at 45 m<sup>3</sup>/s at the campground. As an increasing breakout flow occurs, the river level and upstream head will begin to drop by approximately 0.25 m, meaning that the peak breakout flow will also rapidly drop.

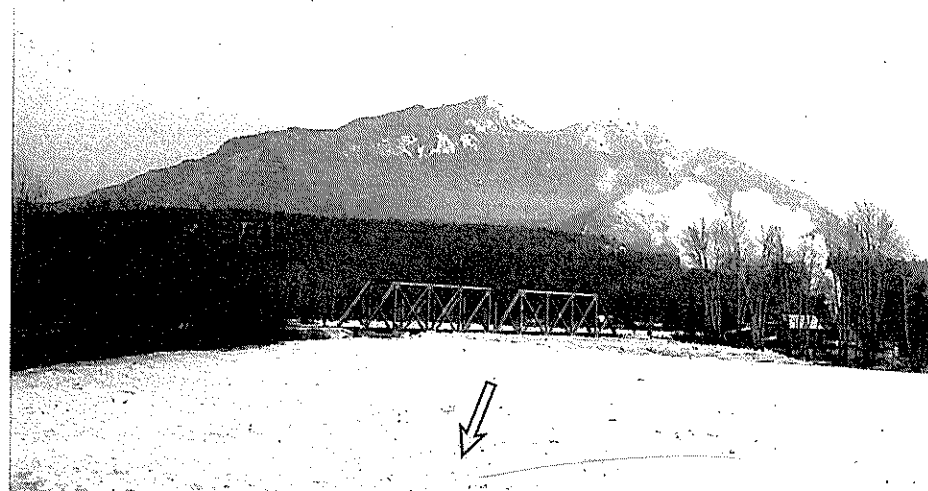
The severe high ice conditions shown in the December 1955 photos in Appendix A may have been exacerbated by the constriction created by the former railroad bridge. This former bridge was located on a skew approximately 150 m upstream of the present Highway 95 bridge crossing. It is difficult to estimate the peak ice and water level in 1955 but it is believed to be adequately below the present dike level based on the photo documentation. (Photo A1 of the 1916 flood and A2 of the 1955 ice level show the ice level was not much higher than the 1916 flood level.) With the railroad bridge constriction now removed the risk of a similar ice event may be reduced. The former sub-channel in the left overbank starting at the Kinsmen Park (Photo A6) has now been filled in.

A2. Looking upstream at former Kootenay Central Railroad bridge - Section K4 to K51.  
High ice level - December, 1955.

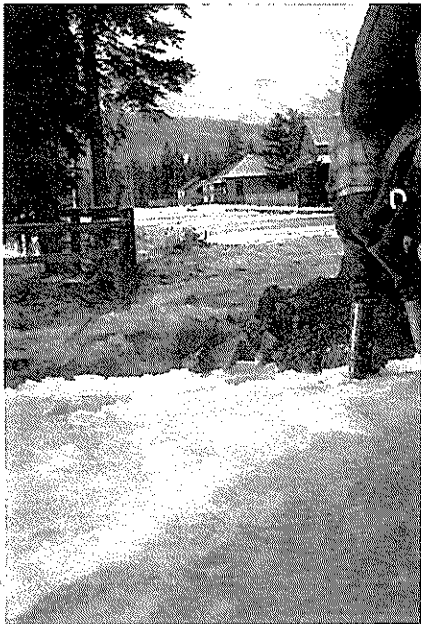
A6. December, 1955. Ice in channel by Kinsmen Park. Channel is now filled in.

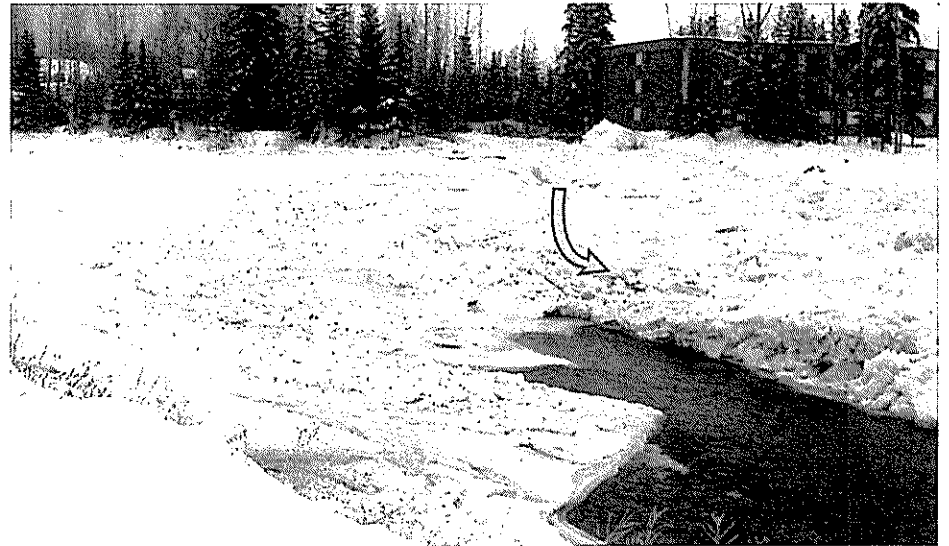
A8. December, 1988. looking south (upstream) at Crichton Apartments on S8<sup>th</sup> Avenue. River discharge was 3.5 to 8 m<sup>3</sup>/s at the time. Ice shove within 1.5 m of top of bank.

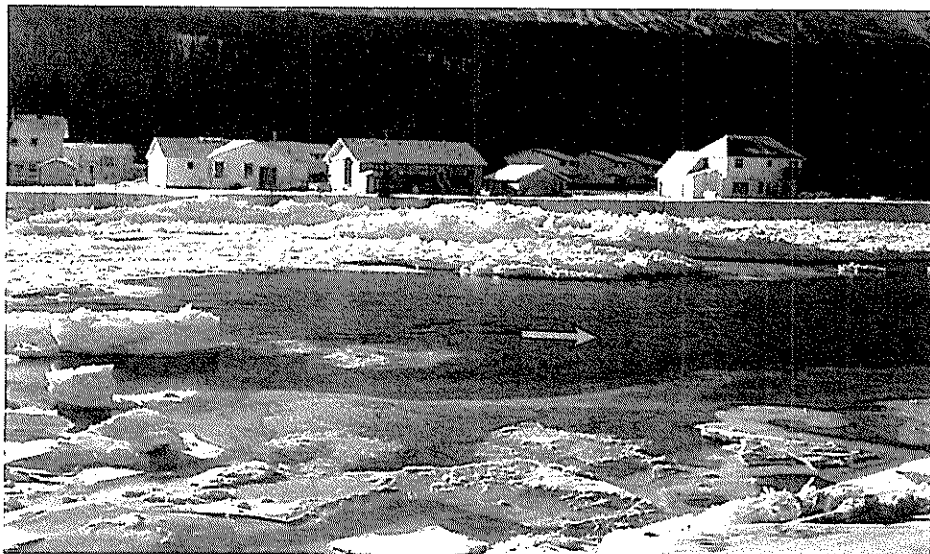
A11. 1995, looking at River Glen (Section K6 to K6a) from north bank. Ice shove approaching top of dike level in places.

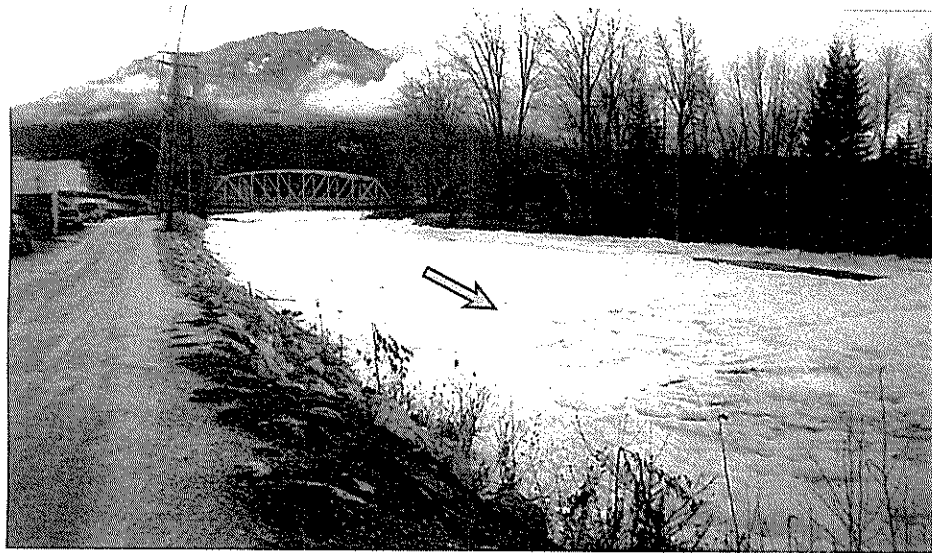
A13. December 1997. Looking upstream towards Highway 95 bridge. Ice shove within 2m of top of dike. Water level more than 1 m lower. River discharge only 8 to 13 m<sup>3</sup>/s at the time.

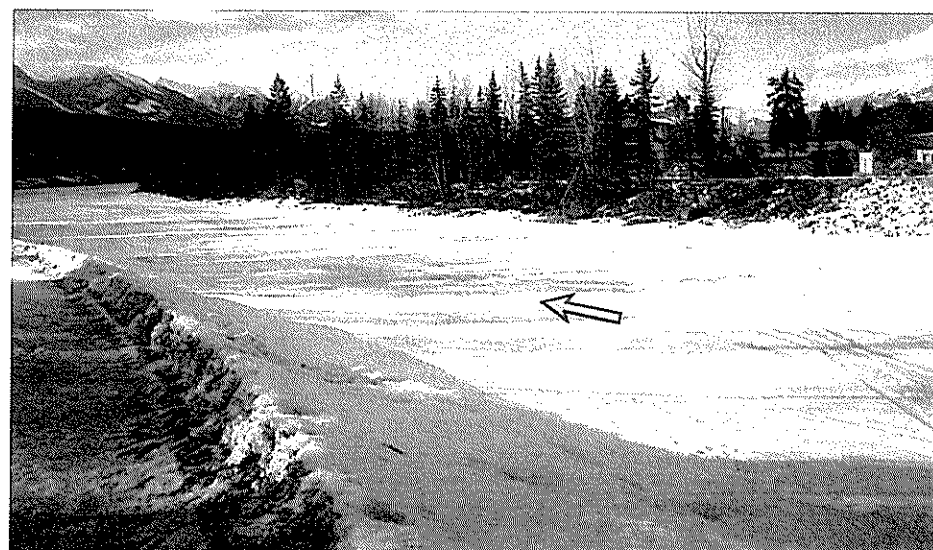
A16. March, 2001. Looking downstream at planned pedestrian bridge site from left bank. Typical river ice level more than 2 m below top of dike.
