Canada Nature Fund: Community-Nominated Priority Places for Species at Risk

Kootenay Connect: 6CW Columbia Wetlands:

Wetlands West of Columbia Lake

March 31st, 2025. Final Report: Year 6

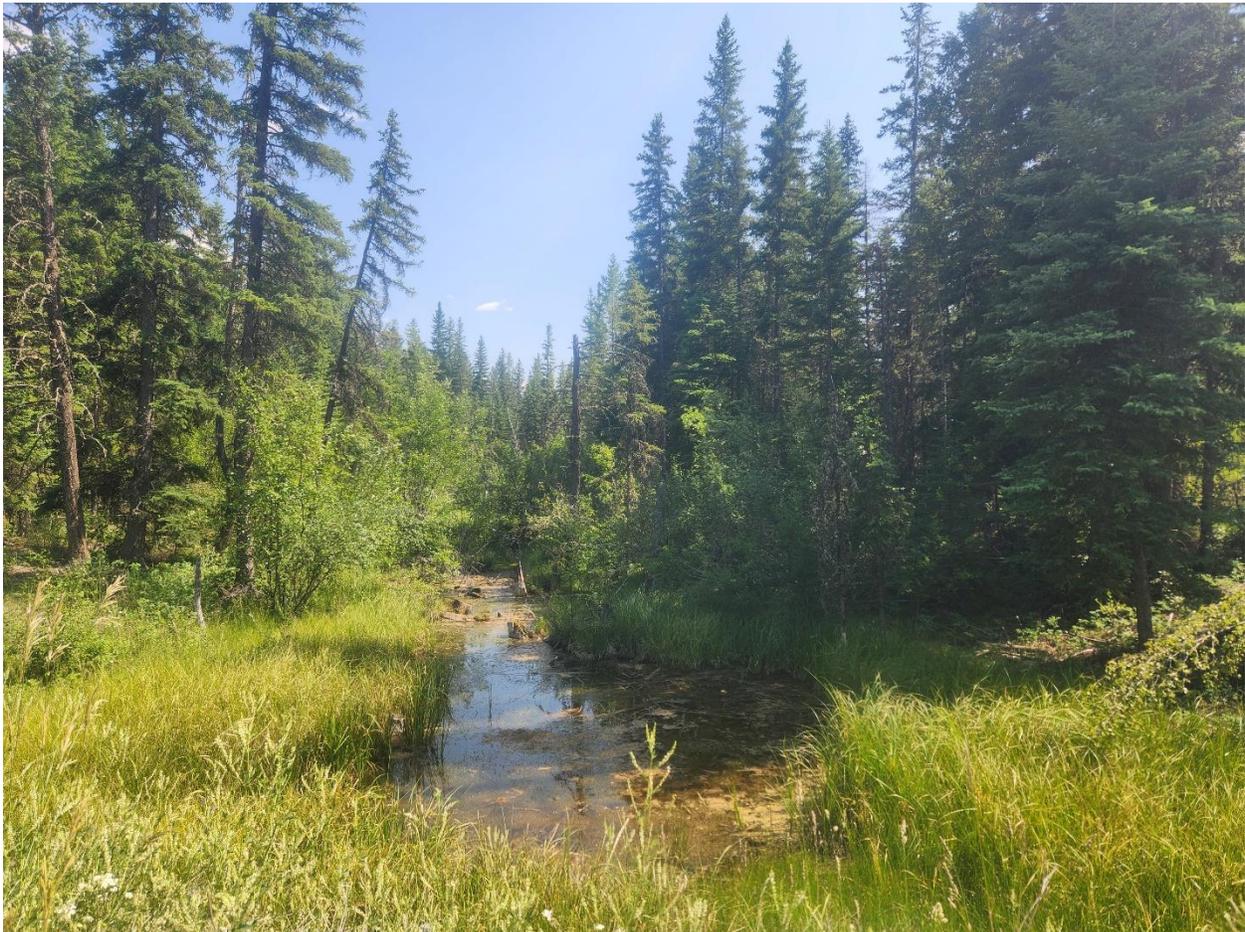
This wetland also consisted of a single plot classified as a Beaked Sedge-Water Sedge marsh in a palustrine system, with a seasonal hydroperiod. As for Wetland 1, impacts to this wetland included the road and culvert, as well as evidence of a berm that created pooling of water along the road. Wetland 2 had significantly more water than Wetland 1. This wetland is not reported in the Freshwater Atlas.

Figure 3: Photograph of Wetland 2, taken from road, showing pooled water, sedges, and tree cover.

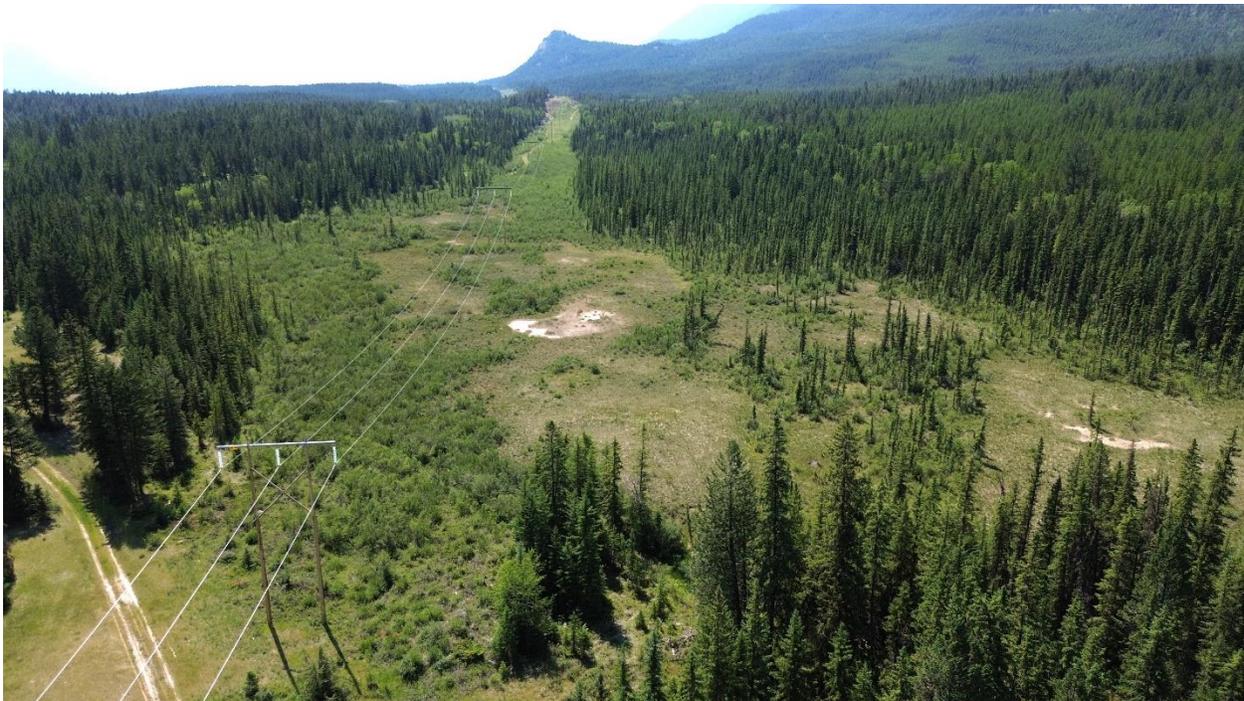
We surveyed four plots within Wetland 3, of which three are classified as fens and one as a swamp. The swamp plot had greater than 51% tree cover, which was dominated by deciduous species. The wetland was considered to be palustrine, with a mix of seasonal and ephemeral hydroperiods, meaning that some areas within it are seasonally inundated while other areas are inundated for shorter periods of time. Surface water of less than 0.02m deep was recorded in one of the four plots, while the other three plots did not have surface water. In the BC Freshwater Atlas, this wetland is numbered as 705005874. This wetland was impacted by a powerline, roadways, and a history of logging.

Figure 4: Aerial photograph showing mix of habitats, and human impacts, notably the power line.

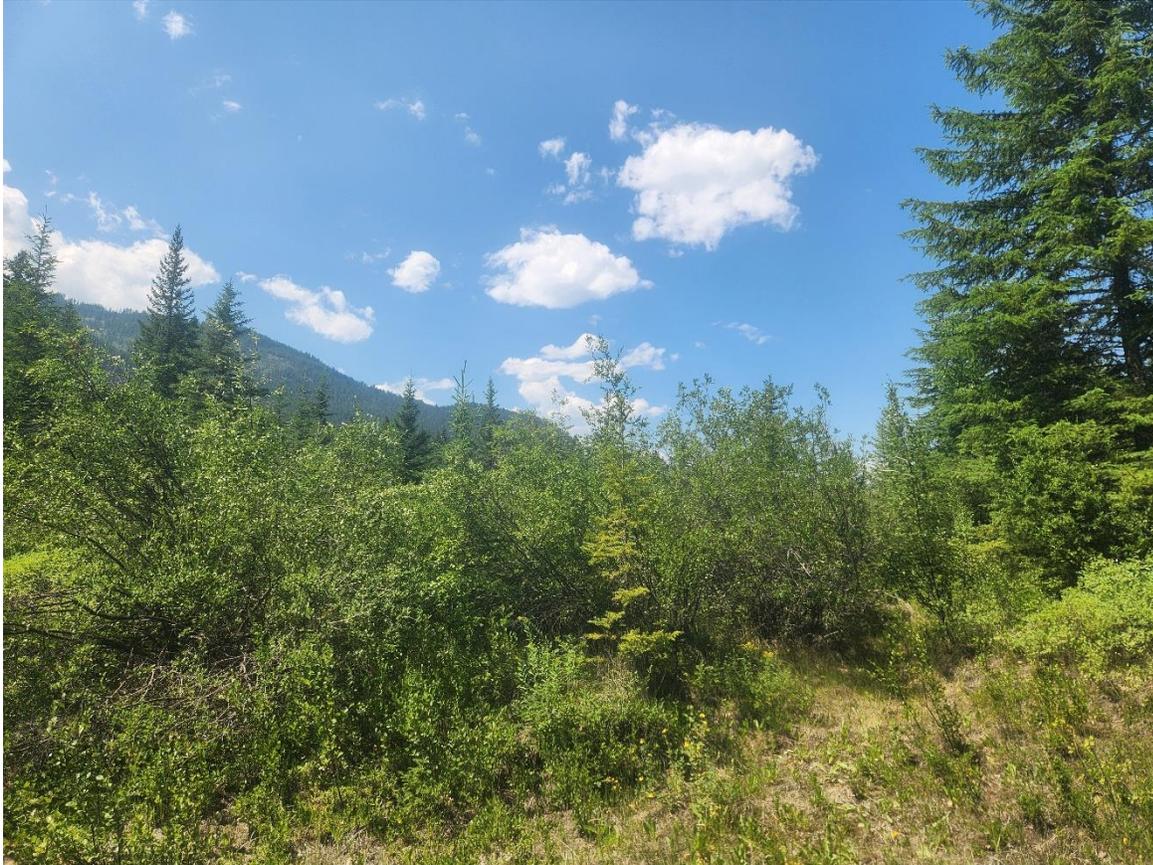
The single plot we surveyed in this wetland was classified as a swamp. The hydrological system was palustrine, with a temporary hydroperiod. Impacts to the wetland include signs of climate change, such as drying, and evidence of human constructed earthworks and overgrown berms along the south perimeter of the wetland. The BC Freshwater Atlas numbers this wetland as 705006490.

Figure 5: Photograph of wetland, showing lots of Scrub Birch present.

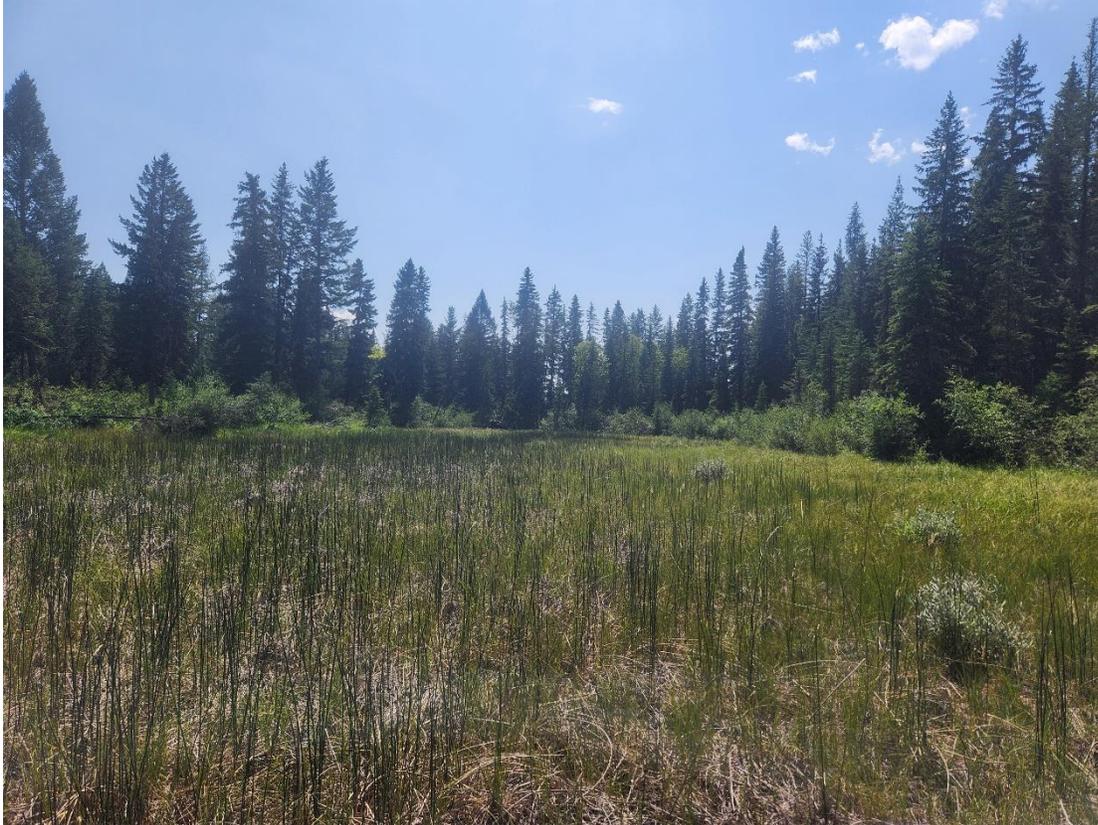
We surveyed two plots in Wetland 6, both of which were classified as marsh, including one classified specifically as Great Bulrush marsh (Wm06). This wetland was considered seasonally inundated and palustrine. Human impacts observed in this wetland included evidence of drought and climate change affecting the wetland's water availability. The BC Freshwater Atlas numbers this wetland as 705005797.

Figure 6: Photograph of Wetland 6, showing Bulrush and Sedges, as well as dry state of wetland in July 2024.

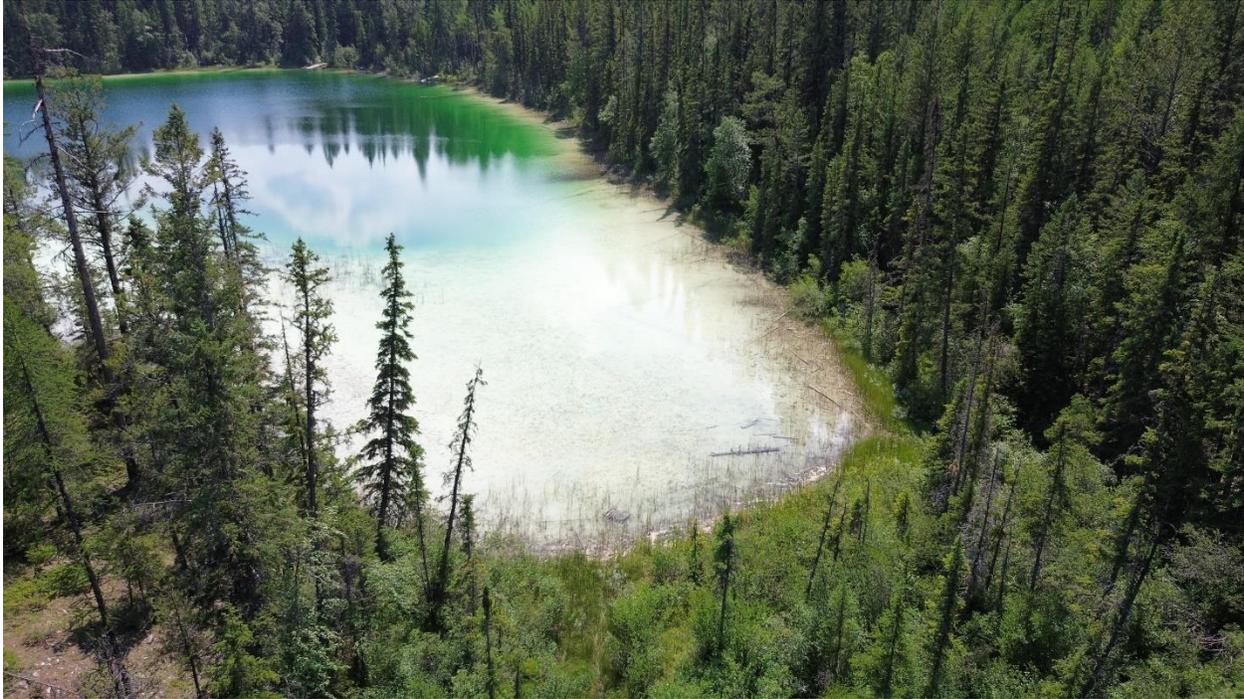
Wetland 7 is located around the north perimeter of Spur Lake and is thus considered a lacustrine wetland. Spur Lake is accessible by road and is used by recreationists, such as anglers and kayakers. We surveyed three plots in this wetland, and they were classified as swamp, marsh, and lake. The swamp has a seasonal hydroperiod, while the marsh and lake are permanently inundated, with surface water present all year round. Water depth in the marsh area was 0.13m. While no adverse human impacts were noted, it is likely that this wetland is affected by climate change and that recreation may be having an impact. The BC Freshwater Atlas numbers this wetland as 705005857.

Figure 7: Spur Lake and perimeter wetland.

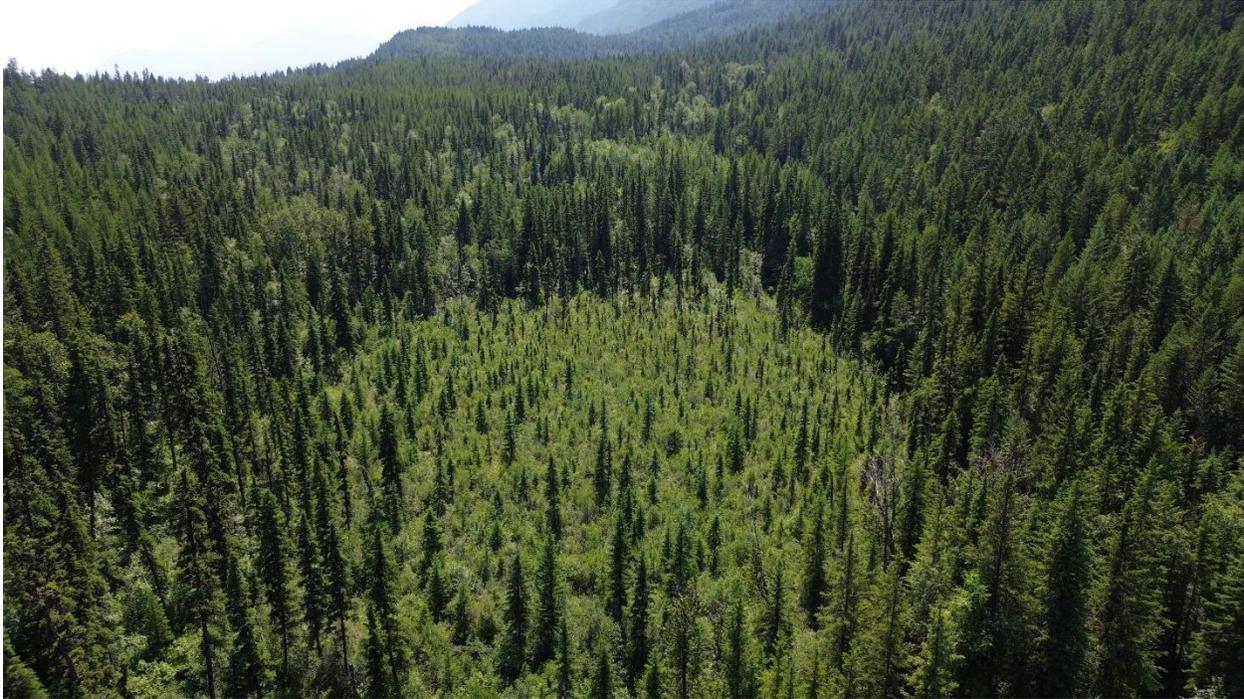
We surveyed one plot in Wetland 8. While it was identified as a bog in the field, it is likely that this is a fen, as conditions are not conducive to bog formation in this area. The high tree percentage reported suggests this may be a wooded fen such as those identified as Wf06 Scrub Birch, which we have found in multiple wetland sites on the benchlands on the west side of the Columbia Valley, and which display a wide range of characteristics that do not appear to be distinguished by the current BC wetland classification system.

This wetland had an ephemeral hydroperiod and was noticeably impacted by periods of drought and reduced water in the system, much like other wetlands in this region. The BC Freshwater Atlas numbers it as 705006373.

Figure 8: Wetland 8, showing Scrub Birch fen conditions.

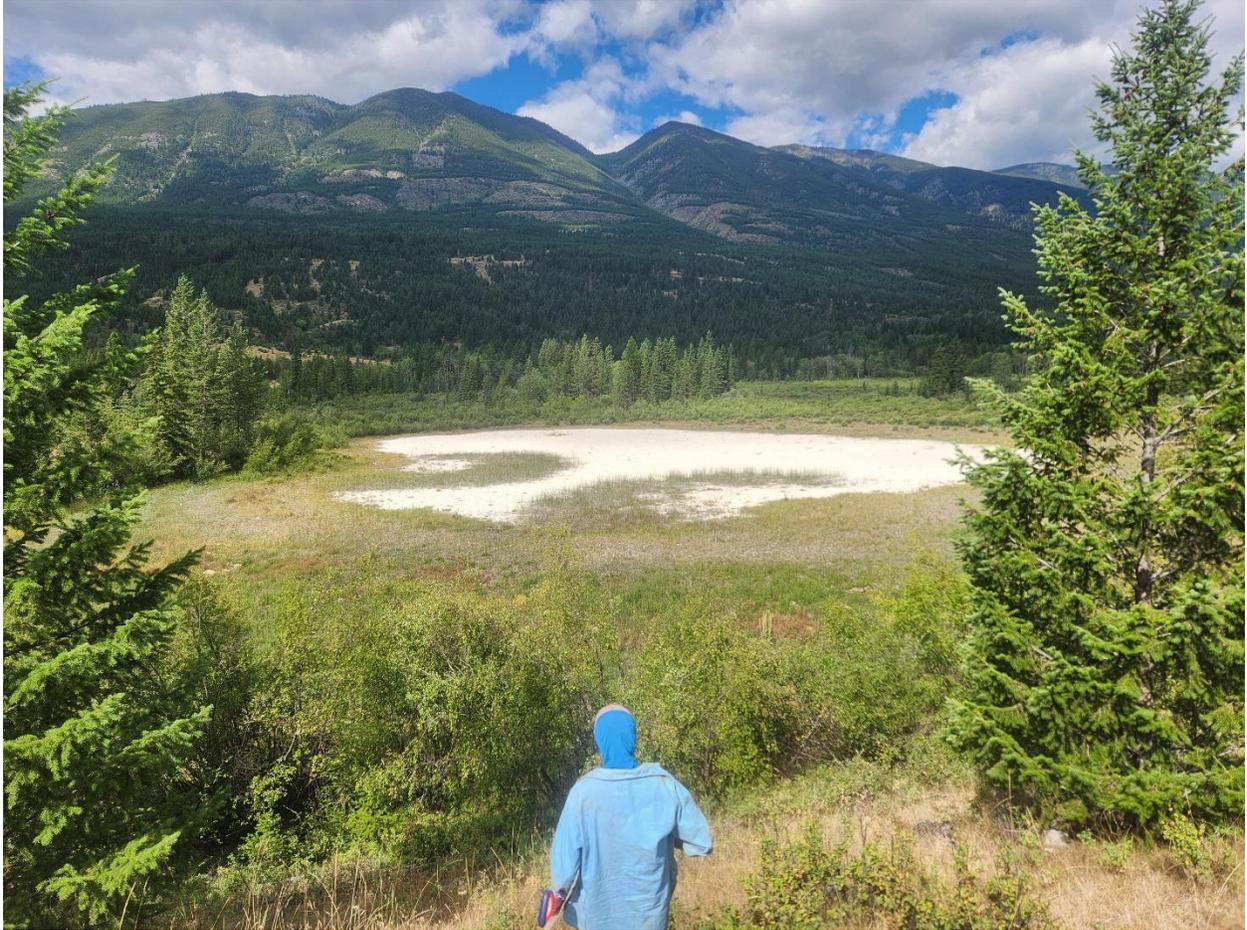
In this wetland we surveyed only one plot, which we identified as an alkaline meadow. A salt crust was visible across this entire wetland area. We classified this wetland as palustrine with a seasonal hydroperiod, and likely to be impacted by its proximity to roads and powerlines, and increased drought conditions due to climate change. In the BC Freshwater Atlas this wetland is numbered as 705006473.

Figure 11: Photograph of wetland, showing obvious salt crust.

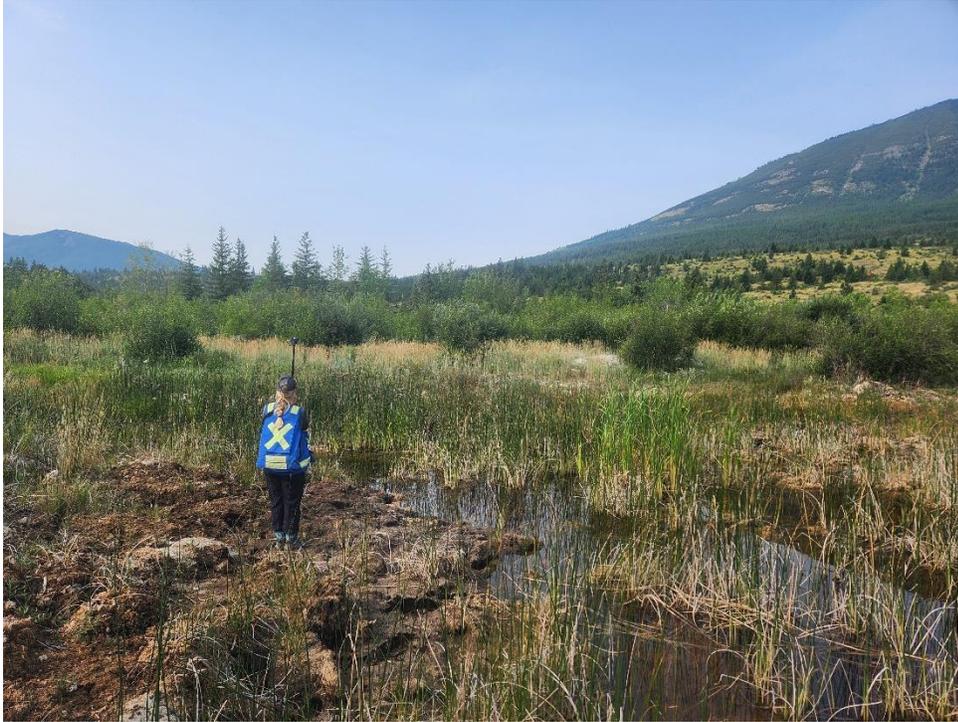
We surveyed six plots at this site, two of which were swamp, two of which were marsh, and two of which were classified as non-wetland. Hydroperiod varied from seasonal to ephemeral, and open water was present in the marsh areas in ponded areas that were dug as part of the restoration project. The depth of water in these areas ranged from 0.05 m to 0.60 m deep. We noted invasive species such as Canada Thistle *Cirsium arvense* growing on the soil mounds that had been excavated from these areas, and suspect that drying due to climate change and water demands for ranching is adversely impacting this wetland, as a portion of Sun Creek is diverted upstream of this wetland to an artificial dam holding water for cattle.

Figure 13: Photograph of restoration area of wetland, classified as marsh, showing open water areas, Bulrush, earth mounds, and presence of invasive species such as Canada Thistle.

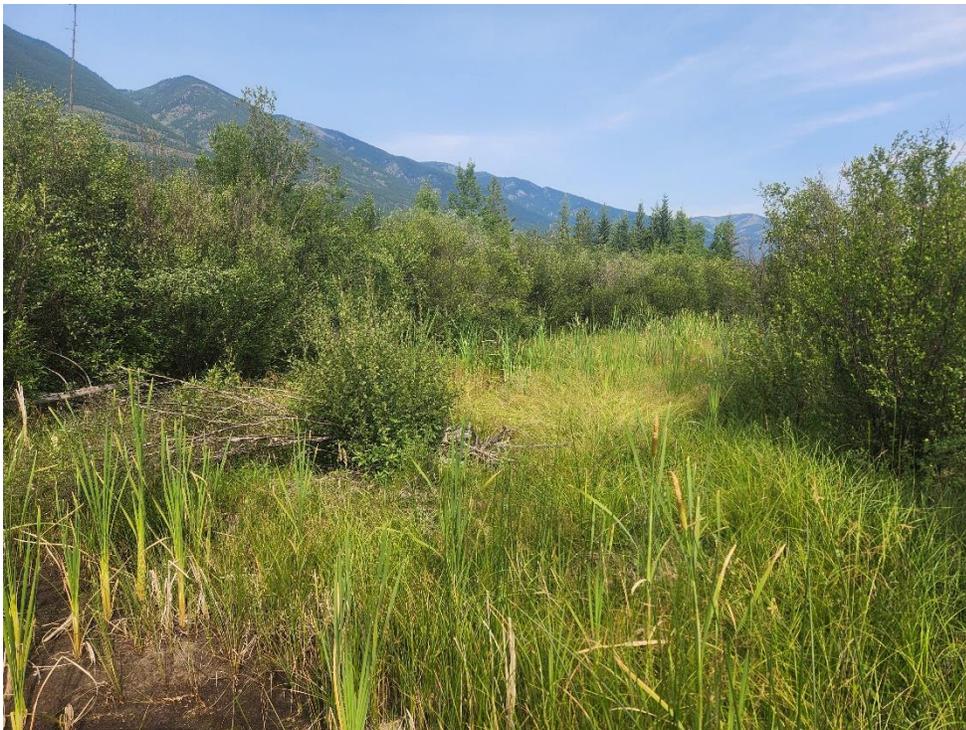
Figure 14: Swamp area of wetland, showing sedges and Scrub Birch. Open water was not present, but the ground was wet underfoot and this area was dominated by wetland plants.

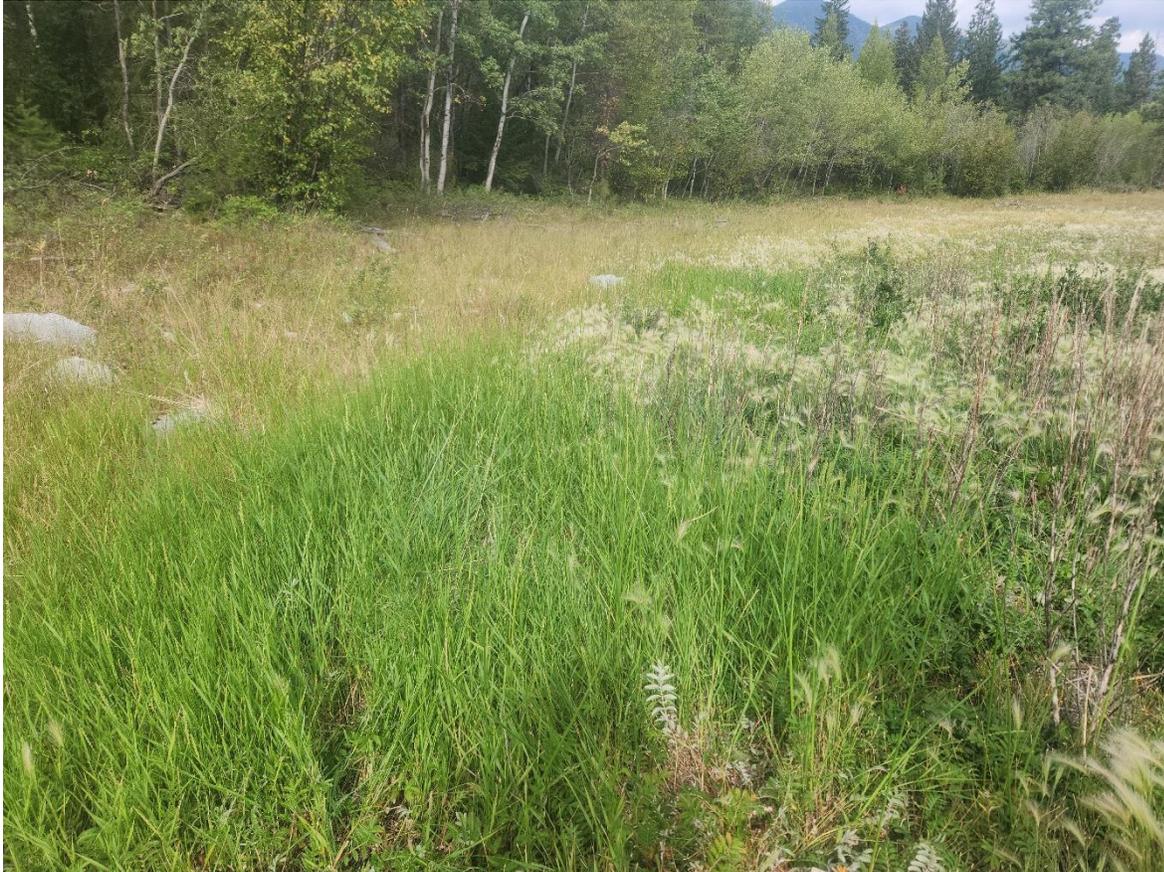
We surveyed a single plot in this wetland and classified it as an alkaline meadow. This wetland is not mapped in the BC Freshwater Atlas.

Figure 15: Photograph showing presence of Foxtail Barley as well as ruderal species.

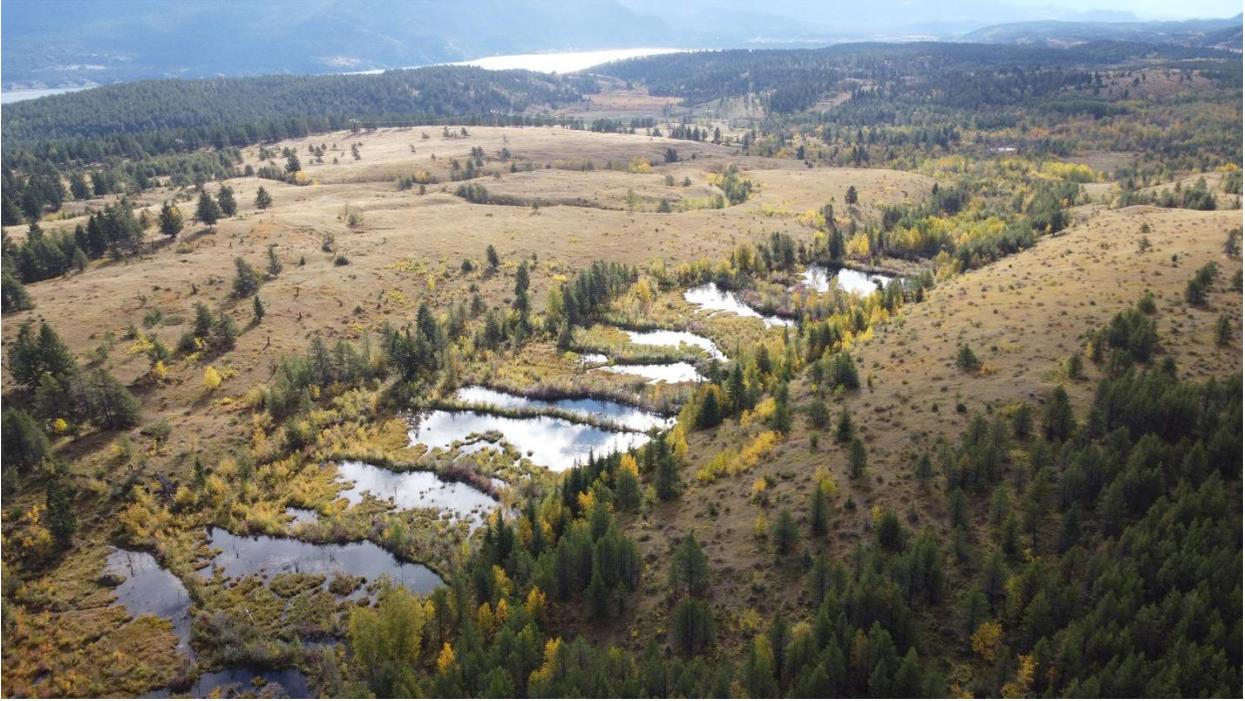
The wetlands within the Marion Creek West Wetlands are highly impacted by beavers; we observed a clear association between the presence of active beaver dams and open water and marsh dominated wetlands (Figure 24). An estimated 4.23 ha of open water area was being maintained by beaver dams in this system, holding an estimated 33,447 m³ of water on the landscape. This is important both for the wetlands themselves and also for the larger system. This is a dry region, with a projected moisture deficit of 45 cm/year (MacDonald Hydrology Consultant Ltd., 2024), and so the presence of water is a valuable resource. Without these beaver dams, there would be far less wetland habitat in this system, and less water available for wildlife and humans.

Figure 24: Aerial photo showing contrast between wetlands maintained by beaver dams along Marion Creek and surrounding landscape.
