Summary of Columbia Lake Stewardship Society's 2018 Water Quantity Monitoring Program

Prepared by W. Thompson

January 2019

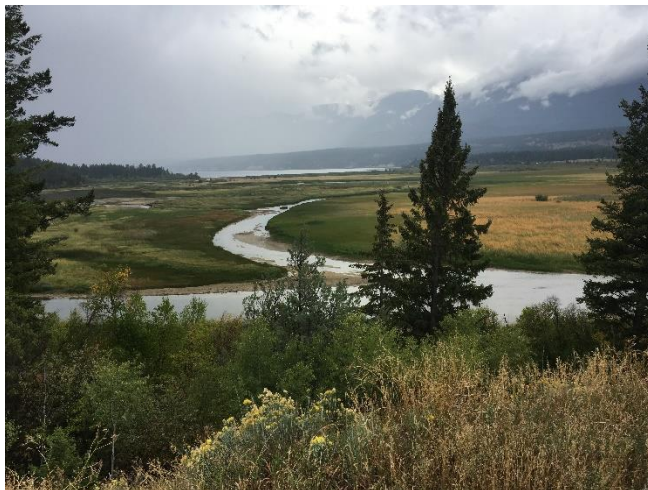
For convenience of measurement the outflow point of the Columbia Lake Watershed is on the Columbia River at the Highway 93/95 crossing near Fairmont Hot Springs. The area above that point is 881 square kilometres. The bulk, 696 square kilometres, is contained in the Dutch Creek sub-basin. The boundaries of the watershed are shown in the inset of Figure 1.

The actual outlet from the lake is not at the Highway crossing but a few hundred metres upstream. Warm Creek enters the Columbia River between the two points and constitutes about 9 square kilometres of the entire 881 square kilometre area. Also, in the area is the delta of Dutch Creek. In its present configuration and when flow rates are low, water from Dutch Creek flows across the delta to directly enter Columbia River. That hasn't always been the case. The channels are continually shifting and at times in the past have entered the Lake before reaching the river (see Jamieson, 2011).

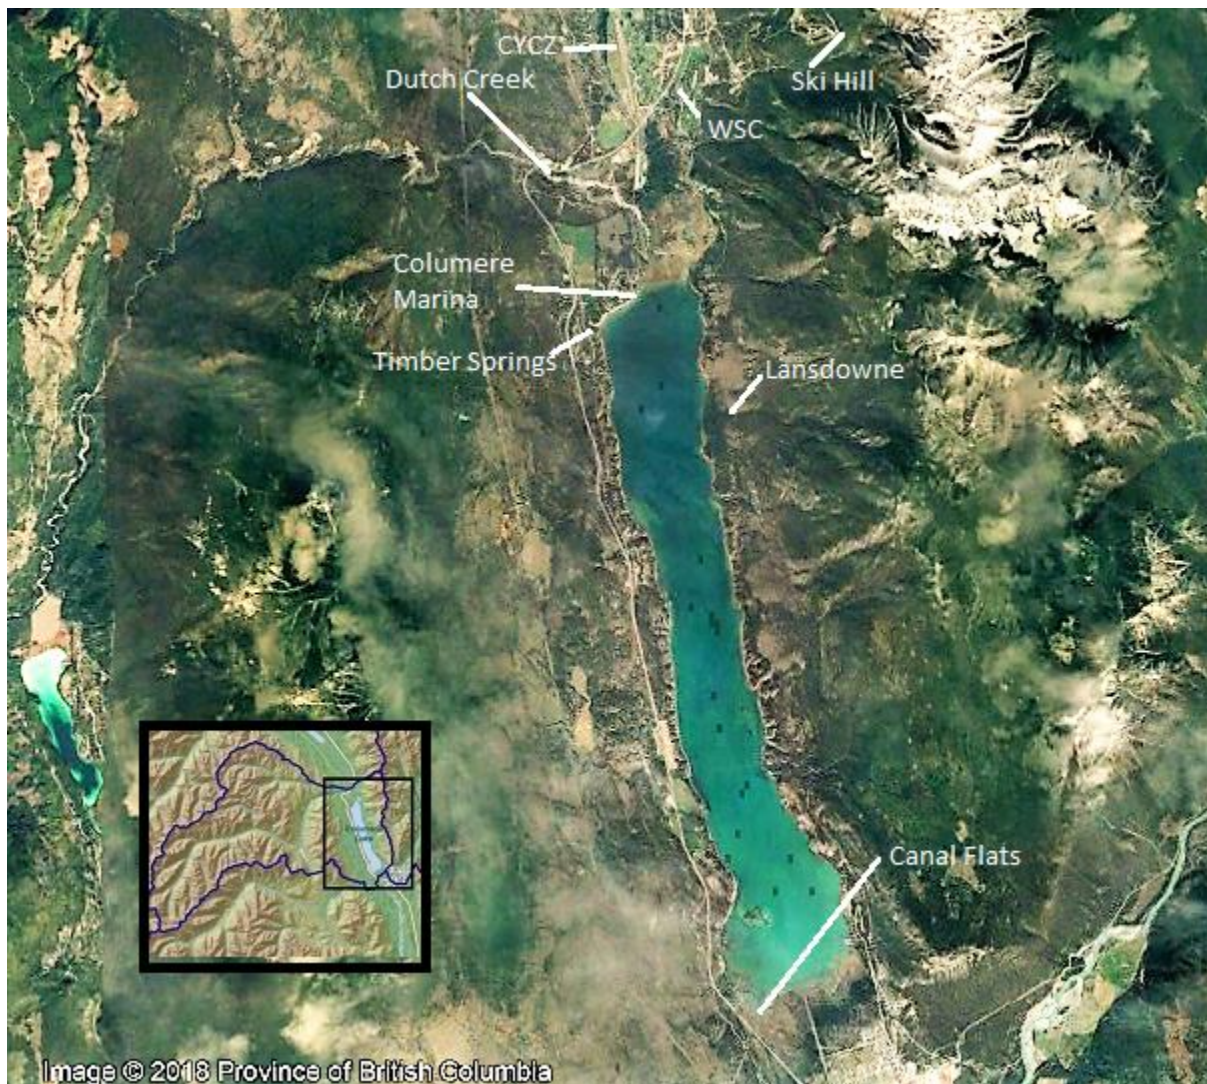
Figure 1 – Map showing station locations. Entire watershed boundary is shown in inset. Site abbreviations are provided in Section 4.1.

Four of the water level monitoring stations installed in 2015 remained in operation during 2018. Their locations are shown in Figure 1. One was situated in the Columere Marina and measured lake level. The others were on the Headwaters Creek in the Columbia River Headwaters Park near Canal Flats (Canal Flats), on the Columbia River near Fairmont Hot Springs (WSC) and on Dutch Creek at the Highway 93/95 Bridge (DC). In cooperation with the Nature Conservancy of Canada a new station was installed on Lansdowne Creek (see Figure 1) in the fall of 2017. That creek flows from the slopes on the east side of Columbia Lake and the purpose of the installation was to examine the behaviour of streams contributing local inflow.

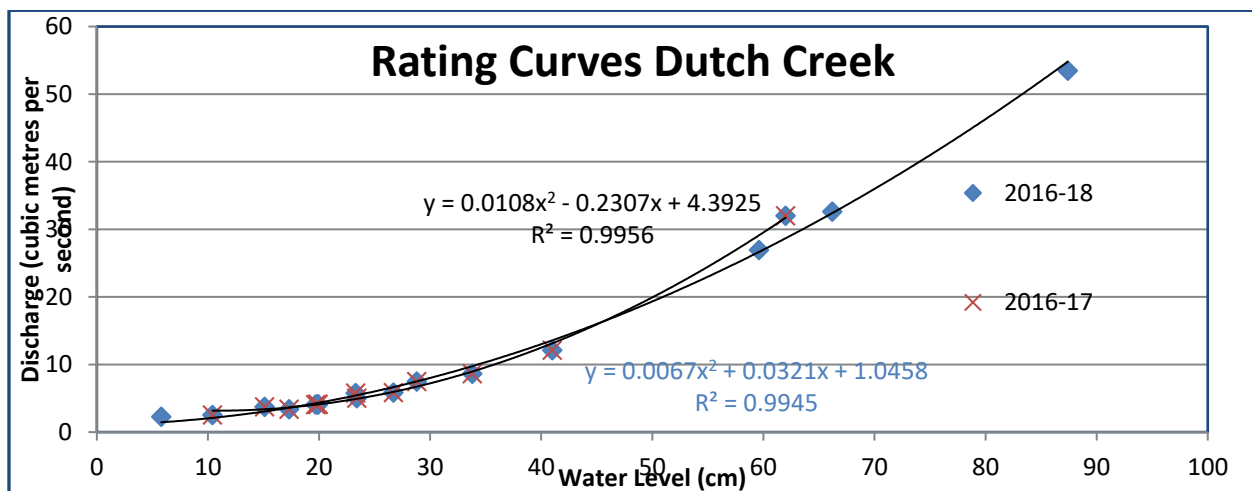
Figure 12 –Rating curves for Dutch Creek. One is based on flow measurements available up to 2017.

The second is derived from the same data set plus four new measurements made during 2018. The upgraded curve yields lower flow rates when water levels are high.

Flow measurements were also made on Dutch Creek during 2016-17 season but all were made when water levels were low. Two measurements made in high water were contributed by a private firm. A major objective in 2018 was to obtain additional measurements in conditions of high water. Dutch Creek is fast flowing and requires the use of a platform located above the water from which to suspend a current meter. In late 2017 a request was made to the BC Ministry of Transportation and Infrastructure to operate from the highway bridge overlying Dutch Creek. A permit was granted on condition that a flagging company be contracted to control traffic. This allowed for three high water flow measurements to be made. A fourth measurement had been made earlier in the season when the water level was low. The 2016-17 data points and corresponding rating curve is shown in Figure 12. The four new points acquired in 2018 are superimposed. Also superimposed is the updated rating curve based on all data points (2016-18).

The contribution of the three high water points is significant. The projected flow rates during high water are much lower using the updated curve than those provided by the earlier curve.

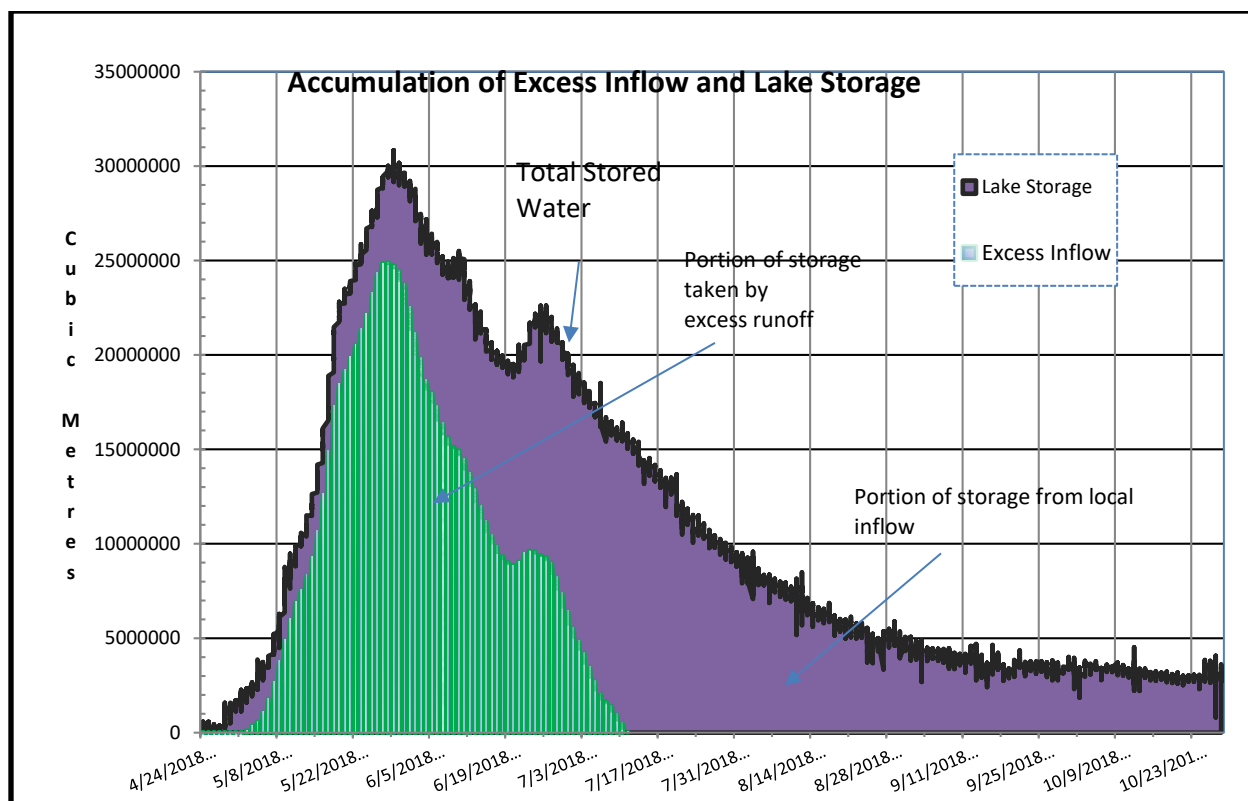
Figure 14 – Comparison of contribution of water from Dutch Creek to total change in lake volume.

The rise in Columbia Lake represents stored water. The rate at which that water is being stored can be calculated from the surface area of the lake and the hourly change in lake level measured at the Columere site. Figure 14 shows the accumulation of the hourly changes over the April 14 – Oct 28, 2018 period. The hourly rate at which excess runoff was being accumulated can also be calculated from the Dutch Creek and WSC records. The accumulation of those hourly amounts is also shown in Figure 14.

Not unexpectedly the amount of stored water reached a maximum when the lake peaked. The stored water is from two sources. One is the excess runoff from Dutch Creek shown in green. The other, shown in purple, is the net local inflow into the lake and is the result of the integration of gains to the Lake from groundwater, surface runoff and precipitation and the losses from evaporation and consumptive use.

By July 11 all of the excess Dutch Creek runoff held in storage had been depleted. After that only accumulated local inflow remained and the lake will continue to draw down until later in the year when it reaches its normal winter level.
