# Summary of Columbia Lake Stewardship Society's 2019 Water Quantity Monitoring Program

Prepared by W. Thompson

February 2020

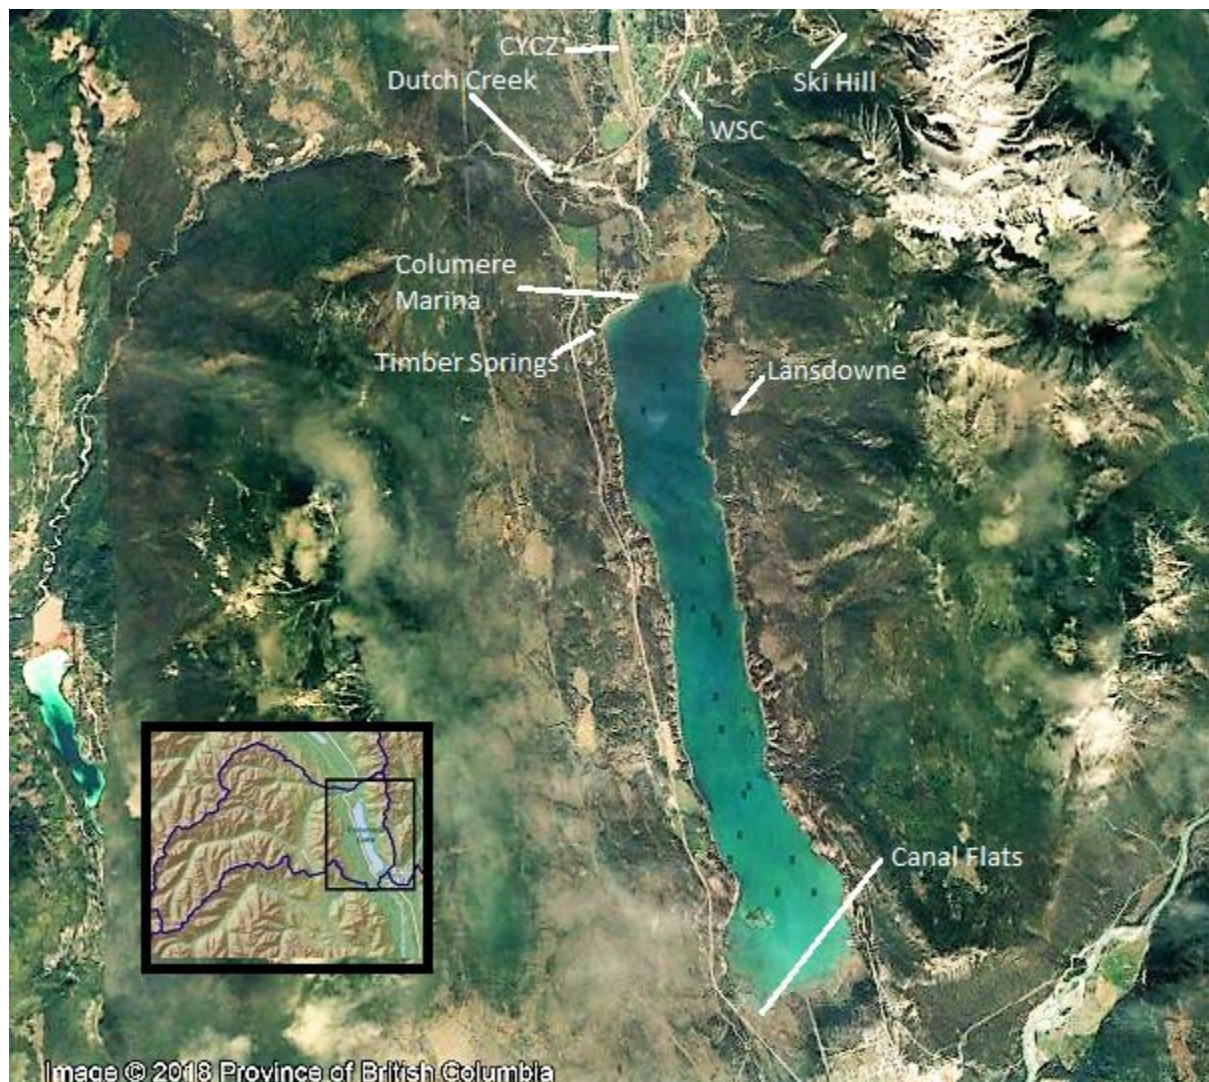
Figure 1 – Map showing station locations. Entire watershed boundary is shown in inset. Site abbreviations are provided in Section 4.1.

For convenience of measurement, the outflow point of the Columbia Lake Watershed has been and will continue to be on the Columbia River at the Highway 93/95 crossing near Fairmont Hot Springs. The area above that point is 881 square kilometres. The bulk, 696 square kilometres, is contained in the Dutch Creek sub-basin. The boundaries of the watershed are shown in the inset of Figure 1.

Four of the water level monitoring stations installed during 2014 and 15 remained in operation. Their locations are shown in Figure 1. One was situated in the Columere Marina (Columere) and measured lake level. The others were on the Headwaters Creek in the Columbia River Headwaters Park near Canal Flats (Canal Flats), on the Columbia River near Fairmont Hot Springs (WSC) and on Dutch Creek at the Highway 93/95 Bridge (DC). A fifth station, Lansdowne Creek installed in 2017 operates on Nature

Conservancy of Canada property. A new station (Outlet) was installed in August on the Columbia River just below the outlet from the lake.

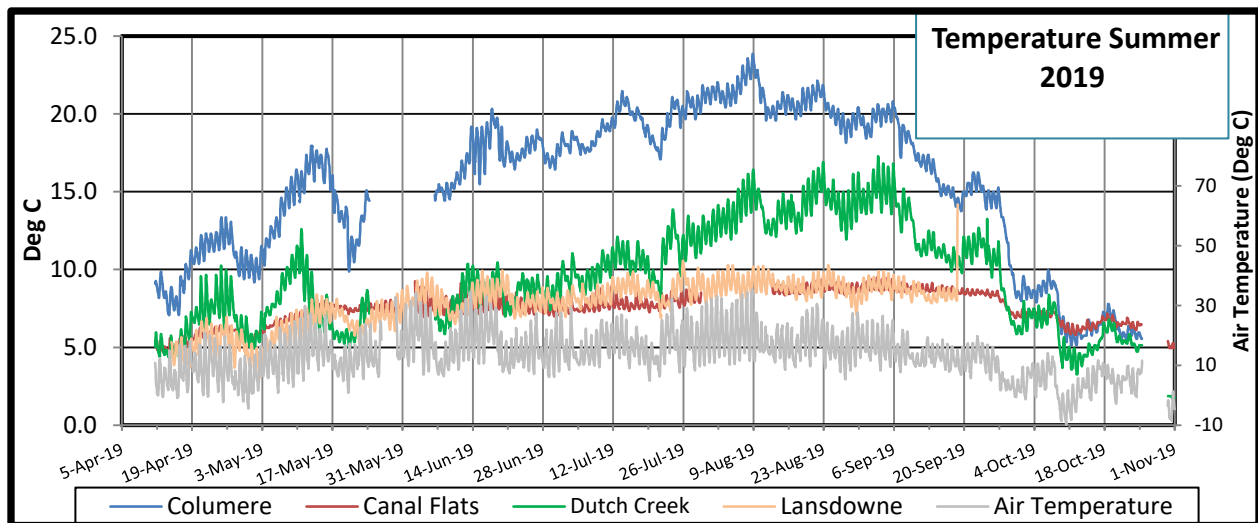
Figure 8 – Water temperatures recorded at the Columere, Canal Flats, Lansdowne and Dutch Creek sites. Air temperature was recorded at Timber Springs.

The water temperatures recorded during the open water season at are shown in Figure 8. Again, temperatures recorded at the WSC site are non-representative and not shown. The temperature of the water recorded in the lake was well above that recorded at other locations for most of the season and is presumed to have been due to the absorption of solar radiation by suspended materials and the lakebed. The cooler temperatures recorded at Canal Flats are attributable to the Creek's groundwater source. Air temperatures recorded at Timber Springs are shown at the bottom of the chart for comparison

Warm temperatures prevailed during the periods: May 13-17, June 1-5, June 13-20 and July 5-7 (see Figure 8). The accelerated rate of snow melt during these periods resulted in corresponding rises in the flow in Dutch Creek that passed downstream into both the Columbia River and into Columbia Lake. The most significant of these was the June 3-7 peak period.

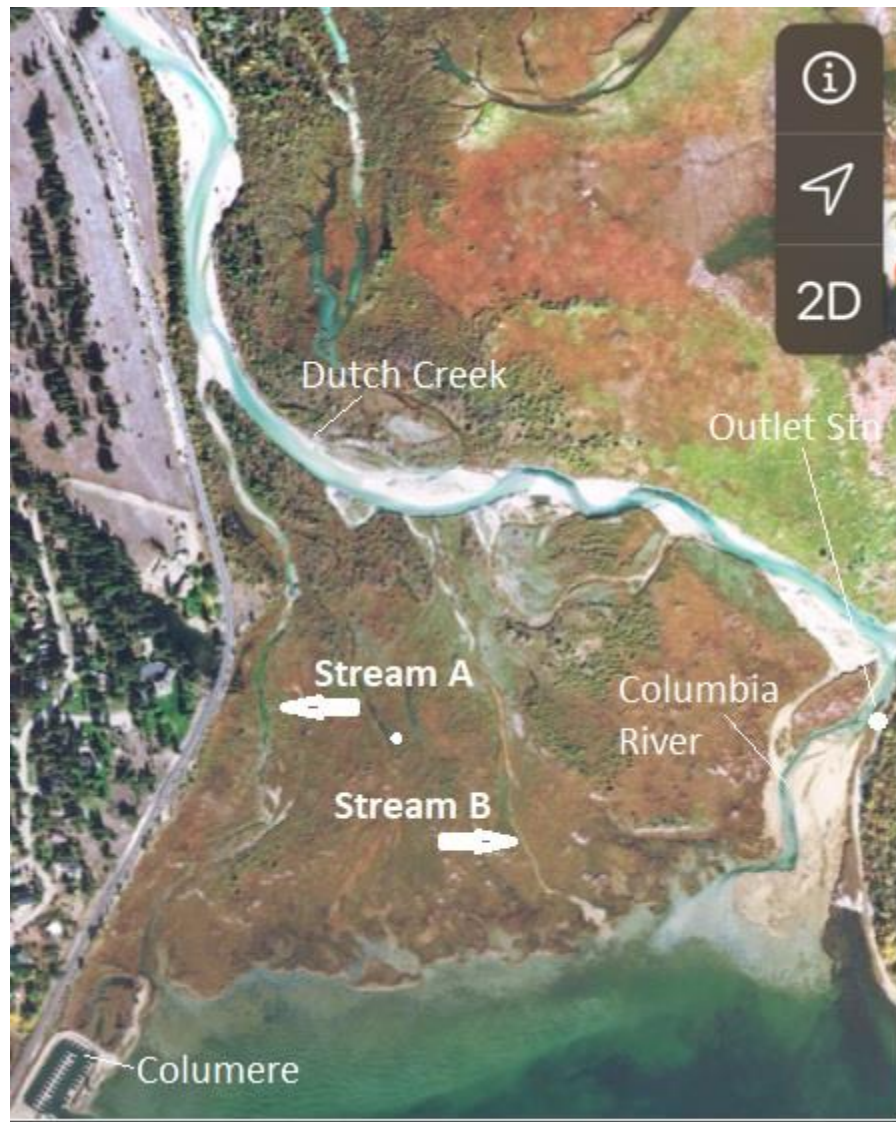
Figure 12 – Image of Dutch Creek delta showing locations of Streams A and B. Date of image unknown.

In order to gain an understanding of the rate of recession, two traverses were made over the delta near the south shore of Dutch Creek. One was made August 8 and the second October 24. A few side channels were found but only two emptied into the lake. They were labelled Streams A and B and are shown in Figure 12. The flow in Stream A was estimated to be about 0.36 cubic metre per second during the August traverse but had dropped to about .10 cubic metre per second by the October traverse. The flow in Stream B was significantly less on both occasions. Thus, it seems that by the end of the open water season much of the flow remains in the main channel and only a small amount enters the lake.
