Beaver and Cottonwoods in Columbia Wetlands

Dr. Suzanne Bayley, Catriona Leven, Annie Pankovitch
CWSP AGM
May 16, 2022

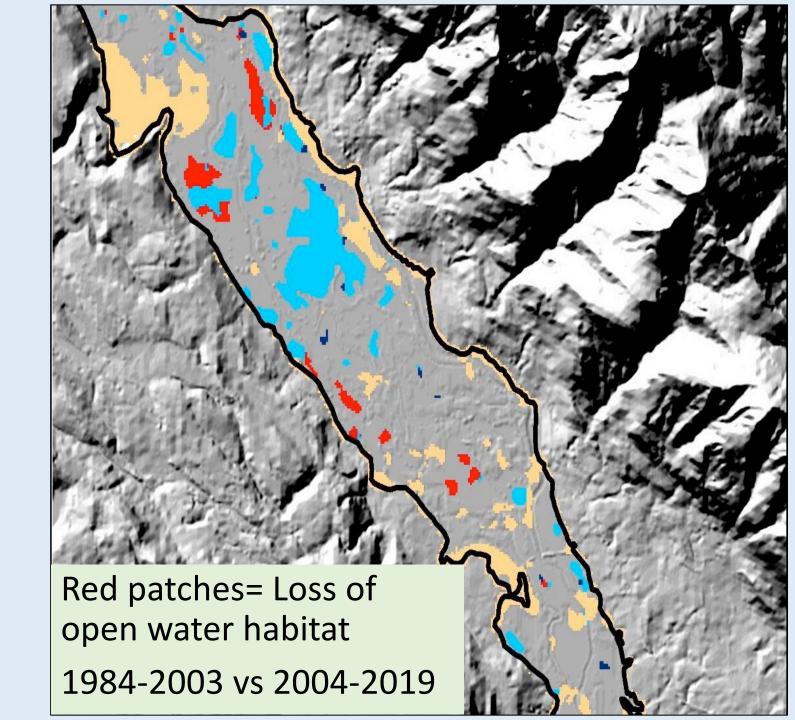
Climate Impacts in Columbia Wetlands 1984-2019

The Columbia
Wetlands are losing
open water habitat
in the summer

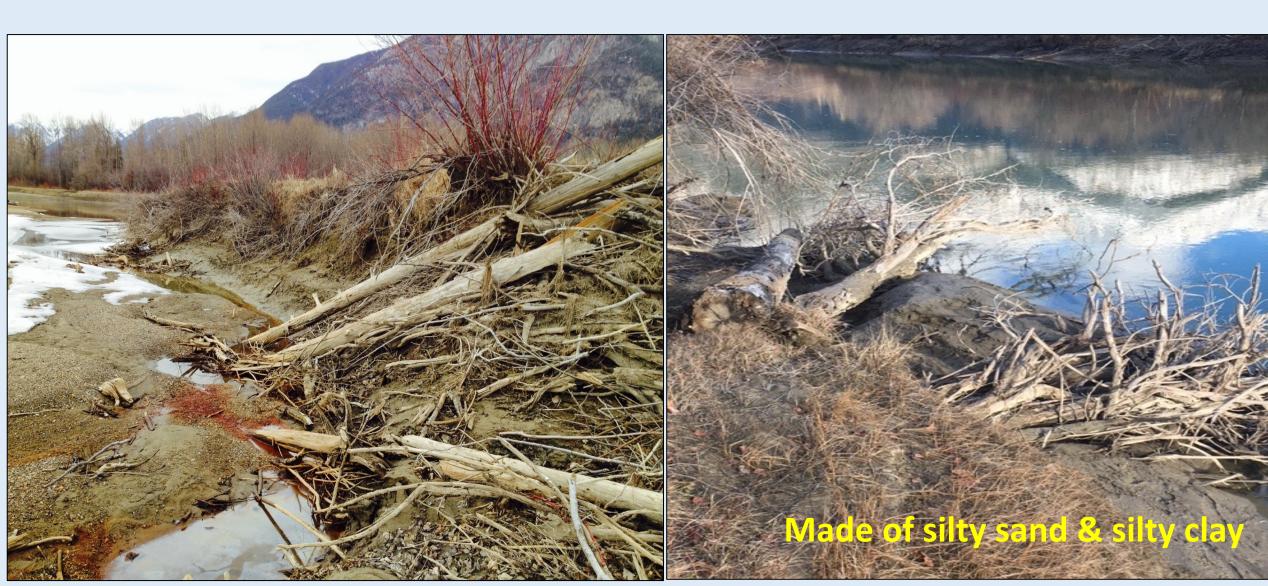
Sediment from the river forms natural levees creating wetlands

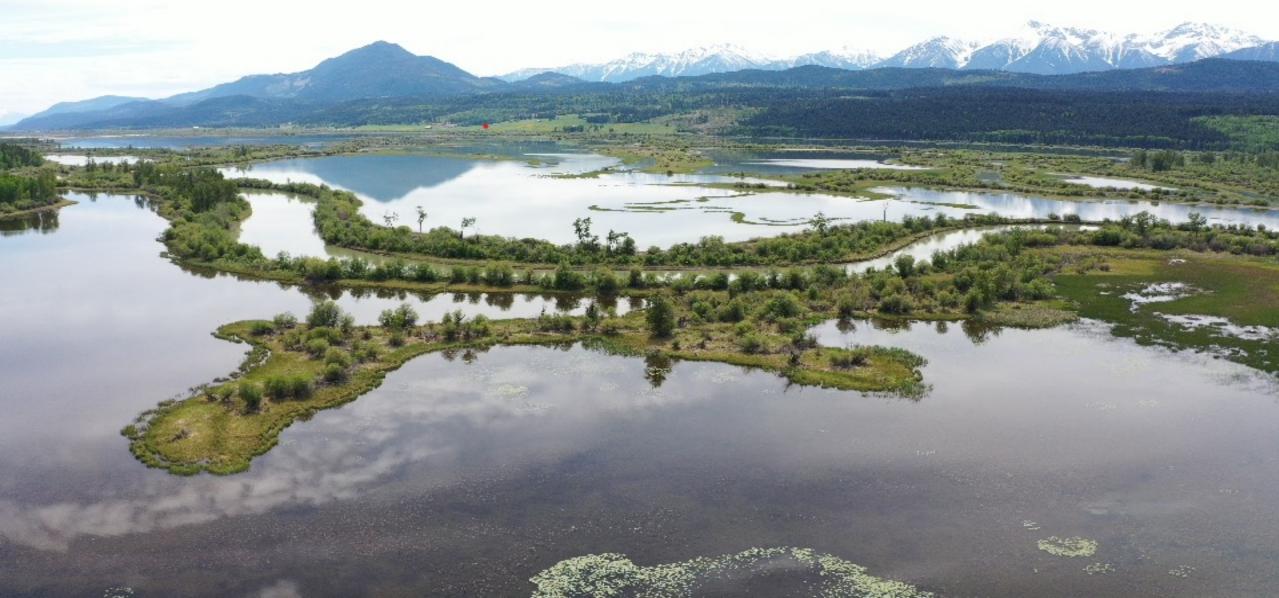
Floodwaters must go over the levees or through gaps in the levees

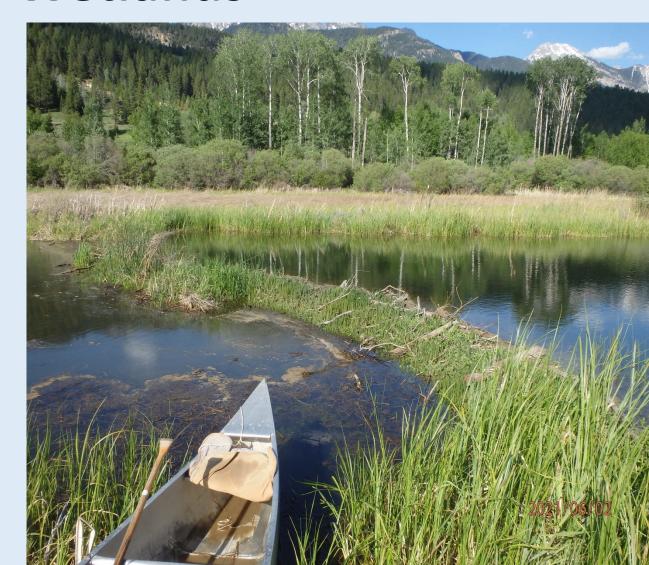
There Are Many Beaver Dams In The Columbia Wetlands

- 273 beaver dams
 within 30m of 38 study
 wetlands
- Measured 76 beaver dams

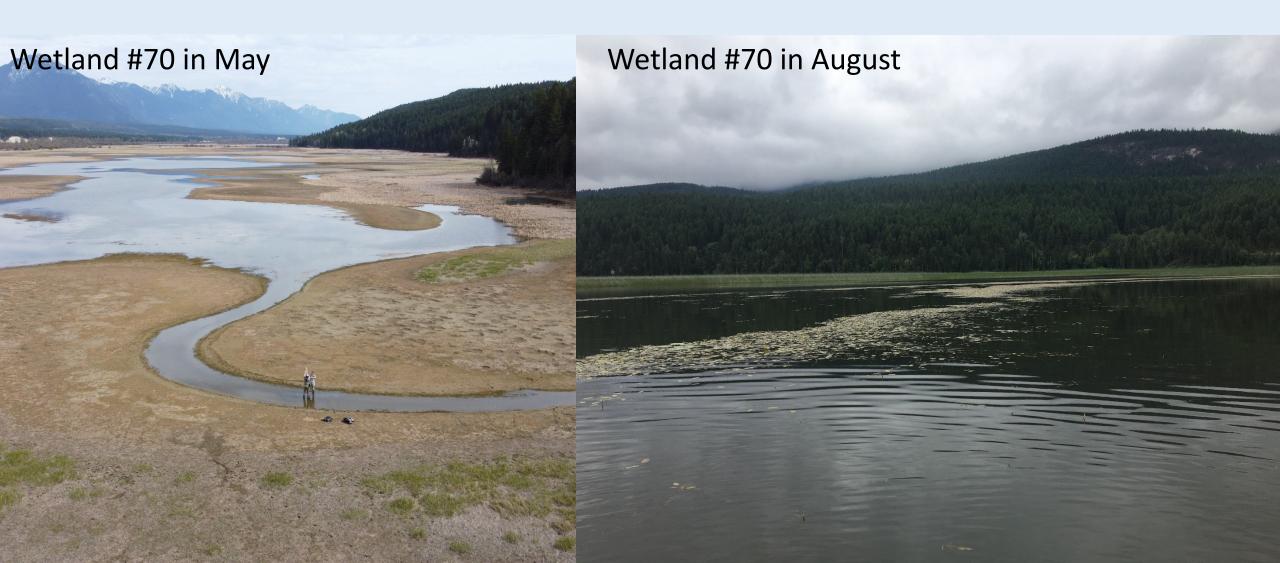
Wetland water levels controlled by the River

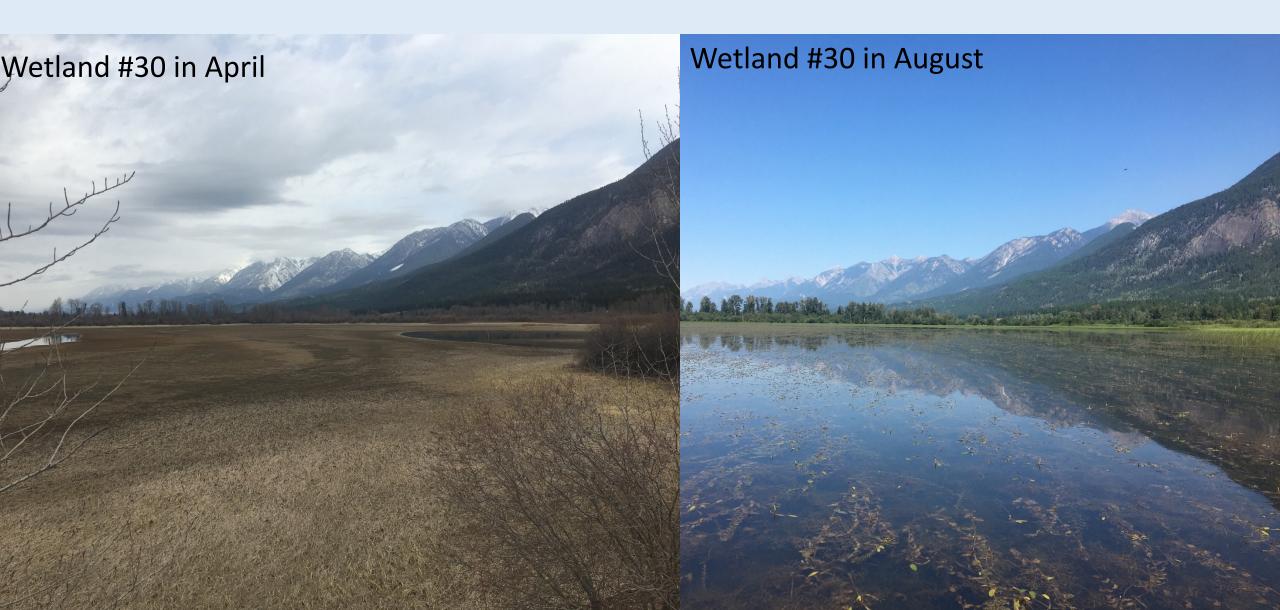
Wetland water levels controlled by the River

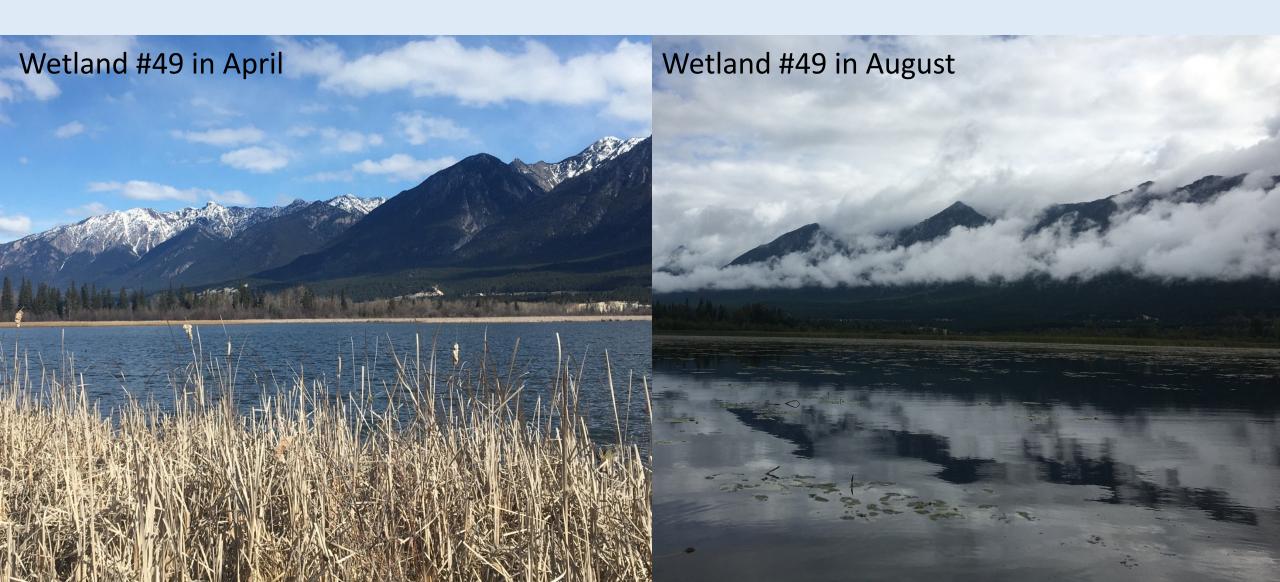
Wetland water levels controlled by beaver dams

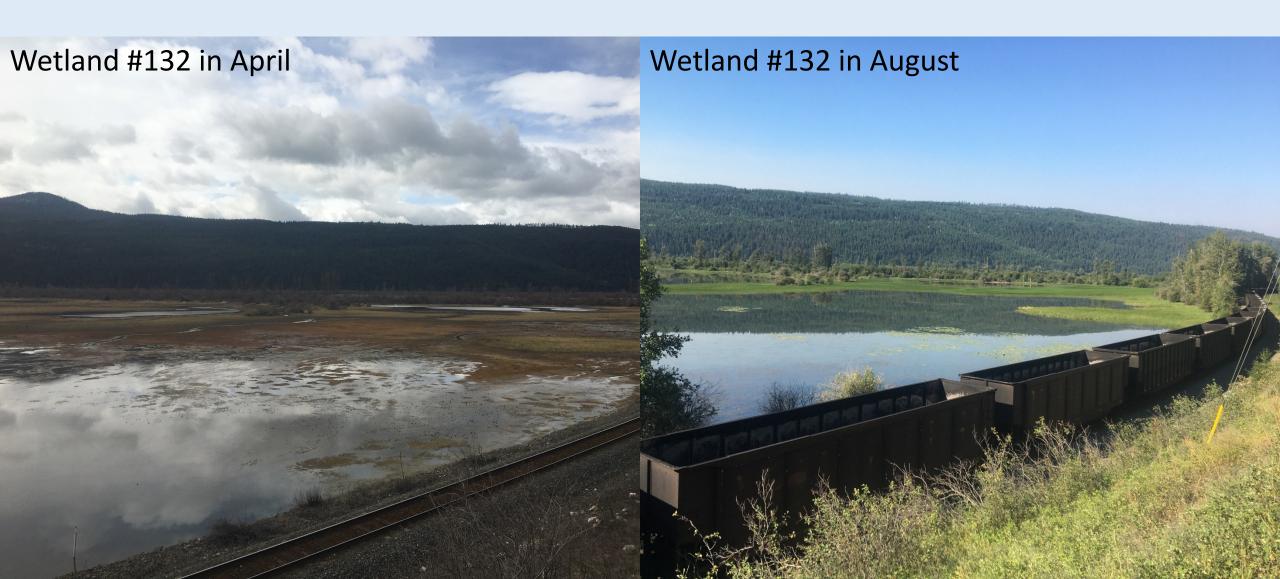
Wetland water levels partially controlled by beaver dams

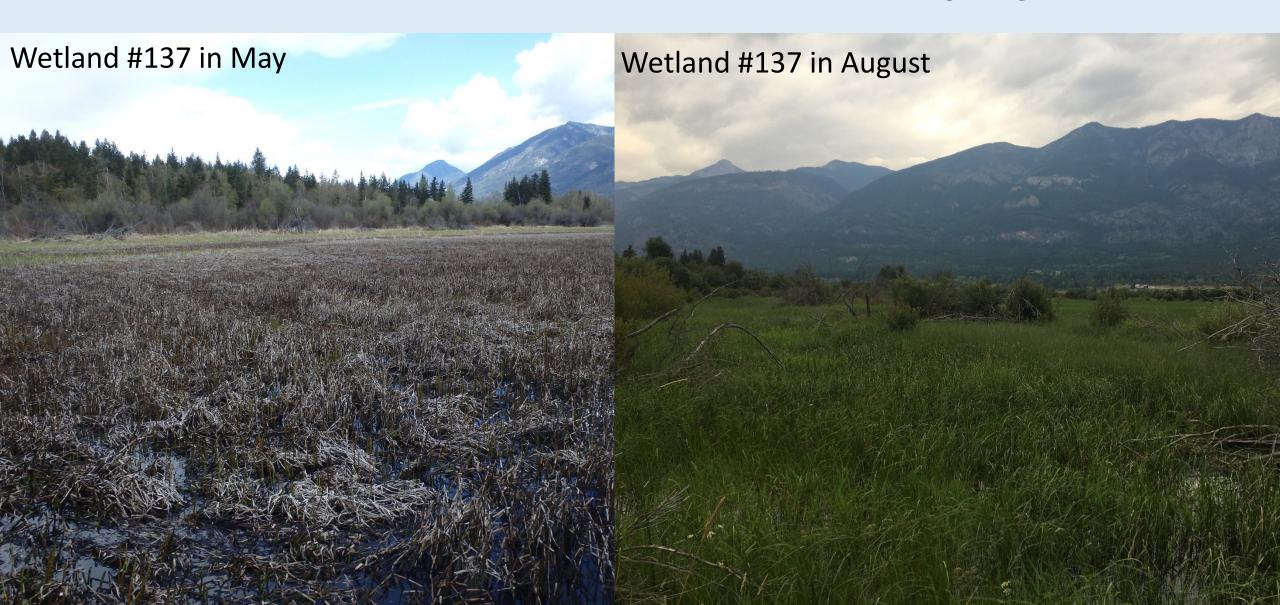
Wetland water levels controlled only by levees

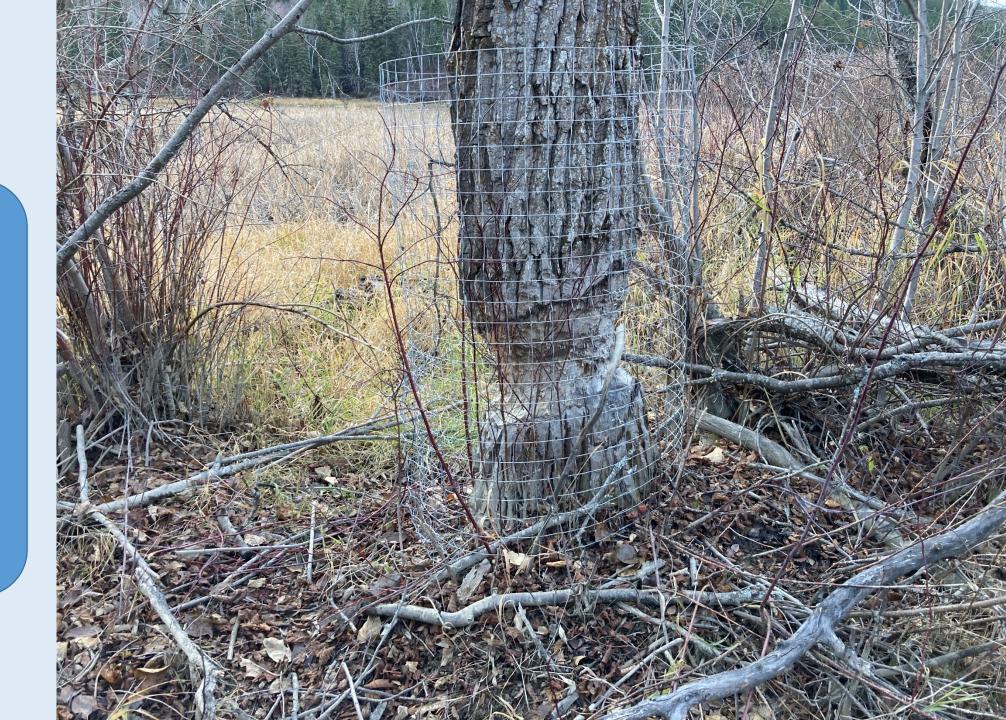
Installed
Wire Guards
on 45 large
cottonwood
trees
