Canada Nature Fund: Community-Nominated Priority Places for Species at Risk

Kootenay Connect: 5CW Columbia Wetlands: Hydrology and Beavers: Wetlands on the Western Upland Bench of the Columbia Valley

March 31, 2024. Final Report: Year 5

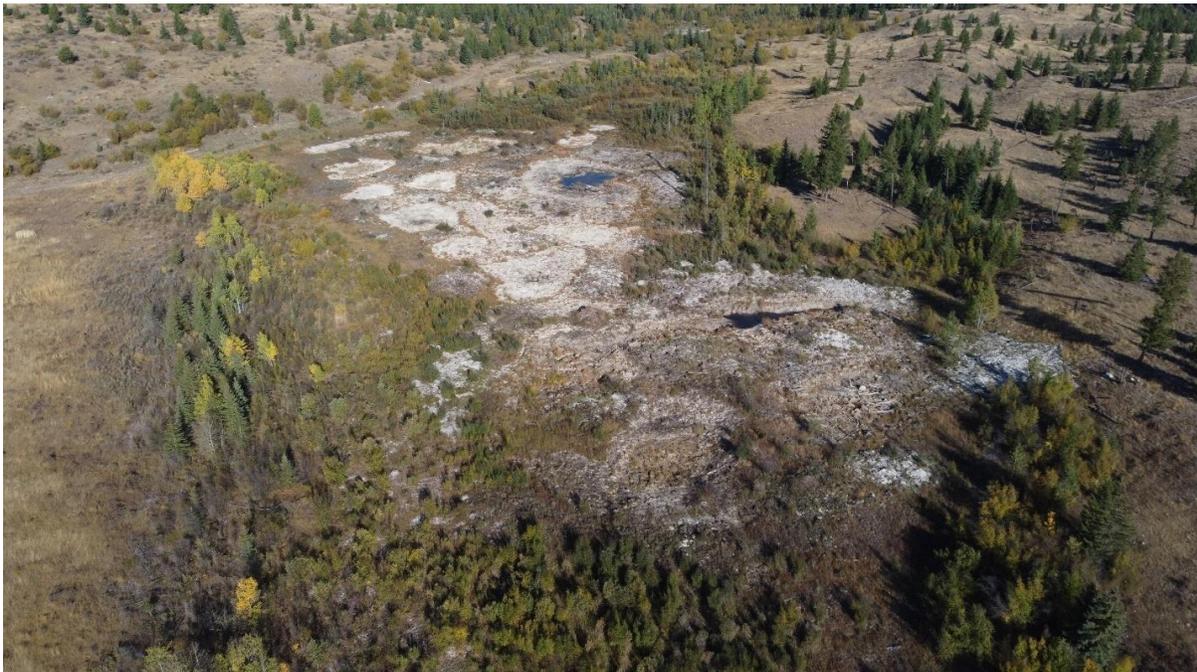
Figure 6. Sun Creek Restoration project located at 50.184874 N, 115.885420 W on the west side of Columbia Lake between Canal Flats and Fairmont. Drone image taken on September 15, 2023.

The southernmost region (between Canal Flats and Fairmont) exhibited the most drying and had no ‘adequately wet’ or ‘mostly wet but drying’ wetlands present (Table 2). However, of the wetlands dominated by hydrophobic communities (e.g., shrub, conifer, mudflat, dryland), there was open water or wetland vegetation present in 50% (n=8) of the wetlands assessed in this region (category: drying with wetted areas). The Sun Creek Wetland Restoration, led by the Nature Trust of British Columbia, is one example of a ‘drying with wetted areas’ wetland within this region (Figure 6).

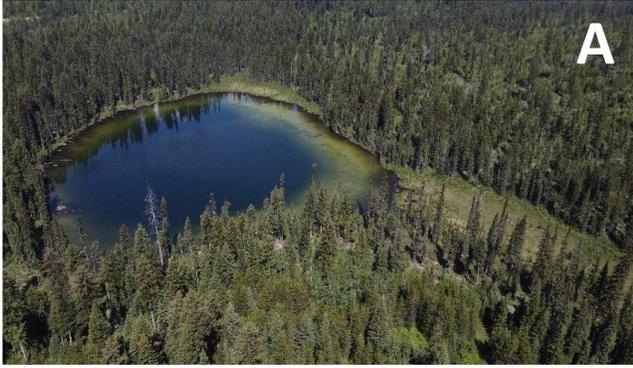
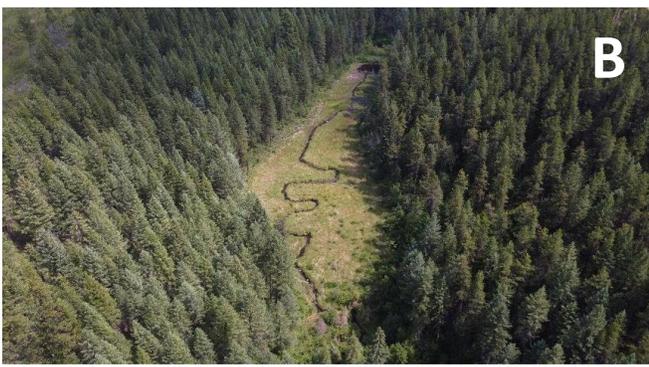
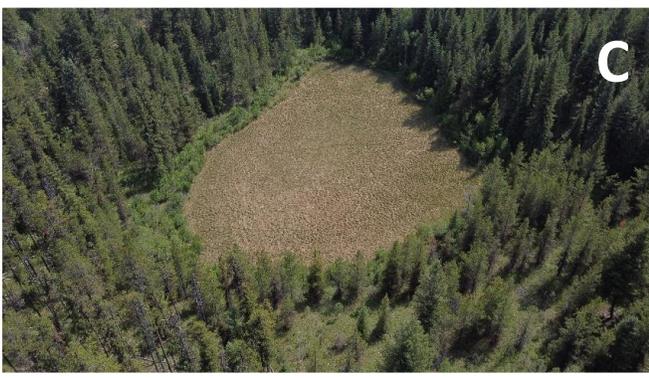
Figure 7. Examples of the three main wetland categories observed on the western upland bench of the Columbia Valley – wetlands on lake edges (A), wetlands in stream channels (B), and isolated pocket wetlands (C). The proportion of wetlands in each status category, derived from vegetation community classifications, is also displayed for the three water source types (D, E, and F). Wetland status was defined as: Adequately wet wetlands have open water/wetland vegetation dominant and subdominant, Mostly wet but drying means open water/wetland vegetation dominant but hydrophobic vegetation (shrub, conifer, deciduous, mudflat, or dryland) subdominant, Drying with wetted areas means hydrophobic vegetation dominant but open water or wetland vegetation present, and No signs of water means no open water or wetland vegetation observed in the polygon.

During field assessments, we identified three main categories of wetlands present on the upland bench – wetlands on lake edges, wetlands in stream channels, and isolated pocket wetlands which presumably obtain their water from precipitation and/or ground water (Figure 7A-C). We classified the FWA wetland polygons with vegetation community information (n = 214) into these categories to reflect the three main apparent sources of water. Wetlands that are on edges of lakes greater than 3 ha were classified as ‘lake edge wetlands’, those with a continuing FWA Route (route is the FWA term for stream) running through them were classified as stream channel wetlands, and those that did not possess a FWA Route or possessed a route contained within the wetland boundary were classified as isolated wetlands.

The most common type of wetland within our study area were those in stream channels (68%; n = 146). We hypothesize that wetlands with smaller drainage basins or are positioned closer to the headwaters of a small stream are likely exhibiting more signs of drying. In an effort to distinguish whether this might be true, we compared wetlands positioned either at the very beginning of a FWA route (n = 23) to those that occur downstream of the FWA route origin (n = 123). Stream channel wetlands at the beginning of a FWA route exhibited a lower percentage of adequately wet polygons (13%; n = 3), open water/wetland vegetation as their dominant and subdominant communities, than wetlands that occurred later in the stream network (n = 28; 23%). In contrast, there was a higher proportion of wetlands with no signs of water (open water or wetland vegetation absent) observed in wetlands located along a stream (n = 35; 28%) than those at the beginning of one (22%; n = 5). Due to the conflicting trends, we hope to quantify drainage basin and stream order to clarify the relationship between water input and vegetation community composition in 2024. This analysis does not incorporate the presence of groundwater sources, which may have significant influence on FWA route source wetlands and the associated streams. All further discussion in this report, and data displayed in Figure 7E, does not distinguish between stream-channel wetlands at the start or along a stream.

The other wetland types, isolated (n = 46; 21%) and lake edge (n = 22, 10%) were significantly less common than stream-channel wetlands in our study area. Wetlands along large lake edges seem to be the most stable as they all had open water or wetland vegetation present. Unexpectedly, isolated wetlands exhibited a fairly equal proportion of adequately wetted wetlands (20%, n = 9) compared to the other wetland types (lake edge = 23%, stream channel (combined) = 21%) – Figure 7D,E, and F. While isolated and stream-channel water sources have fairly similar proportions of wetlands in transition states (i.e., mostly wet but drying, drying with wetted areas), it appears that stream-channel wetlands may be experiencing more drying as the proportion of ‘drying with wetted areas’ state is more common.

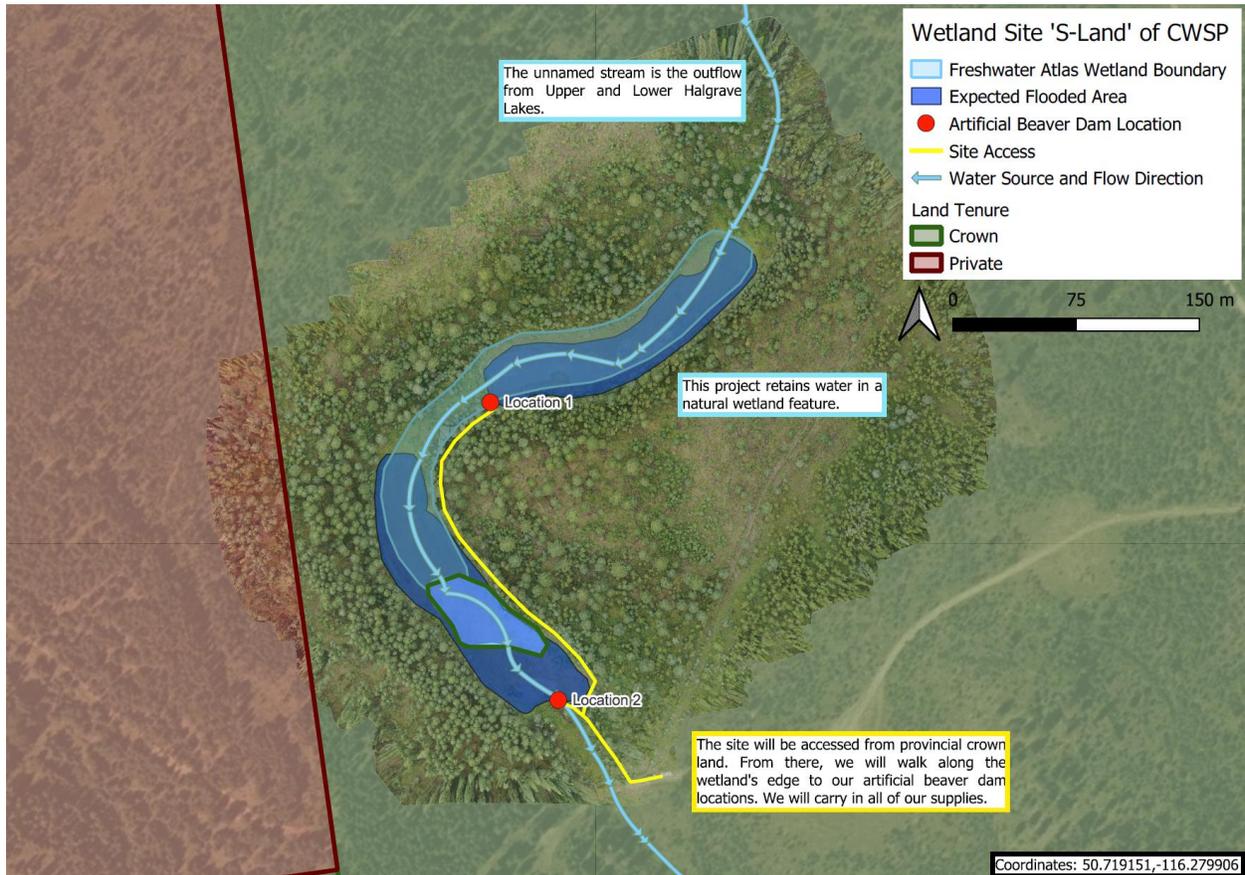
Figure 8. Site restoration plan for S-Land.

The S-Land restoration site is along the outflow of Upper and Lower Halgrave Lakes (a designated recreation site) and is located entirely on provincial crown land (Figure 8). We propose repairing two beaver dams within the perimeter of this wetland to restore 3,797 m³ of open water, spread over 12,793 m². A permit application for a Section 11 Change Approval was submitted to the BC Government on January 3, 2024 (Reference Number: 491817) and we are still awaiting review and feedback.

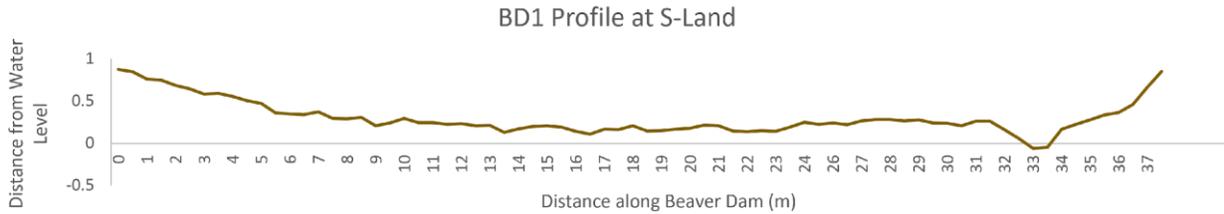
Figure 9. The upstream beaver dam (BD1) profile at S-Land restoration site. Measurements of the beaver dam were taken every 0.5 m using a laser level. Measurements were then normalized to the water depth in the wetland observed on the day of survey.

Based on the profile of Beaver Dam 1 at S-Land, there is a 3.5 meter gap between 31.5 m (0.26 m above water) and 35 m (0.275 m above water) from the left bank that needs to be constructed (Figure 9). However, there are additional low spots along the length of the dam that would require some extra material in order to raise the water level in the wetland by 0.26 m. The total distance of the dam that would need additional material is 18.5 m, which includes regions 9 – 26.5 m and 29.5 – 30.5 m from the left bank. If we did not add additional material, the lowest elevation is at 16.5 m from the left bank and would only allow us to increase the water level by 0.109 m.

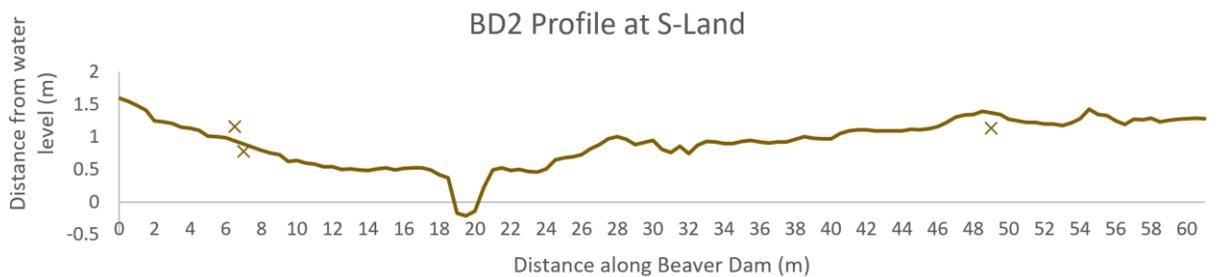
Figure 10. The downstream beaver dam (BD2) profile at S-Land restoration site. Measurements of the beaver dam were taken every 0.5 m using a laser level. Measurements were then normalized to the water depth in the wetland observed on the day of survey.

The downstream beaver dam, Beaver Dam 2, at S-Land has a 2.5 m gap between 18.5 m (0.37 m above water) and 21 m (0.49 m above water) from the left bank that requires a BDA repair (Figure 10). If we only did this small repair, we could raise the water level in the wetland by 0.415 m. However, if we increased the height of this main repair and added additional material, about 30 cm in height, to the left and right of this main BDA (7 - 18.5 m and 21 - 27 m) we could raise the water level in the wetland by 0.85 m.

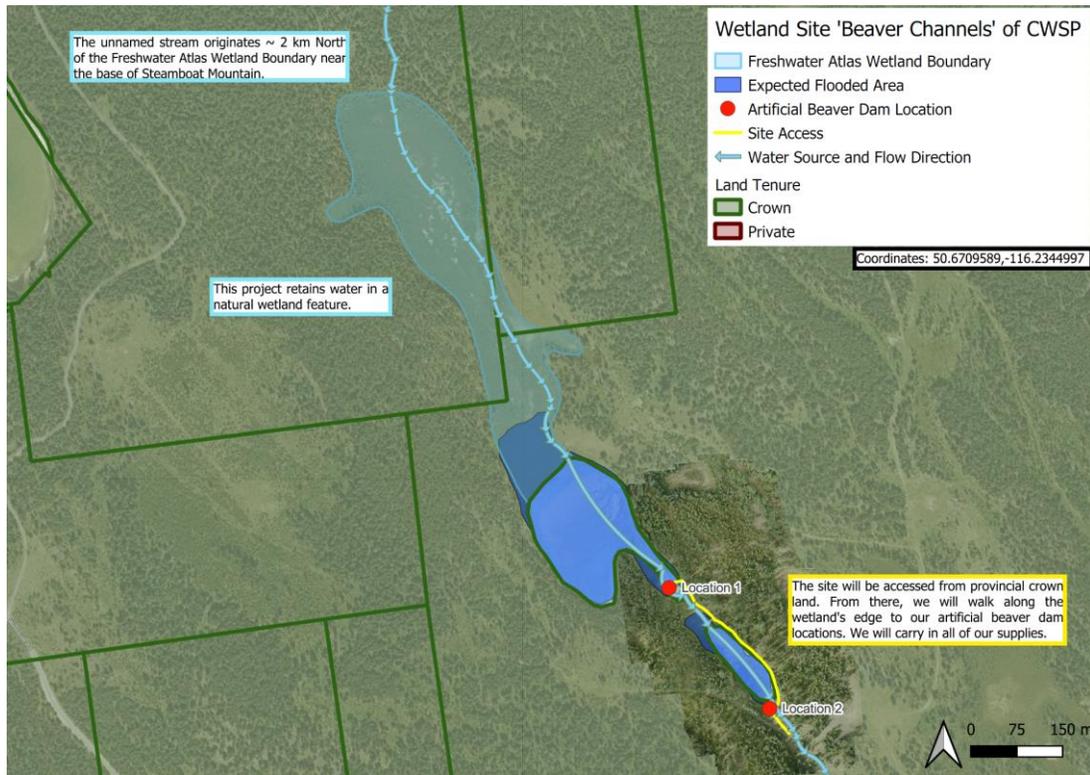
Figure 13. Site restoration plan for Beaver Channels.

The Beaver Channels restoration site is along an unnamed creek and is located entirely on provincial crown land (Figure 13). We propose repairing two beaver dams within the perimeter of this wetland to restore 23,233 m³ of open water, spread over 50,517 m². A permit application for a Section 11 Change Approval was submitted to the BC Government on January 4, 2024 (Reference Number: 464746) and we are still awaiting review and feedback.

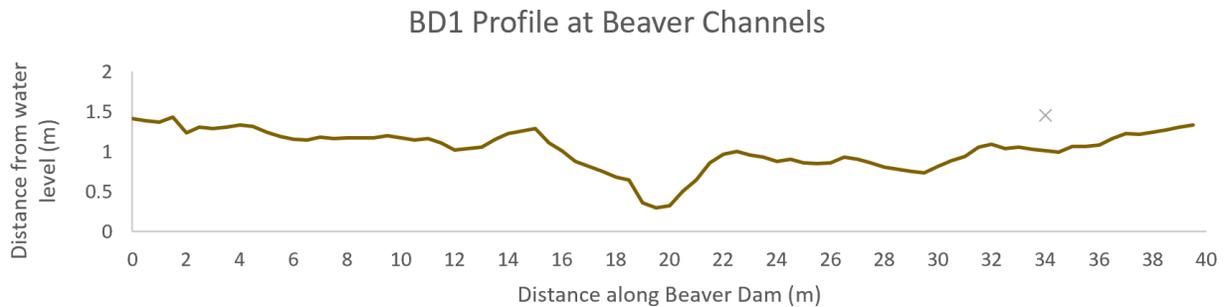
Figure 14. The upstream beaver dam (BD1) profile at Beaver Channels restoration site. Measurements of the beaver dam were taken every 0.5 m using a laser level. Measurements were then normalized to the water depth in the wetland observed on the day of survey.

Based on the profile of Beaver Dam 1 at Beaver Channels, there is a 6.5 meter gap between 15.5 m (1.12 m above water) and 22 m (0.97 m above water) from the left bank that needs to be constructed (Figure 14). However, there are additional low spots along the length of the dam that would require some extra material in order to raise the water level in the wetland by 1 m. The total distance of the dam that would need additional material is 9.5 m, which extends from 22 m to 31.5 m from the left bank. If we did not add additional material, the lowest elevation is at 29.5 m from the left bank and would only allow us to increase the water level behind the dam by 0.74 m.

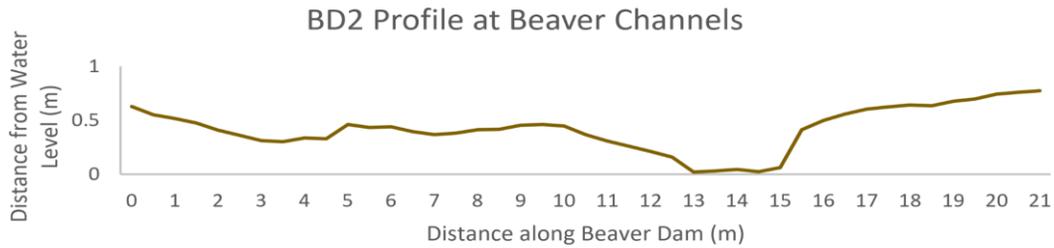
Figure 15. The downstream beaver dam (BD2) profile at Beaver Channels restoration site. Measurements of the beaver dam were taken every 0.5 m using a laser level. Measurements were then normalized to the water depth in the wetland observed on the day of survey.

Based on the profile of Beaver Dam 2 at Beaver Channels, there is a 5 meter gap between 10.5 m (0.37 m above water) and 15.5 m (0.42 m above water) from the left bank that needs to be constructed (Figure 15). However, there are additional low spots along the length of the dam that would require some extra material in order to raise the water level in the wetland by 0.46 m. The total distance of the dam that would need additional material is 6 m, which occurs in two different sections - 2 m to 4.5 m, 5.5 m to 9 m from the left bank. If we did not add additional material, the lowest elevation is at 3 m from the left bank and would only allow us to increase the water level behind the dam by 0.31 m.

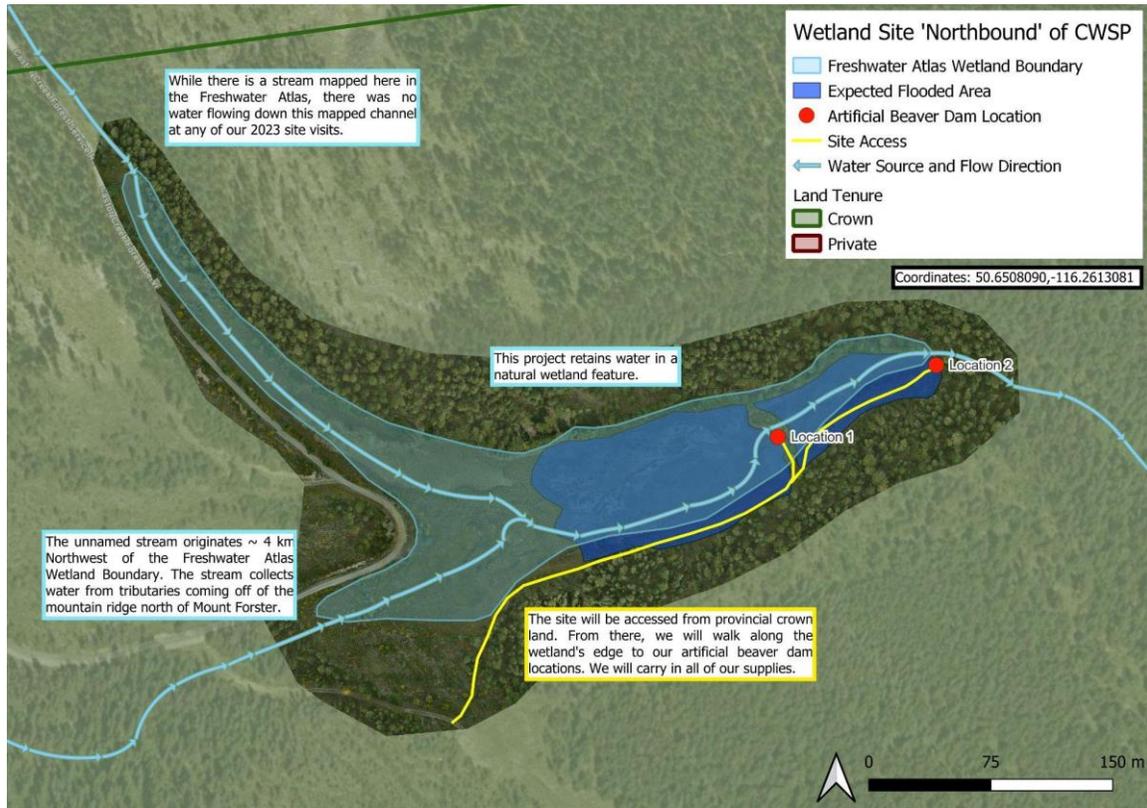
Figure 18. Site restoration plan for Northbound.

The Northbound restoration site is at the confluence of two unnamed creeks (no flow observed in northern creek) and is located entirely on provincial crown land (Figure 18). We propose repairing two beaver dams within the perimeter of this wetland to restore 6673 m³ of open water, spread over 13776 m². The culvert that is located at the nearest road crossing of the south stream is no longer functioning properly and would benefit from replacement. A permit application has been prepared but won't be submitted until we receive feedback from the province on other submitted applications.

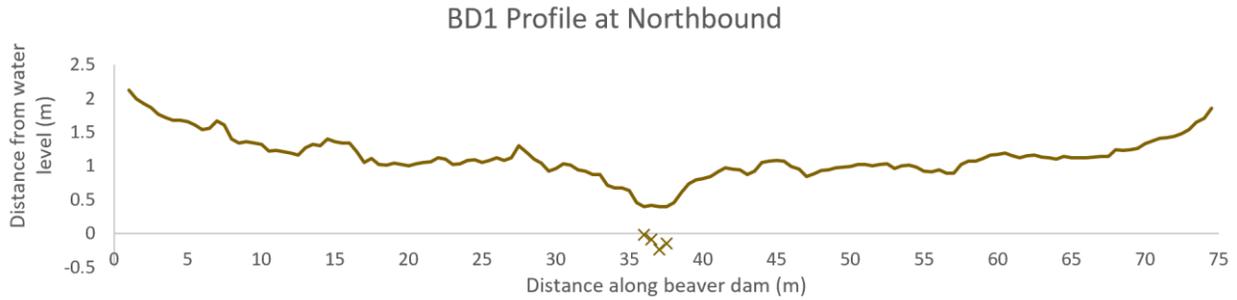
Figure 19. The upstream beaver dam (BD1) profile at Northbound restoration site. Measurements of the beaver dam were taken every 0.5 m using a laser level. Measurements were then normalized to the water depth in the wetland observed on the day of survey.

The main repair will be focused in a 1.5 m section, at 36 m (0.40 m above water) to 37.5 m (0.39 above water) from the left bank, where the existing degraded beaver dam is undercut and the stream flows through (Figure 19). We will have to excavate this section of dam, likely with 1 - 2 m extra on each side to ensure structural stability, and then build the main BDA (3.5 m to 5.5 m repair) here. In order to increase the water level by 0.94 m additional material would need to be added to 8.5 m of the dam (from 32.5 m to 40.5 m and from 47 to 47.5 m from left bank). If we did not add additional material to these low spots, we would only be able to raise the water in the wetland by 0.39 m.

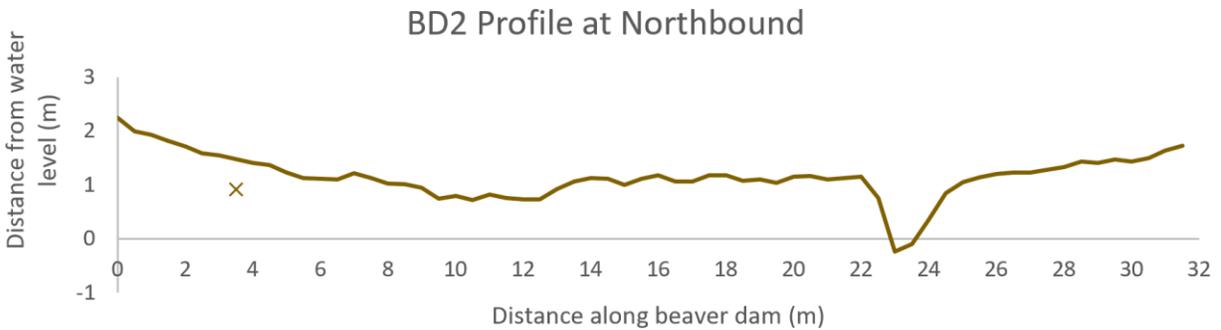
Figure 20. The downstream beaver dam (BD2) profile at Northbound restoration site. Measurements of the beaver dam were taken every 0.5 m using a laser level. Measurements were then normalized to the water depth in the wetland observed on the day of survey.

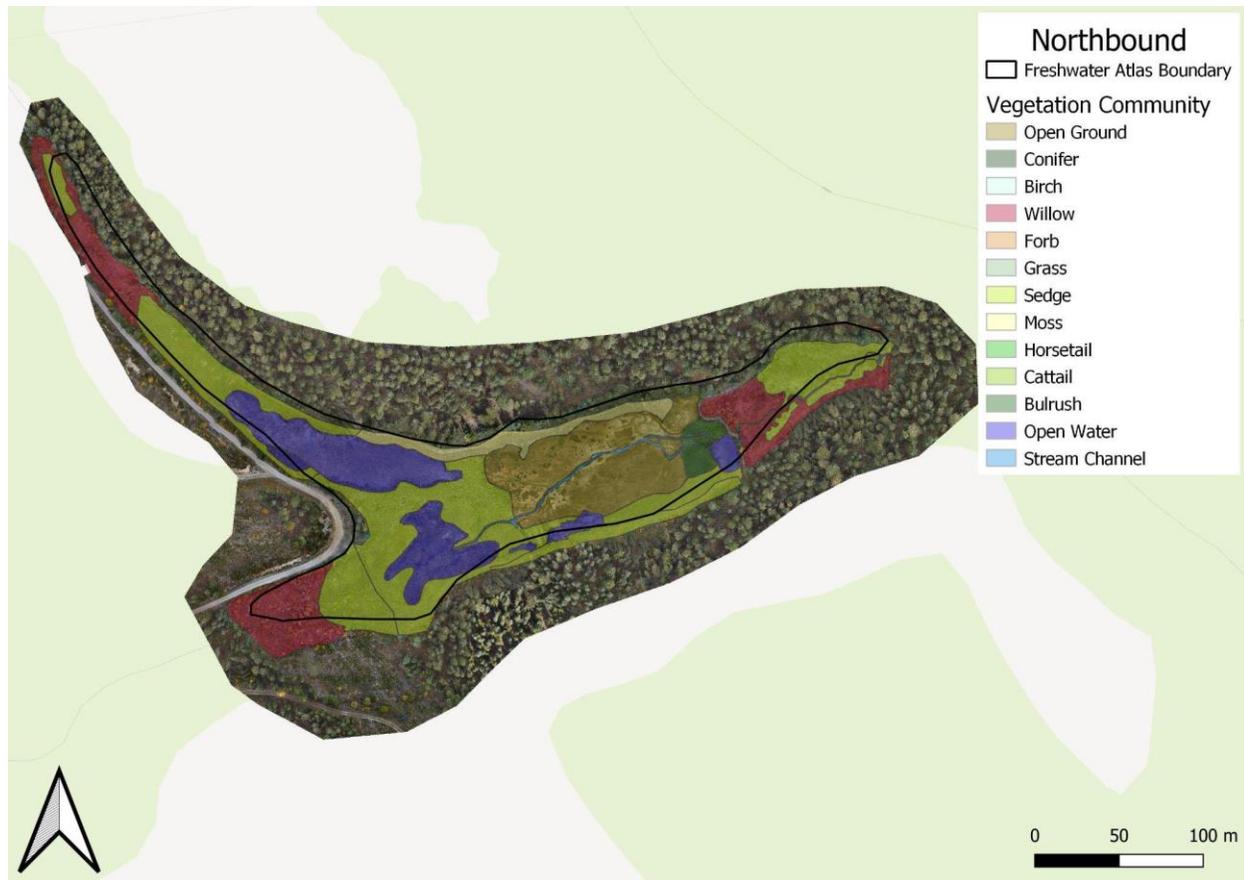
Figure 22. Pre-restoration vegetation communities at Northbound mapped during the summer of 2023.

Vegetation communities were mapped during a site visit on September 18, 2023 (Figure 22). There are small discrepancies between the FWA boundaries and our vegetation community mapping, which means the area calculations of vegetation communities will not equal the area of the FWA polygon.

There is currently 0.56 ha of open water habitat at Northbound, all of which is located behind Beaver Dam 1. We expect to add depth to the existing open water and expand the flooded area to 1.38 ha. We observed bulrush, cattail, sedge, moss, and willow vegetation communities within the wetland basin. Overall, the dominant vegetation type was sedge (1.27 ha), which was followed by willow (0.58 ha) and open ground (0.4 ha). We expect to see the most dramatic vegetation changes behind Beaver Dam 2 as this dam is no longer holding any open water on the landscape.

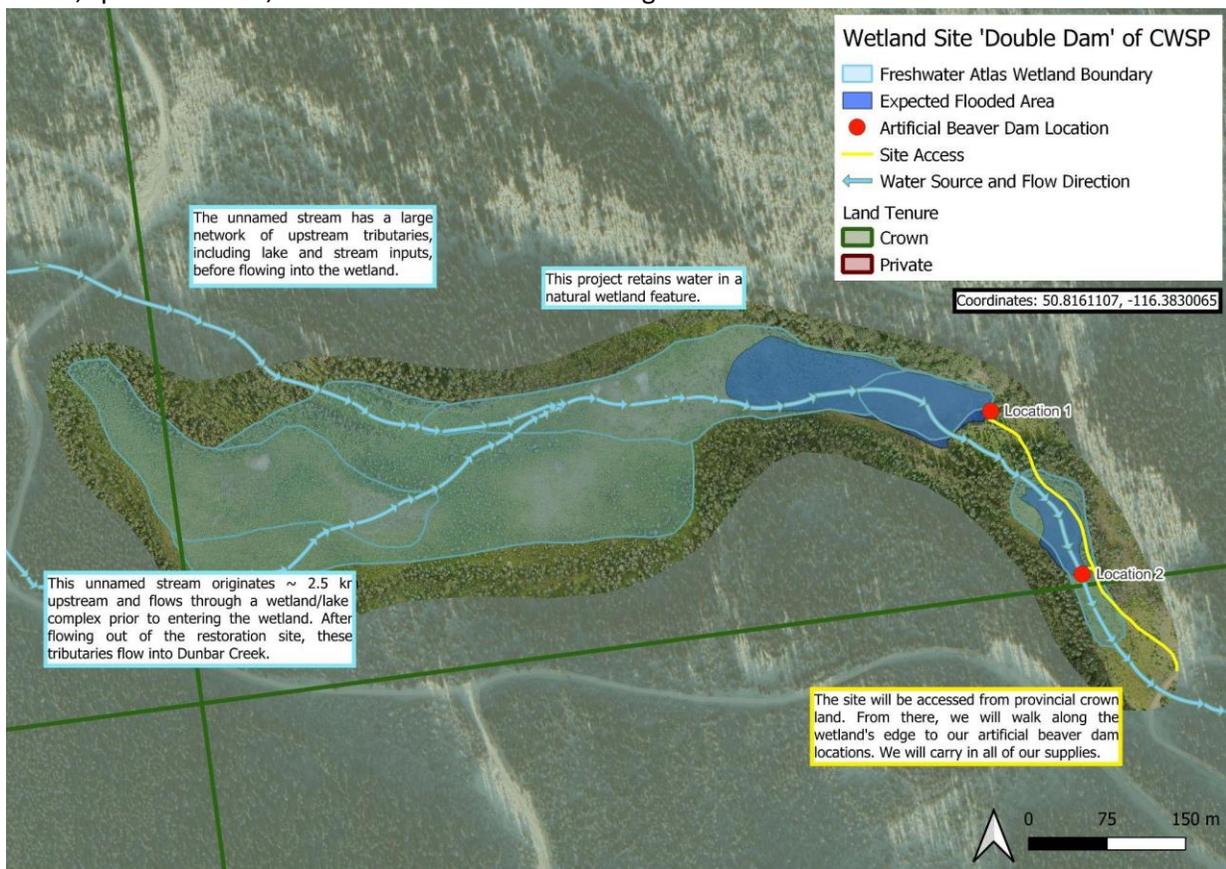
Figure 23. Site restoration plan for Upper and Lower Double Dam.

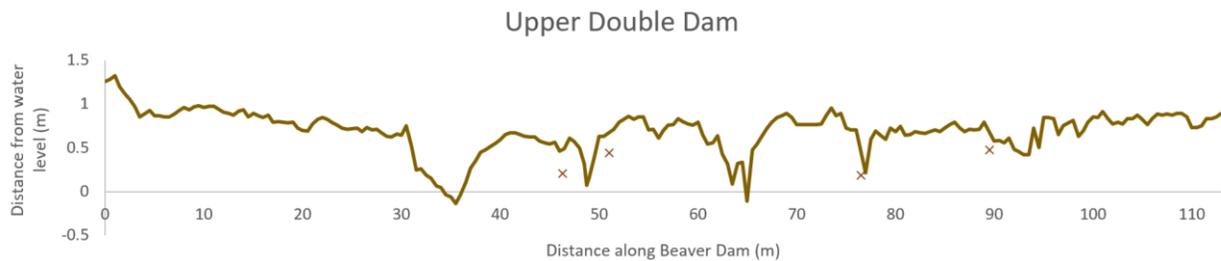
Figure 24. The beaver dam profile at Upper Double Dam restoration site. Measurements of the beaver dam were taken every 0.5 m using a laser level. Measurements were then normalized to the water depth in the wetland observed on the day of survey.

There are multiple repairs needed to restore the degraded beaver dam at Upper Double Dam (Figure 24). The largest gaps that require repairs are from 30 m to 40.5 m, 47.5 m to 50 m, 60 m to 67.5 m, and 76 m to 78 m. These repairs vary in height from 0.5 m to 0.9 m and are large enough that they should receive post, wicker weave, and burlap sack constructions. The steam channel is currently flowing through the dam between 34.5 m to 36 m and at 65 m from the left bank. There are other areas of the dam that would need additional material added in order to raise the water level by 0.69 m. These sections include 28 m to 29.5 m, 41 m to 47 m, 79 m to 83.5 m, and 90 m to 93.5 m from the left bank. In addition, there are a few sections (at 46.5 m, 51 m, 76.5 m, and 89.5 m from left bank) that are undercut or are compromised by large conifer roots that will need extra material to ensure structural stability of the dam. Therefore, this dam would require 22.5 m of large, 15.5 m of small, and four areas of internal repairs. If the smaller repairs weren't made, the water level would only be increased by 0.43 m.

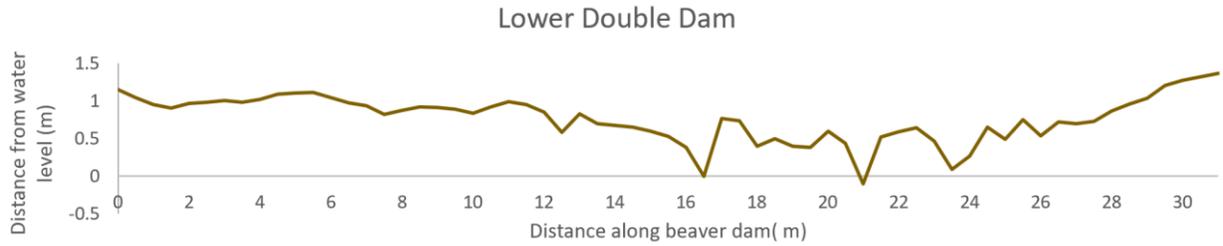
Figure 25. The beaver dam profile at Lower Double Dam restoration site. Measurements of the beaver dam were taken every 0.5 m using a laser level. Measurements were then normalized to the water depth in the wetland observed on the day of survey.

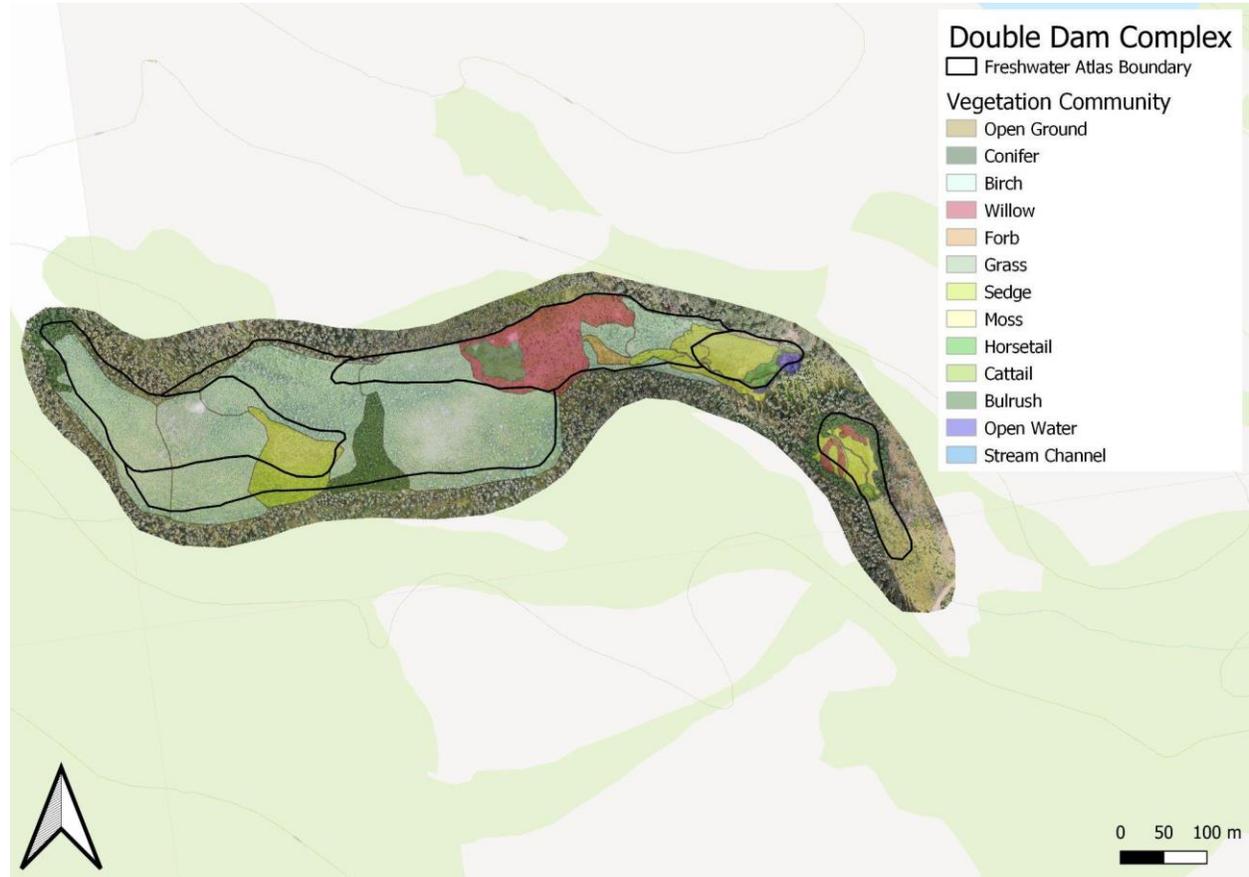
Figure 27. Pre-restoration vegetation communities at Upper and Lower Double Dam mapped during the summer of 2023.

Vegetation communities were mapped during site visits on August 14 and August 29, 2023 (Figure 27). There are small discrepancies between the FWA boundaries and our vegetation community mapping, which means the area calculations of vegetation communities will not equal the area of the FWA polygon.

There is currently 0.1 ha of open water in the Upper Double Dam restoration site. Our beaver dam construction will add depth to this existing area and expand the flooded area and increase this area to 1.38 ha. The mapped area that we expect to flood looks very similar to open water visible behind this beaver dam in provincial air photos from 1980 - 1989. Historic air photos also show another open water pond further upstream within this restoration site; however, that lost pond is not addressed in our restoration plans. The most common vegetation community found at Upper Double Dam was birch (7.6 ha) as a majority of this wetland is dry and grown in with shrubs. The other most common vegetation types were sedge (2.0 ha) and willow (1.1 ha). Bulrush, cattail, horsetail, forb, and conifer vegetation communities were also found within the wetland basin.

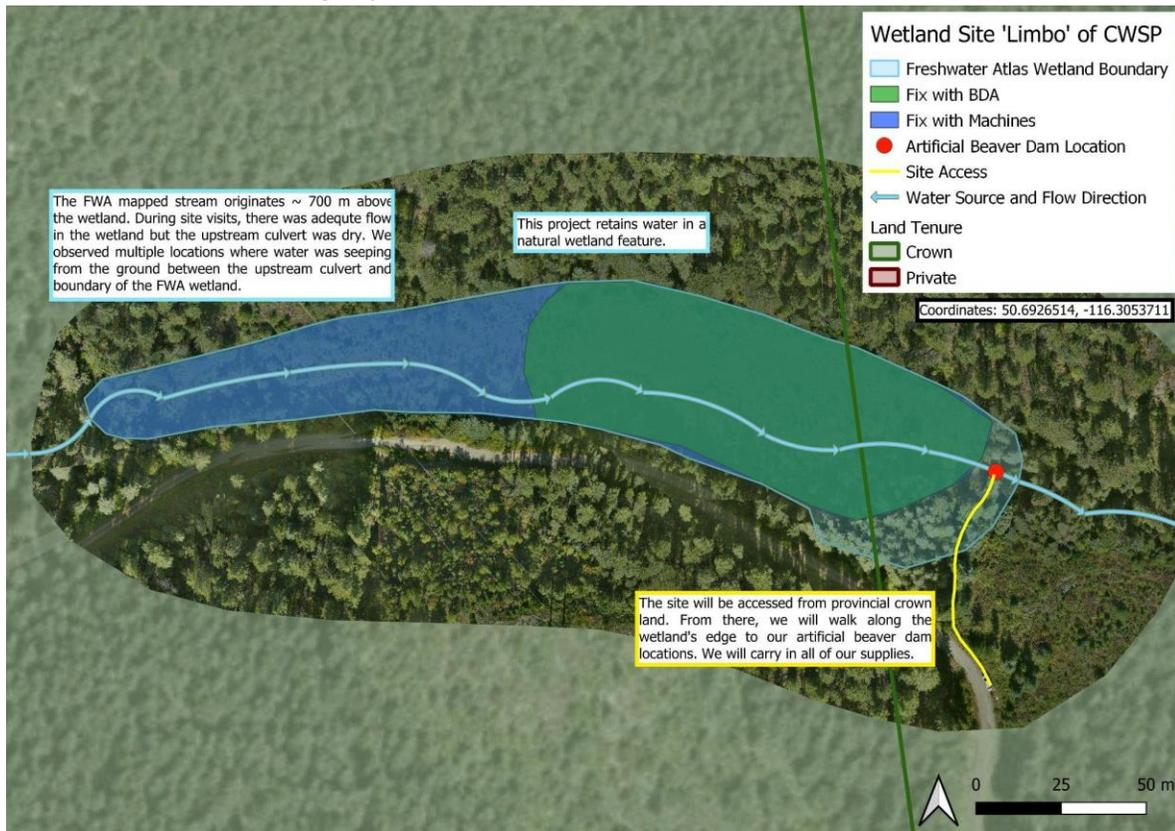
Figure 28. Site restoration plan for Limbo.

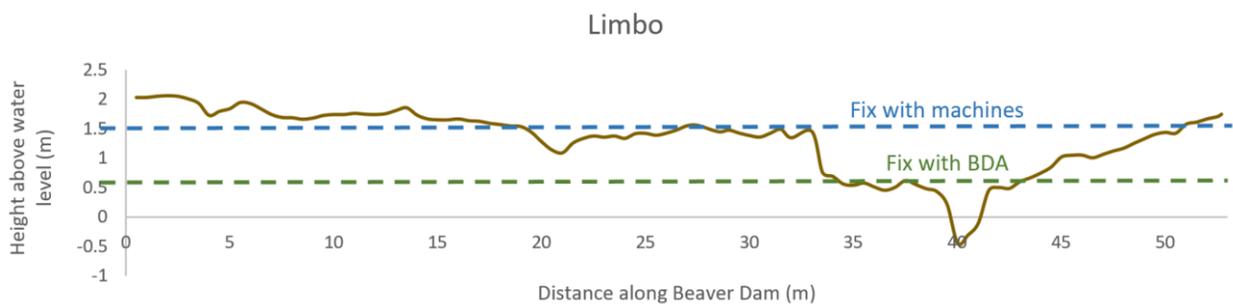
Figure 29. The beaver dam profile at Limbo restoration site. The height and area that would require fixing is illustrated for both BDA construction (green) and construction with machinery (blue) by the area between the line and profile of the beaver dam. Measurements were then normalized to the water depth in the wetland observed on the day of survey.

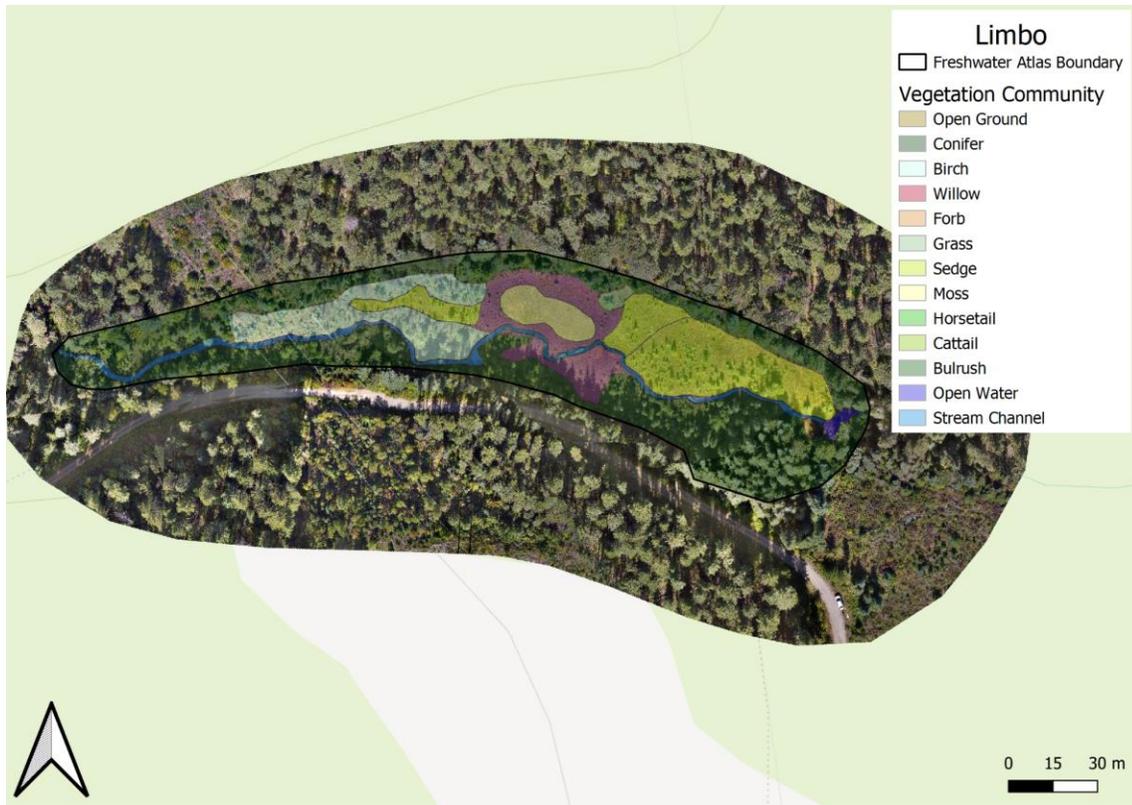
Figure 31. Pre-restoration vegetation communities Limbo mapped during the summer of 2023.

Vegetation communities were mapped during site visits on September 21, 2023 (Figure 31). There are small discrepancies between the FWA boundaries and our vegetation community mapping, which means the area calculations of vegetation communities will not equal the area of the FWA polygon.

There is currently 0.01 ha of open water in the Limbo restoration site. Our beaver dam construction will add depth to this existing area and expand the flooded area to 0.5 or 0.9 ha (pending restoration method decision). The dominant vegetation community found at Limbo was conifer (0.54 ha), followed by sedge (0.18 ha) and birch (0.11 ha). Moss, grass, and small rush vegetation communities were also observed in the wetland basin.

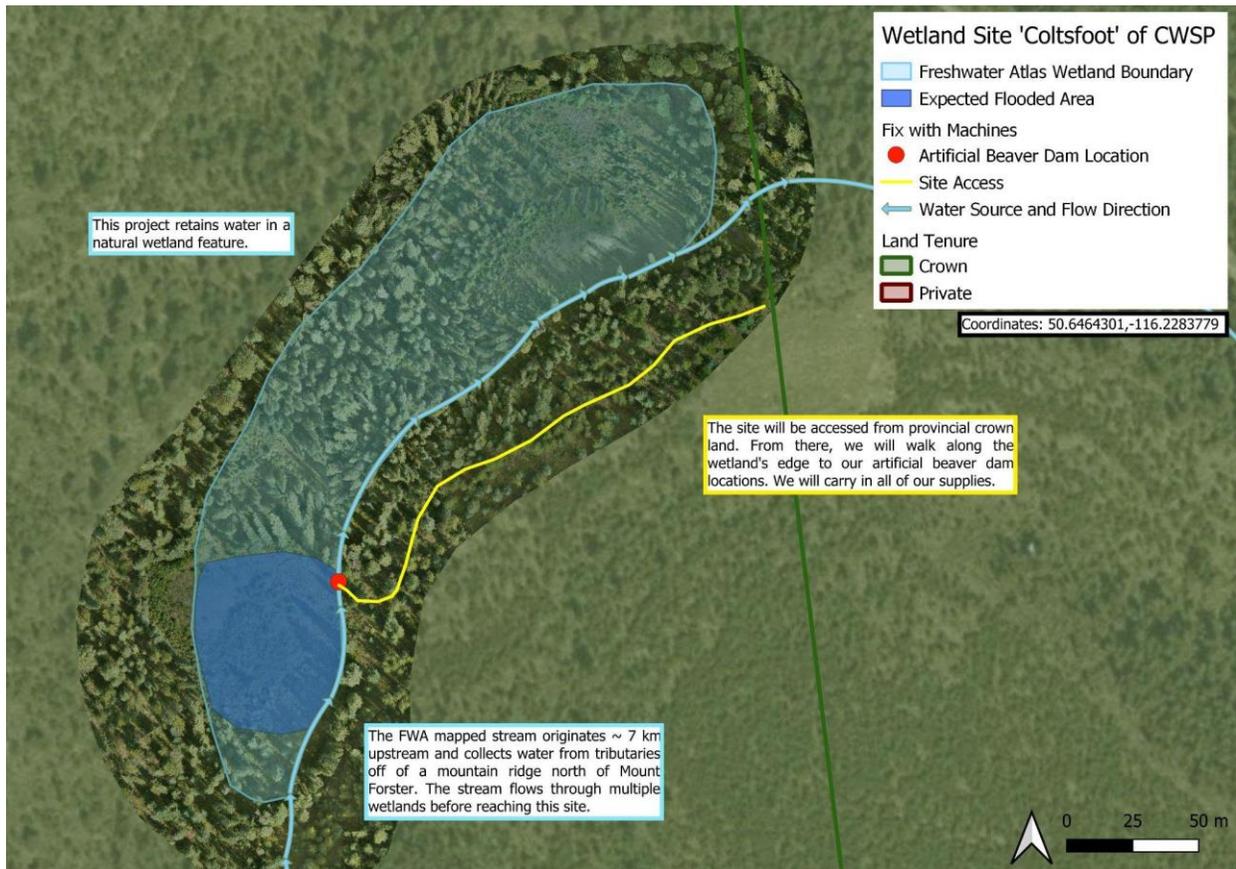
Figure 32. Site restoration plan for Coltsfoot.

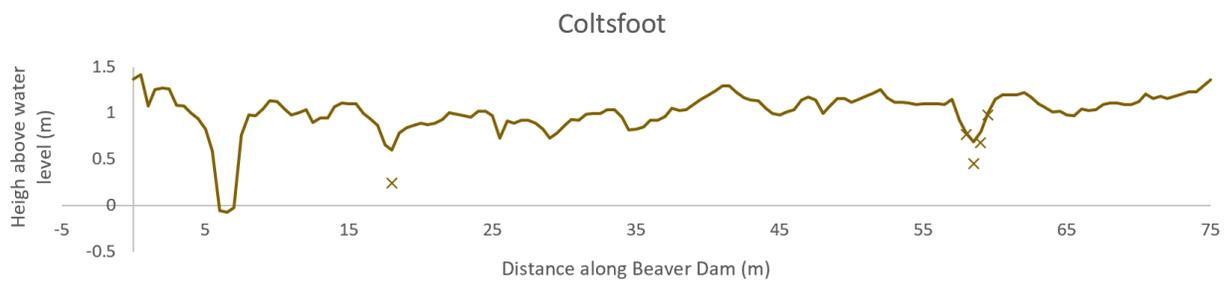
Figure 33. The beaver dam profile at Coltsfoot restoration site. Measurements of the beaver dam were taken every 0.5 m using a laser level. Measurements were then normalized to the water depth in the wetland observed on the day of survey.

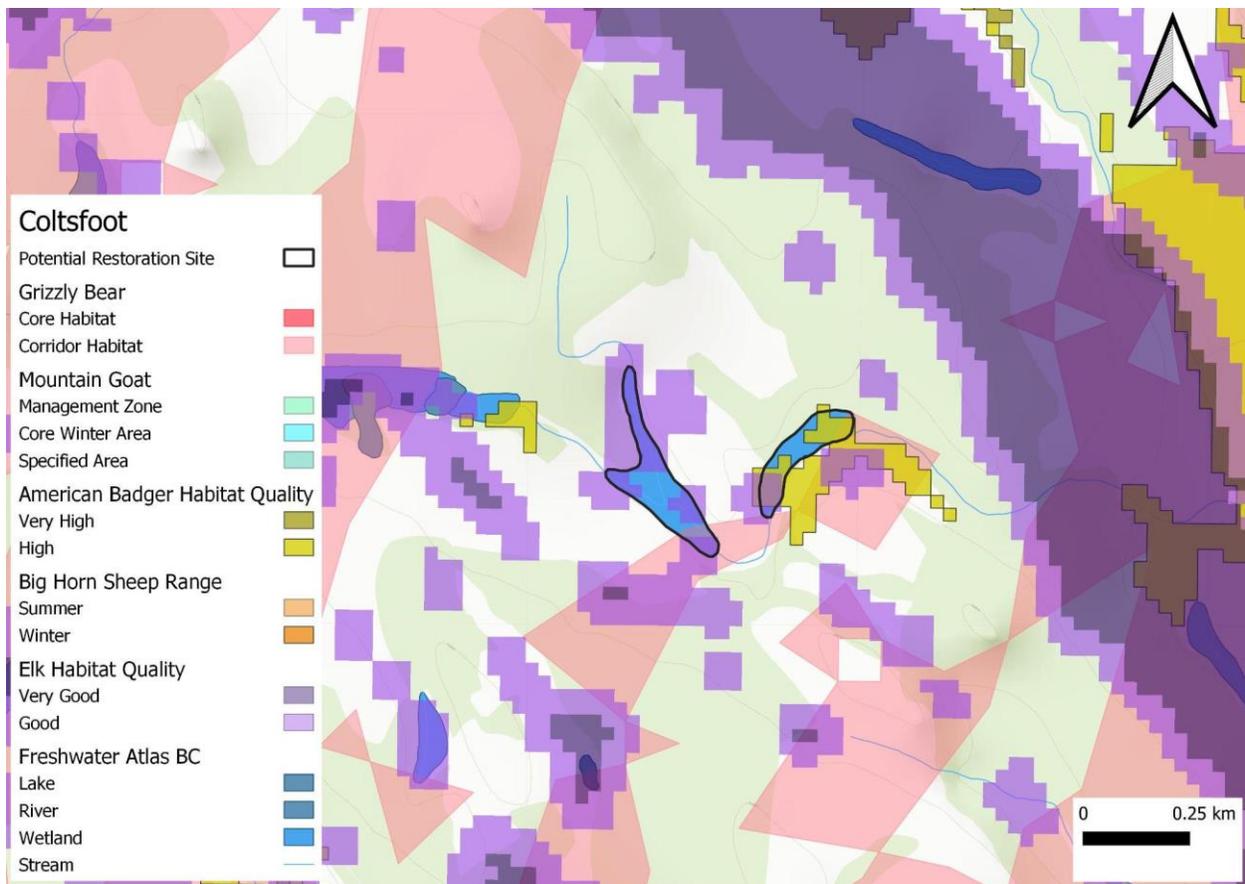
Figure 34. Wildlife habitat values for Kootenay Conservation Program’s identified focal species (Grizzly Bear, Mountain Goat, American Badger, Big Horn Sheep, and Elk) around the Coltsfoot restoration site.

The wetland is within federally mapped critical habitat for Woodland Caribou (Southern Mountain Population) and American Badger. The wetland is surrounded by ungulate winter range for Mule deer (*Odocoileus hemionus*), White-tailed deer (*O. virginianus*), Elk (*Cervus elaphus*), Bighorn Sheep (*Ovis canadensis*), and Moose (*Alces alces*). The wetland and surrounding area also provide important habitat for Kootenay Conservation Program’s identified wildlife species – specifically Grizzly Bear, Elk, and American Badger (Figure 34). Other wildlife observations include a Western Toad spotted on the upland bank of the wetland.

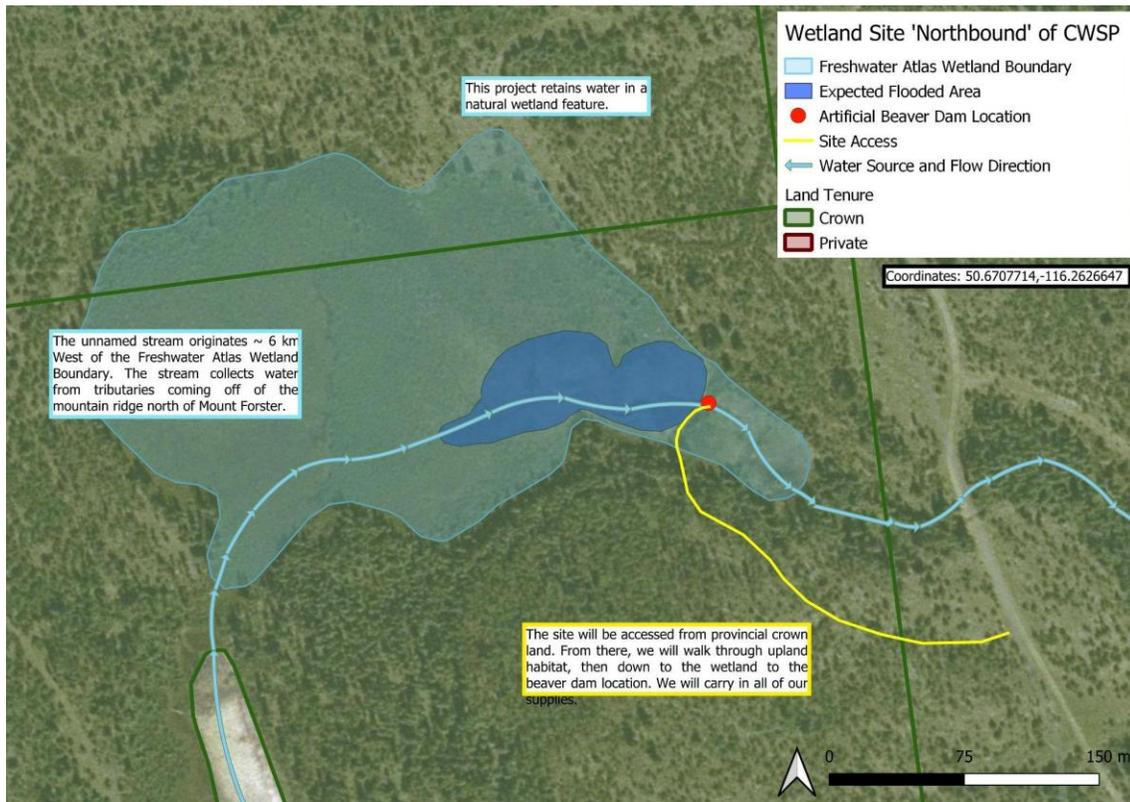
Figure 35. Site restoration plan for Sam's Folly Outflow.

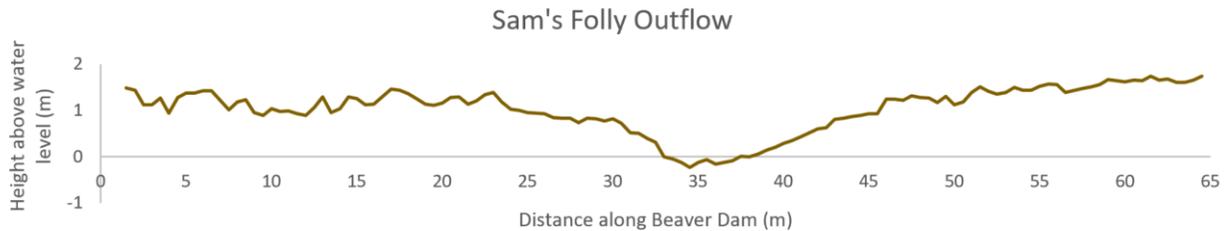
Figure 36. The beaver dam profile at Sam’s Folly Outflow restoration site. Measurements of the beaver dam were taken every 0.5 m using a laser level. Measurements were then normalized to the water depth in the wetland observed on the day of survey.

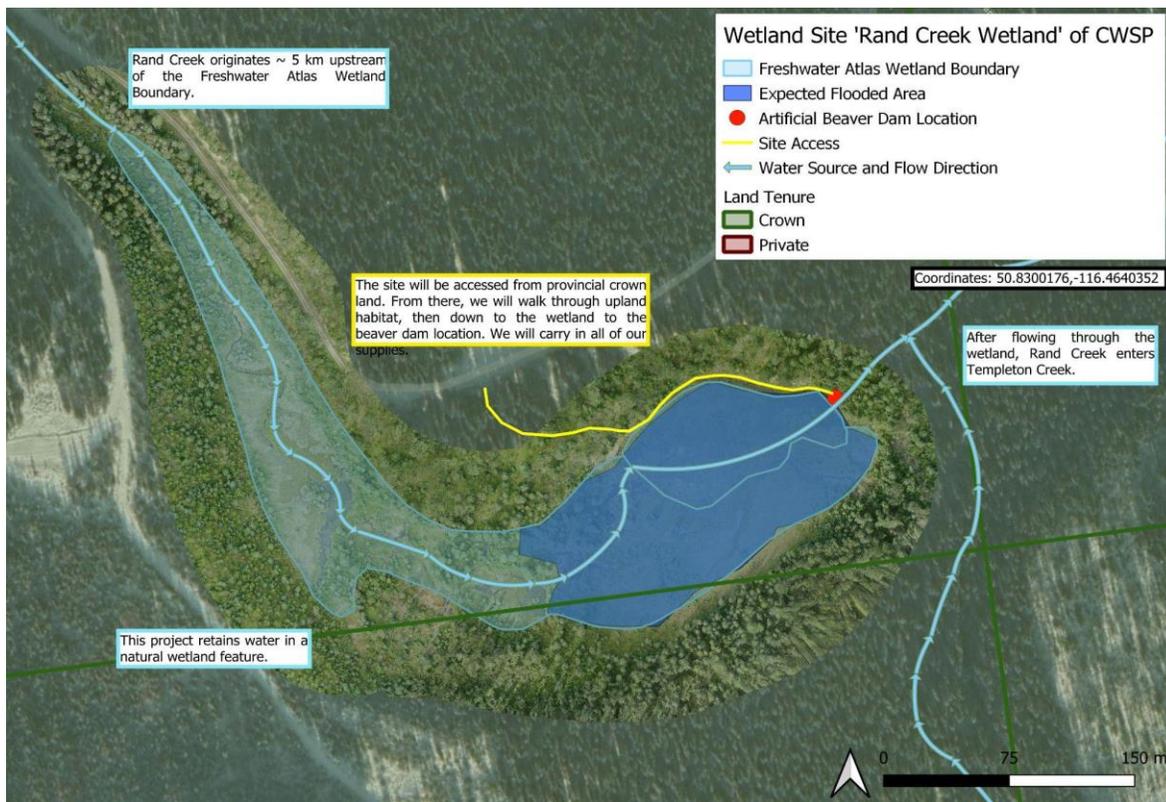
Figure 38. Site restoration plan for Rand Creek Wetland.

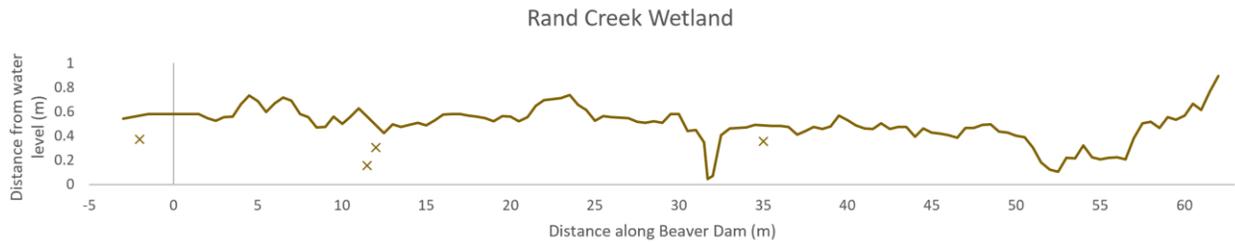
Figure 39. The beaver dam profile at Rand Creek Wetland restoration site. Measurements of the beaver dam were taken every 0.5 m using a laser level. Measurements were then normalized to the water depth in the wetland observed on the day of survey.
