Canada Nature Fund: Community-Nominated Priority Places for Species at Risk

Kootenay Connect: 6CW Columbia Wetlands: Upland Wetlands Restoration

March 31, 2025. Final Report: Year 6

Columbia Wetlands Stewardship Partners

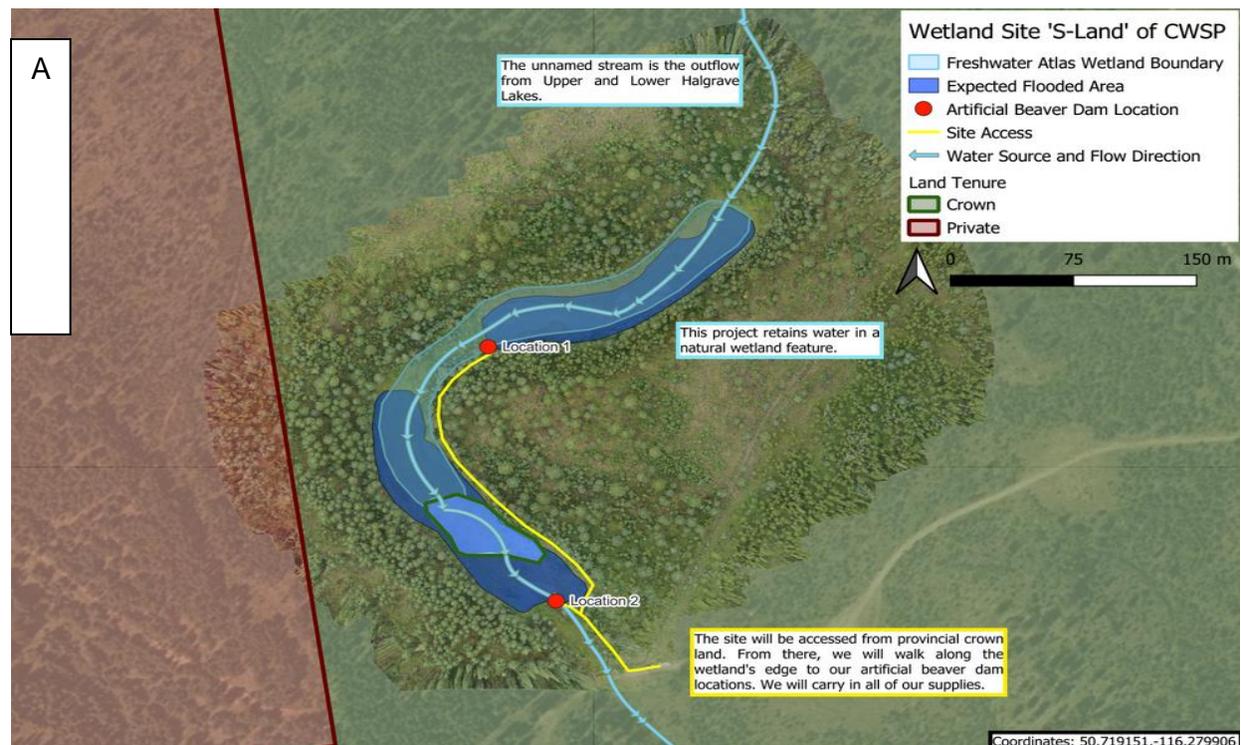
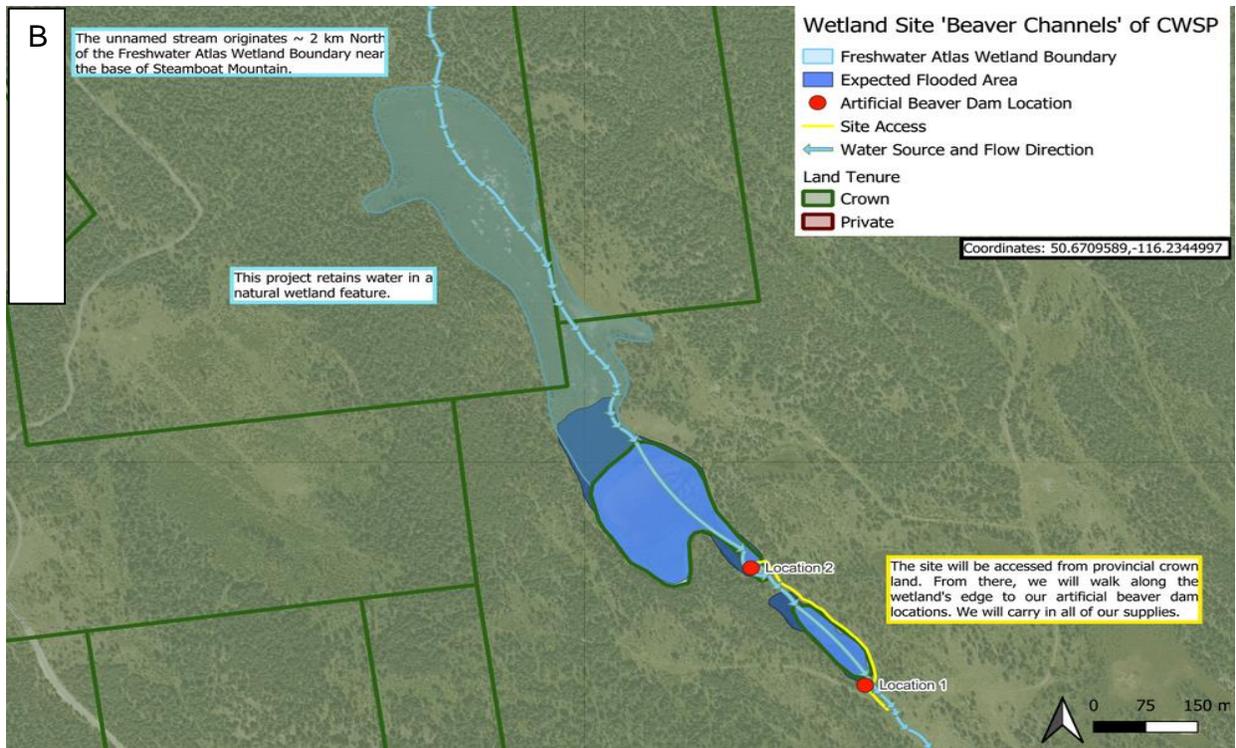
Figure 1. A) Map of S-Land showing location of both beaver dams, current flooded area, and projected flooded area with beaver dam repair. B) Map of Beaver Channels showing location of both beaver dams, current flooded area, and projected flooded area with beaver dam repair.

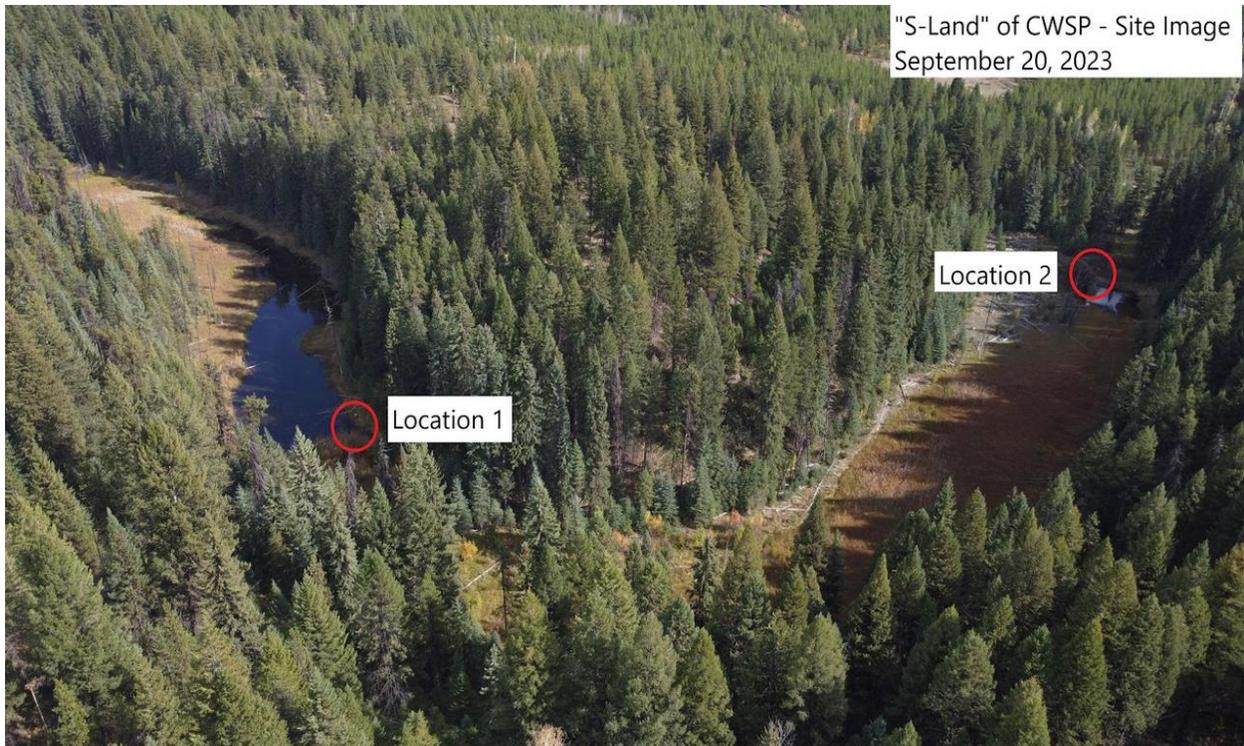
In S-Land, we built two beaver dams, to retain more water in two wetland areas (Figure 2). The upstream dam is 3.5 m long, 0.66 m wide, and 0.21 m tall, and within one week water levels had increased in the wetland area by 0.21 m (Figure 3, 4). This means that 1168 m³ more water is being retained in this wetland. The downstream dam is 1.8 m long, 0.69 m wide, and 0.32 m tall, and within one week water levels had increased in the wetland area by 0.32 m (Figure 9, 10). This has resulted in an increase of 2315 m³ of water being retained in this wetland. Thus, these two structures have increased wetland habitat and specifically open water area.

Figure 2. Drone photograph showing the location of the two beaver dams within the S-Land wetland site.

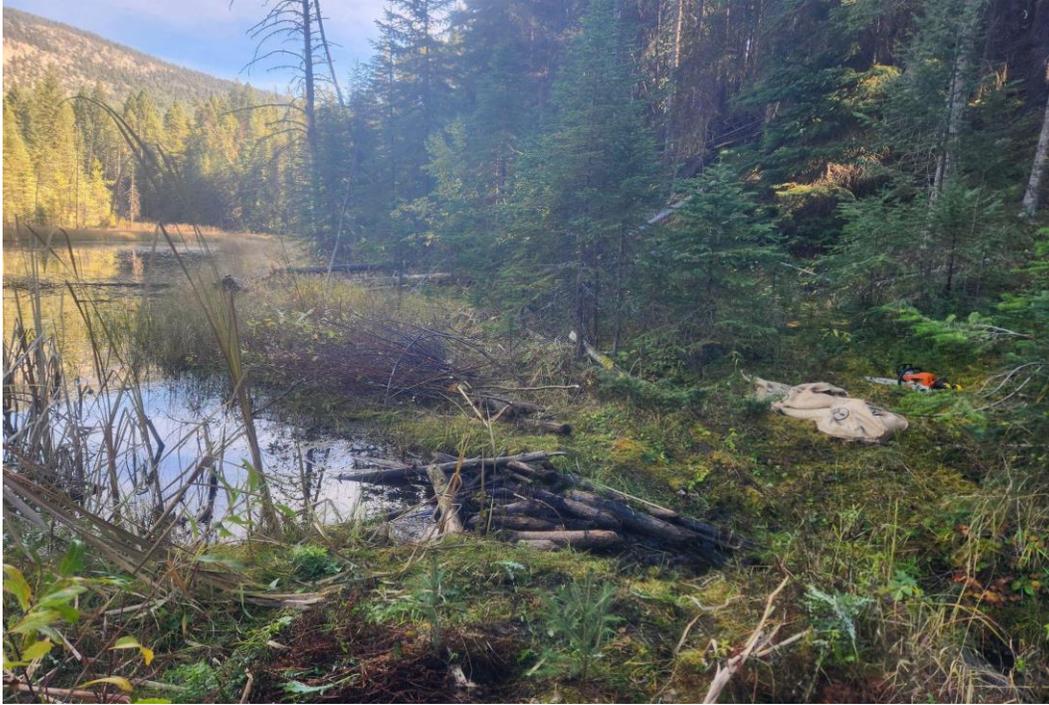
Figure 3. S-land upper dam site (location 1) prior to construction. October 7, 2024.

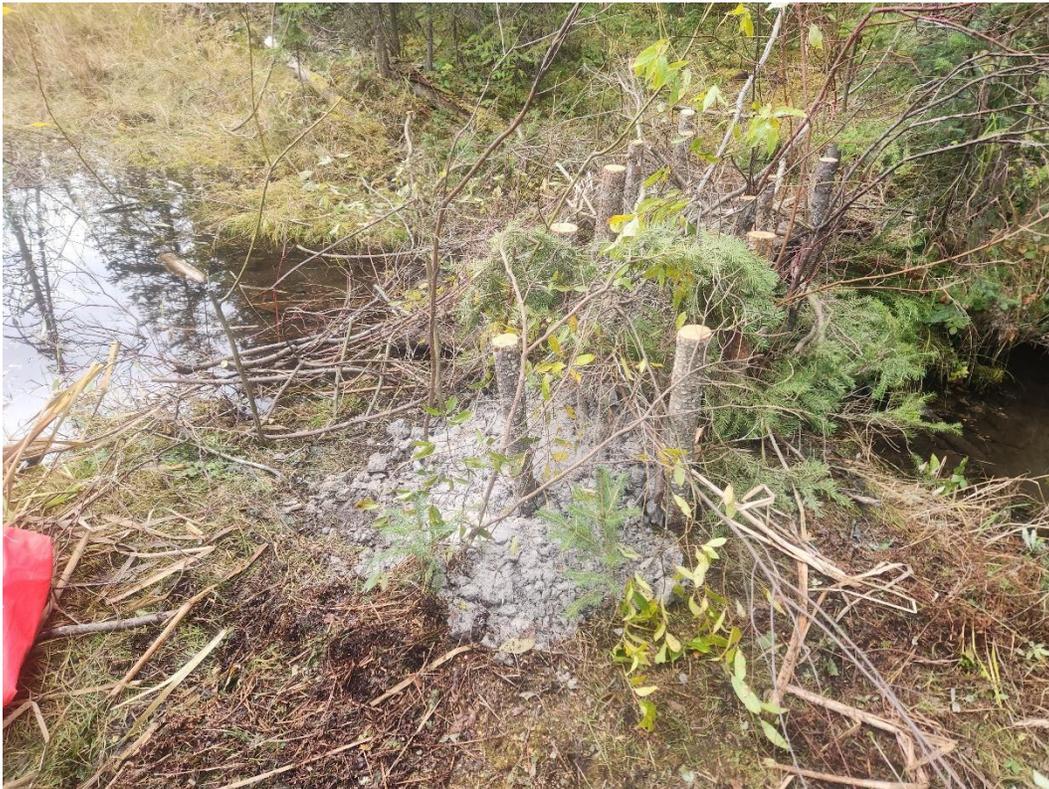
Figure 4. S-land upper dam site (location 1) post construction.

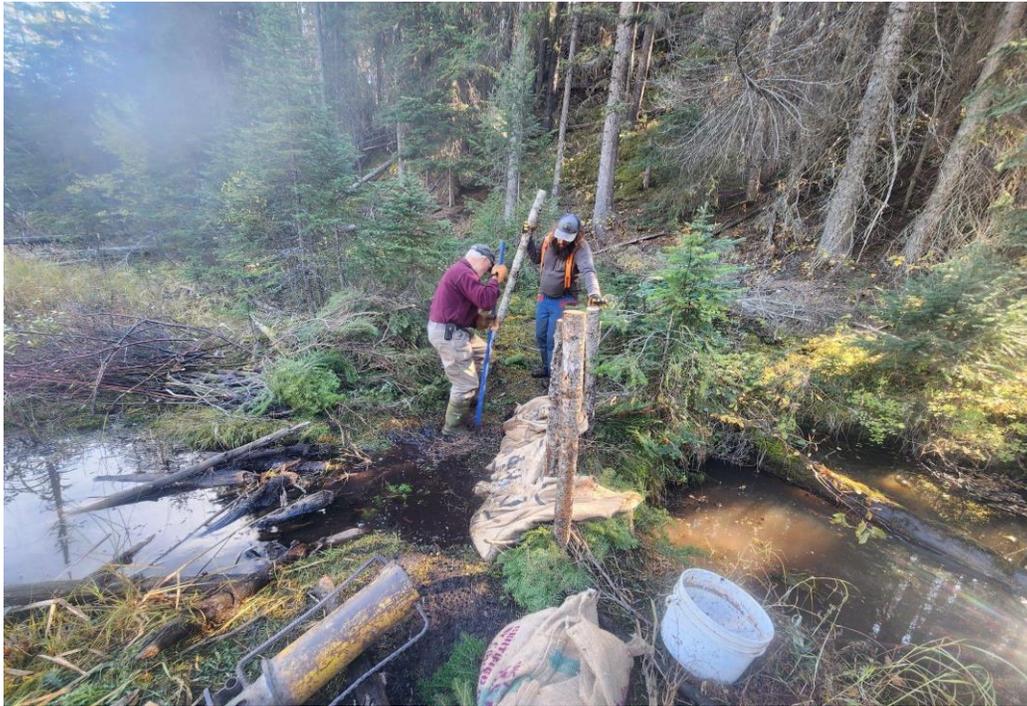
Figure 5. Pounding posts into the ground at S-Land upper dam site (location 1) during the construction.

As indicated in our permit applications, these dams were built with entirely natural materials, with wooden posts being pounded at least 0.3 m into the ground in two rows 0.60 m apart, and then the area inside the dams being filled with burlap sacks filled with sand and mud, woven branches, and mud (Figure 5, 6).

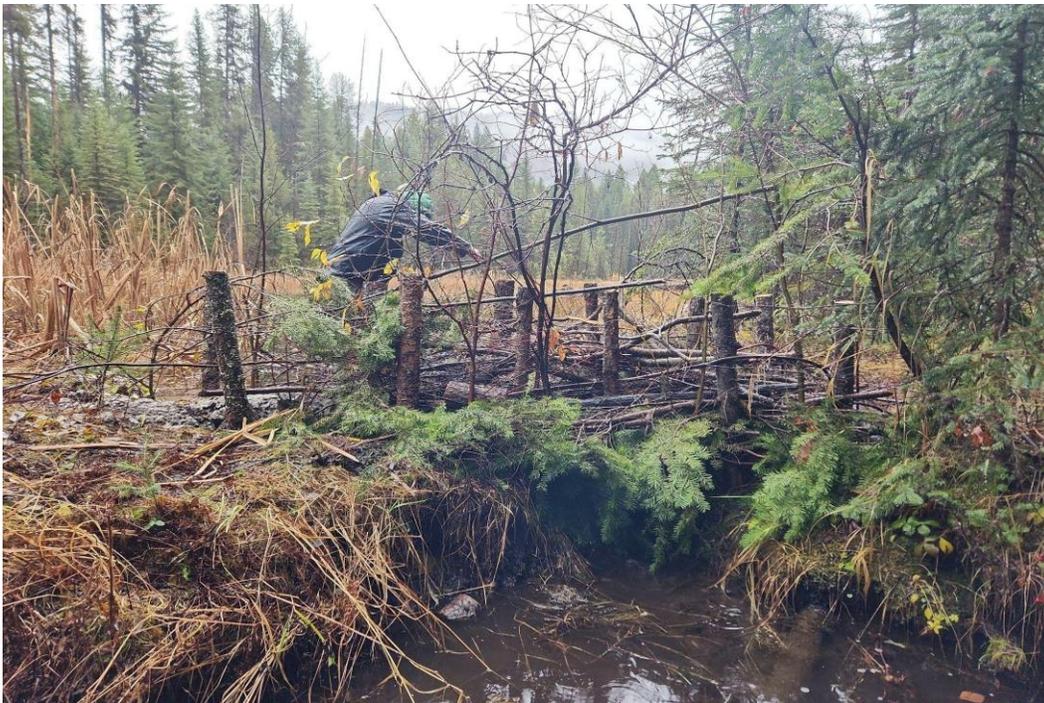
Figure 6. S-land upper dam site (location 1) post construction. Photo taken from the pool below the dam, looking upstream.

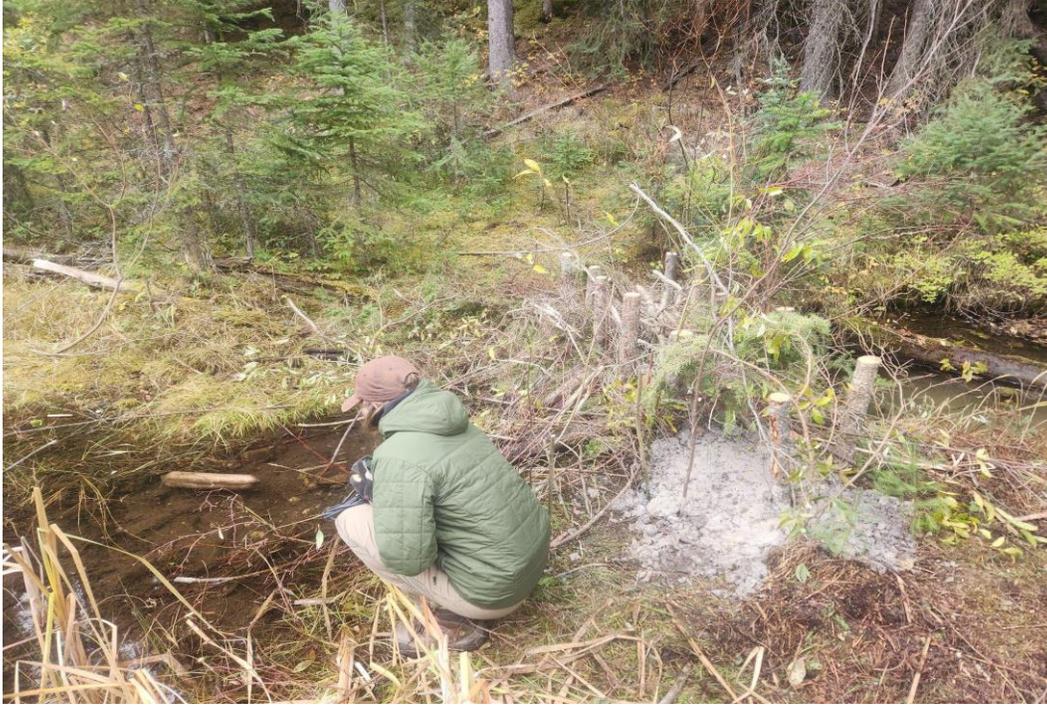
Figure 7. Water quality parameters being measured upstream of the Upper Dam site following its construction. Oct 8, 2024.

We monitored water quality before and after construction, specifically turbidity, in order to detect potential muddying of the creek. While there was a short-term increase in turbidity downstream of the BDA built at location one, turbidity had returned to pre-construction levels a week later, so long-term effects to the creek are not present.

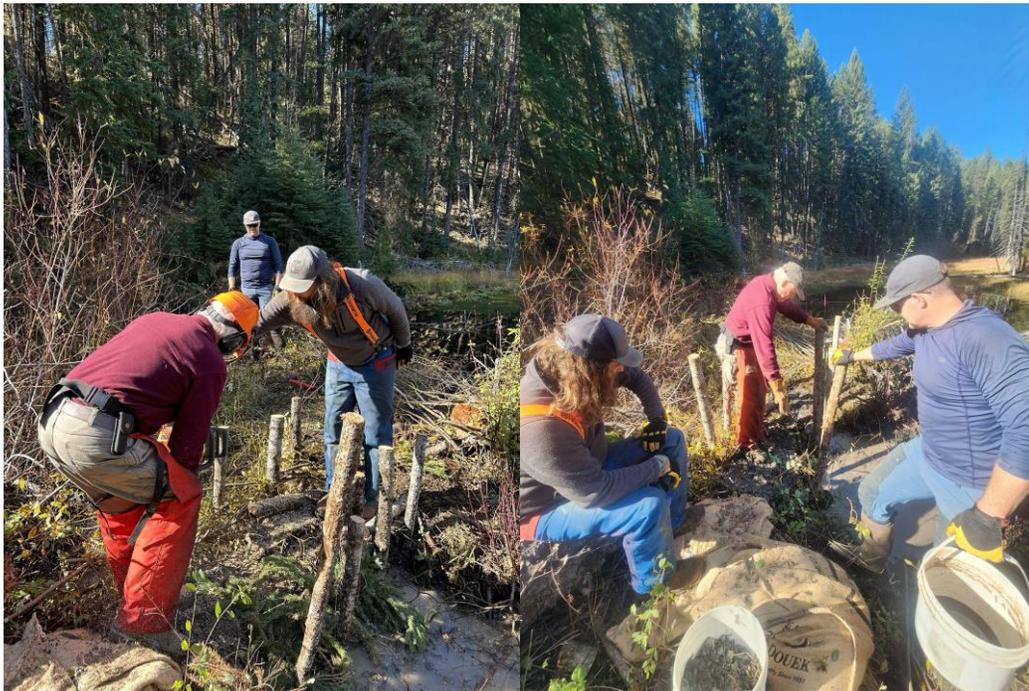
Figure 8. Lower S-land dam (Location 2) during construction, cutting down the posts to required height (left) and infilling the dam with mud and vegetation (right). Oct 7, 2024.

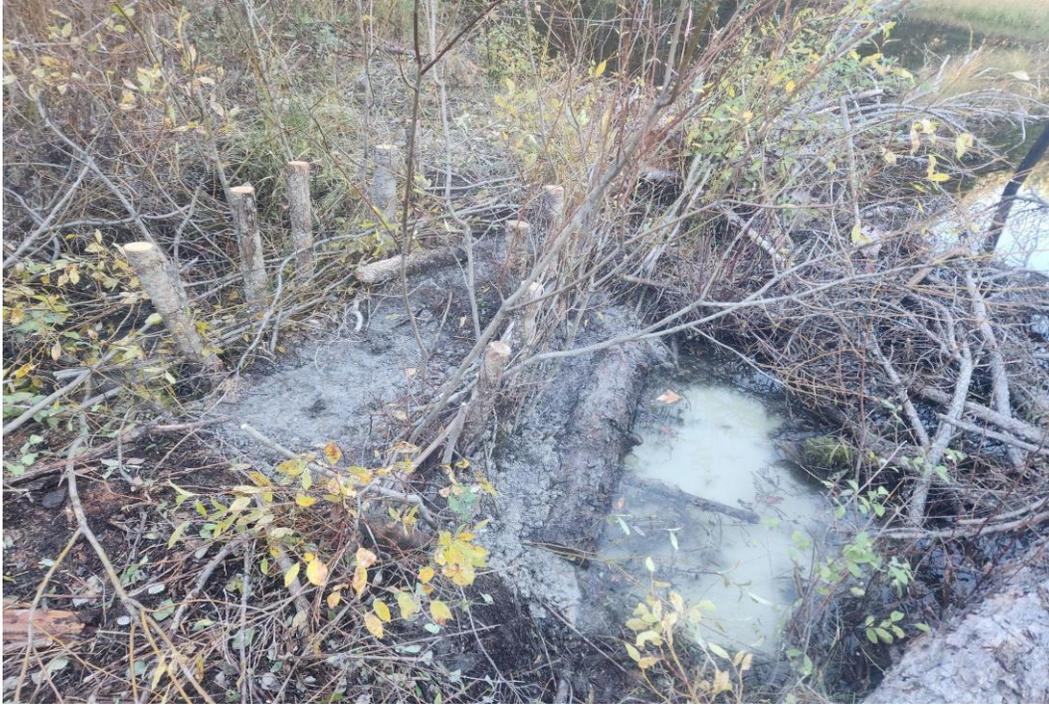
Figure 9. S-land lower dam (Location 2) post construction. Oct 7, 2024.

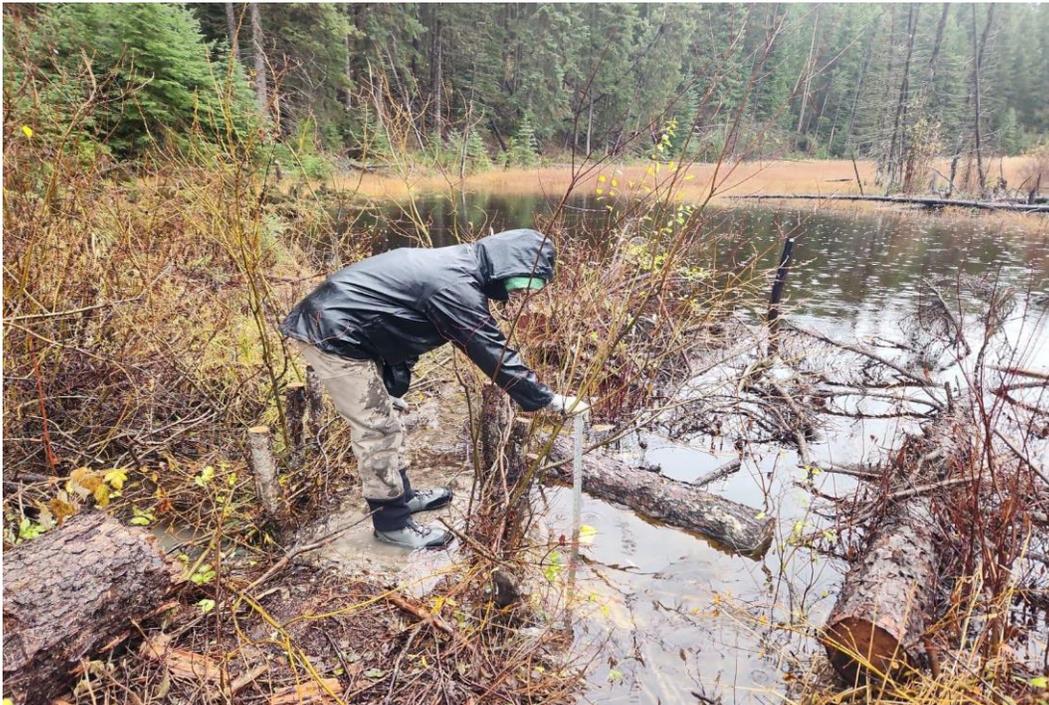
Figure 10. Post construction monitoring at lower S-land dam (Location 2). Measuring changes to water depth. October 21, 2024.

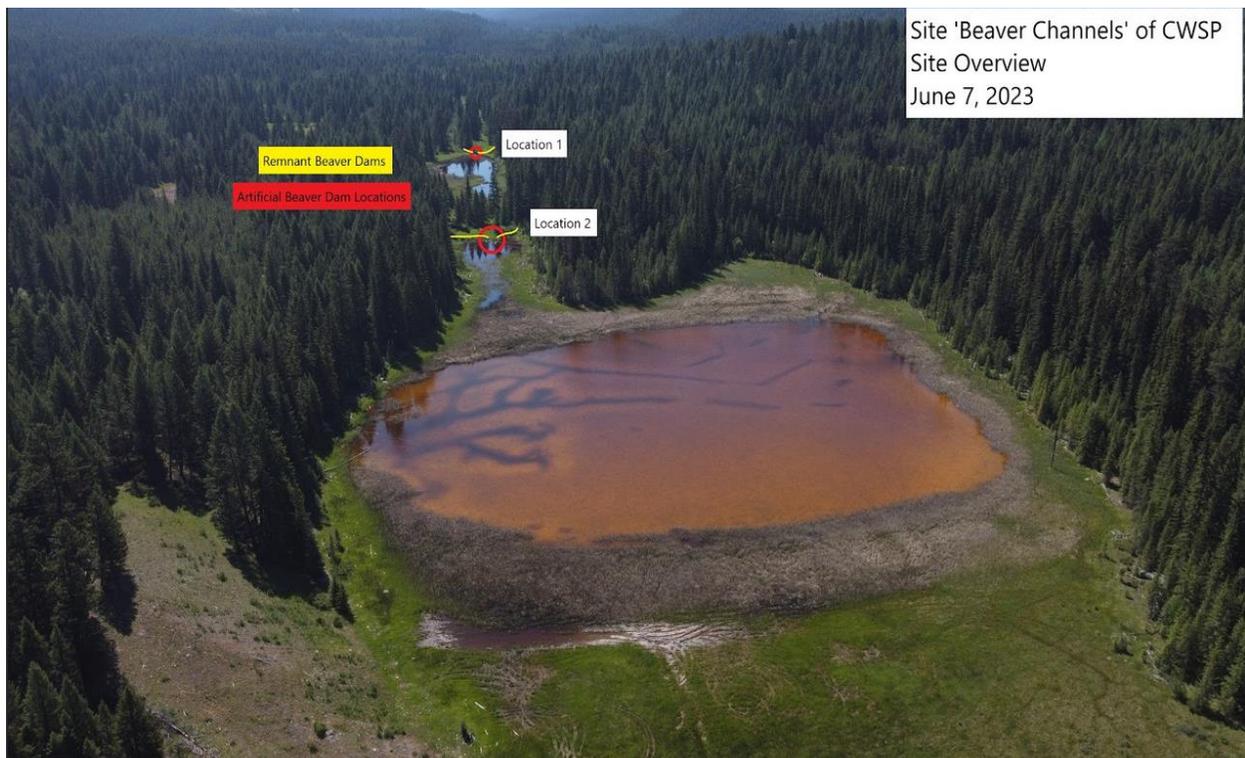
In Beaver Channels we built two dams, in order to retain more water in two wetland areas (Figure 11). The downstream dam is 5 m long, 0.45 m wide, and 0.46 m tall. The upstream dam is 6.5 m long, 0.45 m wide, and 0.45 m tall. As the creek in this site is ephemeral and stops flowing in May, water levels have not yet increased behind these dams; however, as detailed above we will continue monitoring water levels next year to document increases.

Figure 11. Drone photo of the site Beaver Channels showing the location of the two beaver dams.

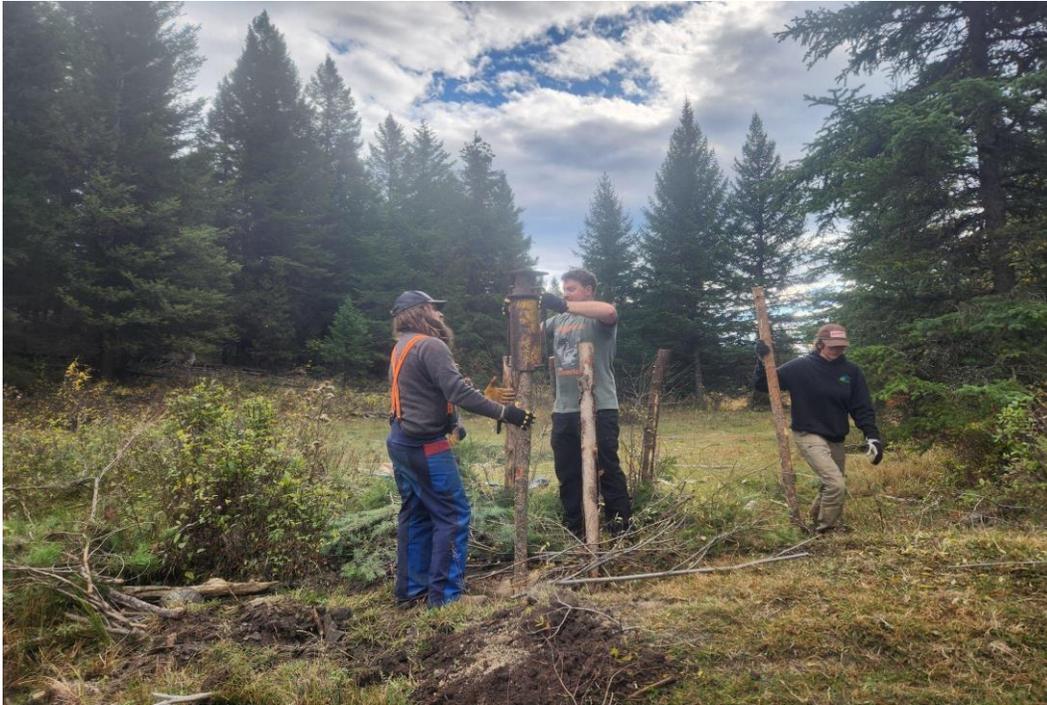
Figure 12. Pounding posts into the ground for the upper dam (location 2) at Beaver Channels. Oct 8, 2024.

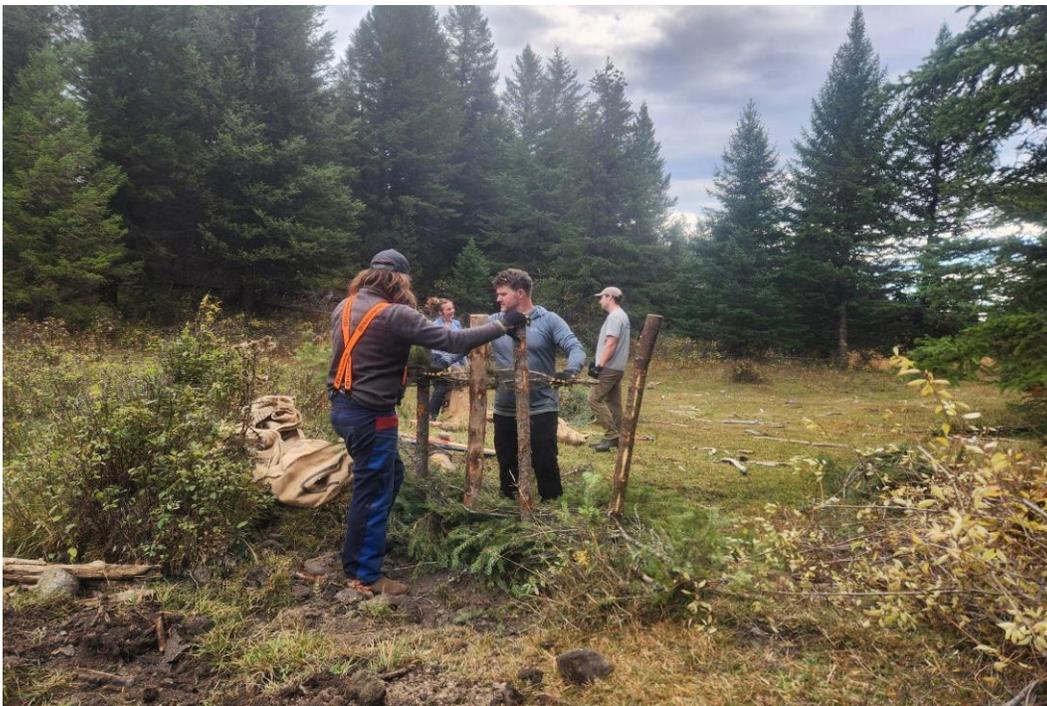
Figure 13. Weaving vegetation between posts at Beaver Channels' upper dam (Location 2).

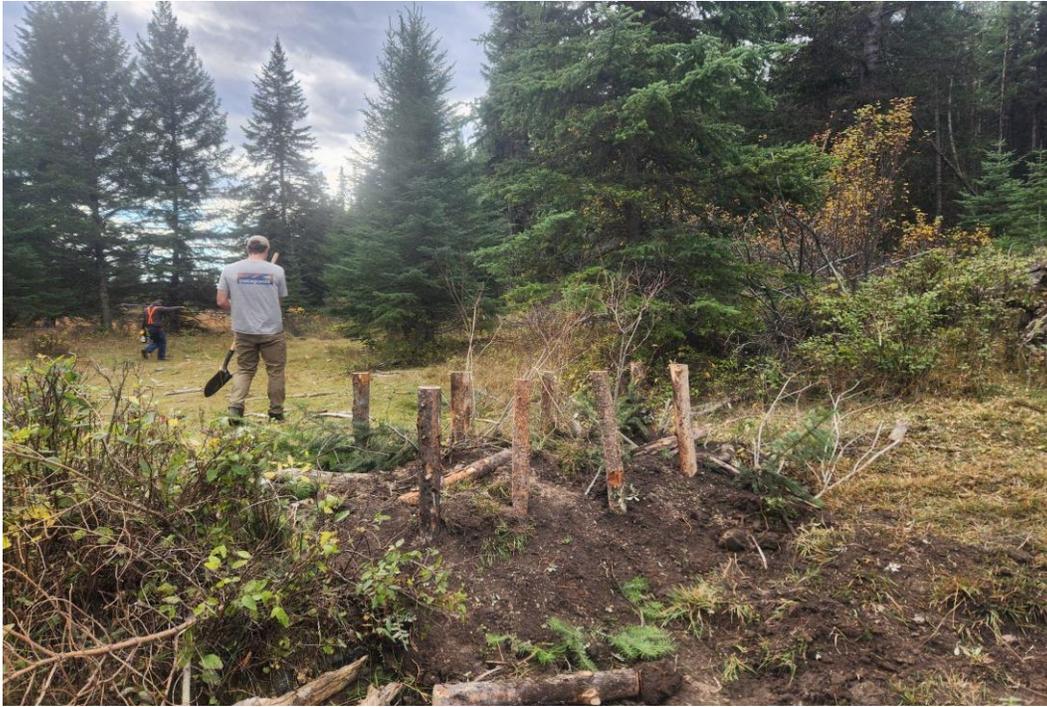
Figure 14. Completed dam construction of the upper dam at Beavers Channels site. Oct 8, 2024.

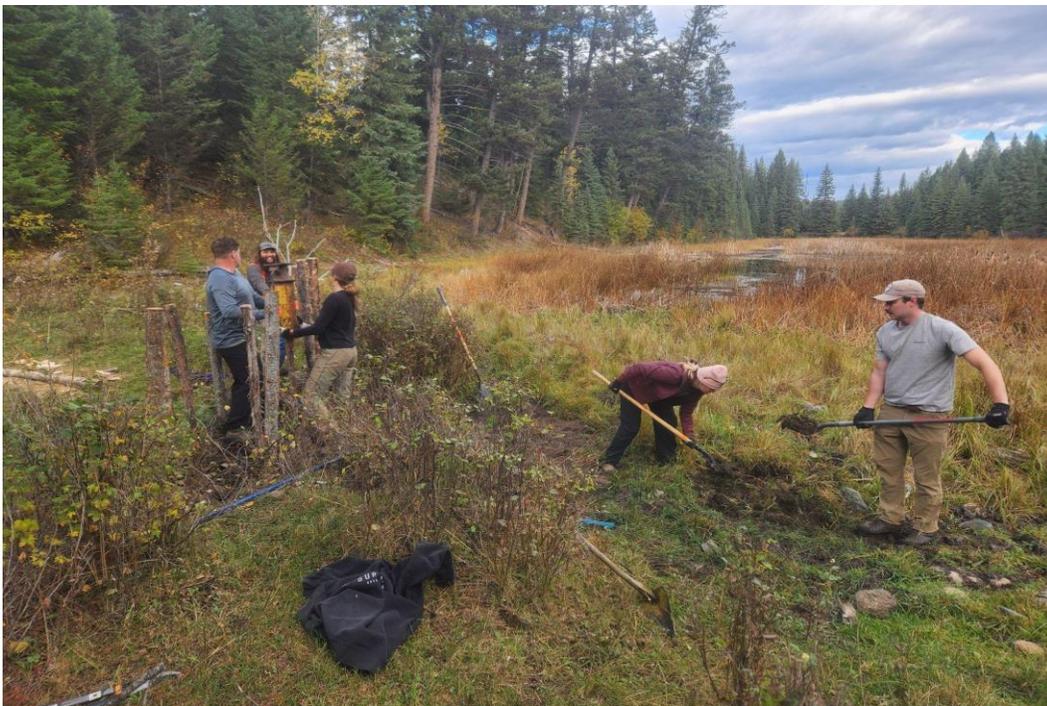
Figure 15. During the construction of the lower dam (Location 1) at Beaver Channels. Oct 8, 2024.

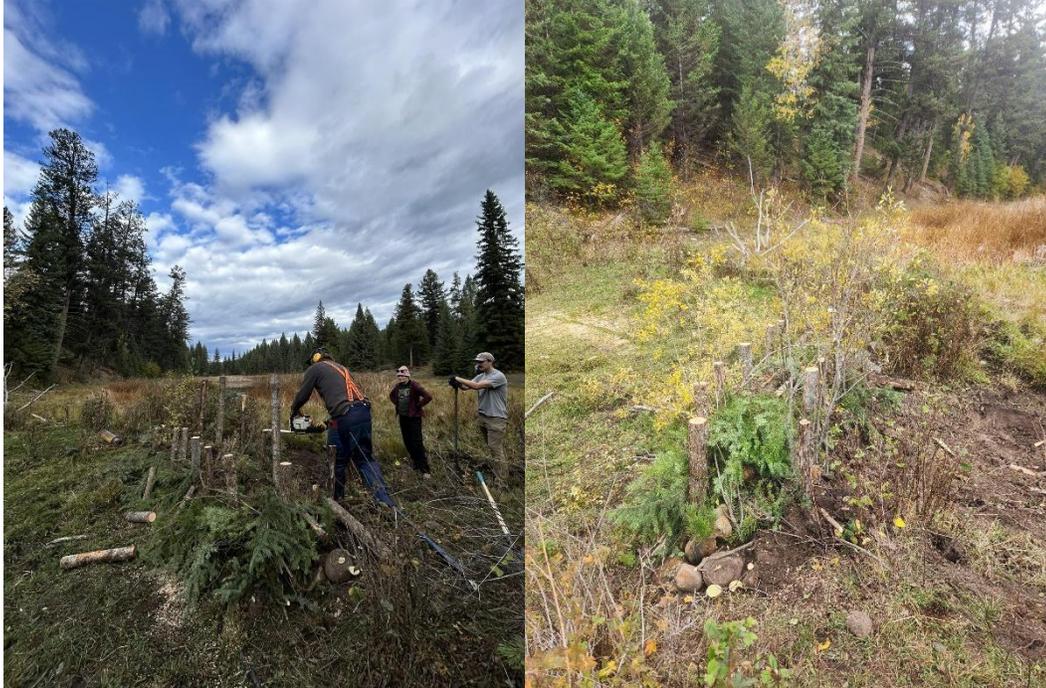
Figure 16. Cutting posts to appropriate height (left) and completed dam (right) at lower Beaver Channels dam (Location 1). Oct 8, 2024.

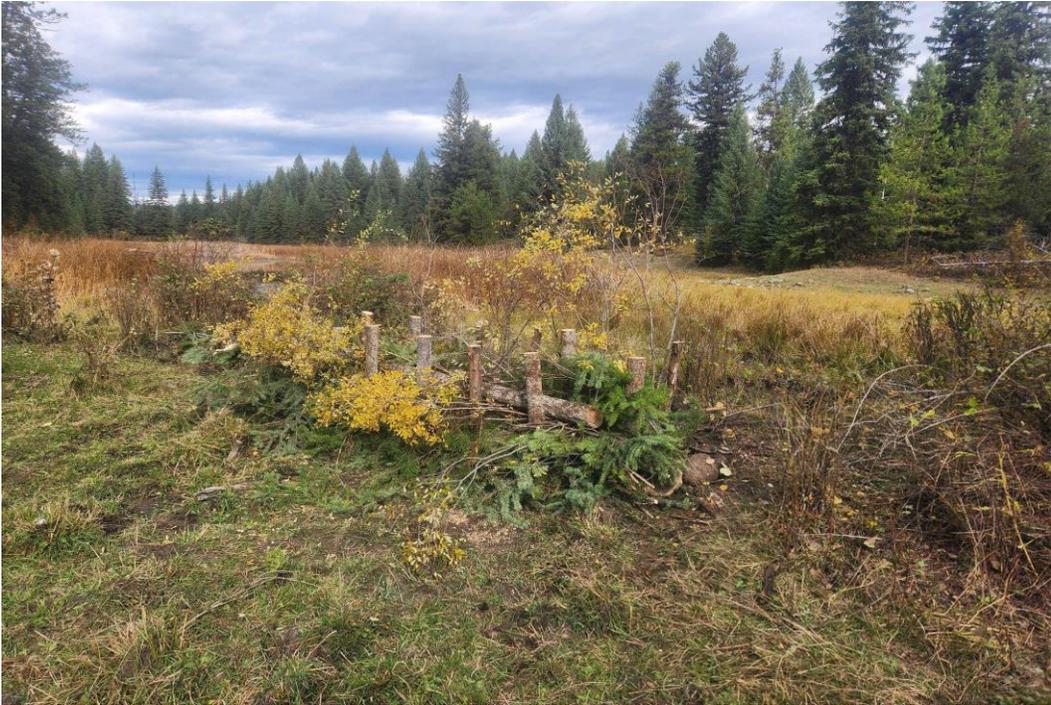
Figure 17. Completed dam construction of the lower Beaver Channels dam site (location 1). Oct 8, 2024.

As indicated in our permit applications, these dams were built with entirely natural materials, with wooden posts being pounded at least 0.3 m into the ground in two rows 0.45 m apart, and then the area inside the dams being filled with burlap sacks filled with sand and mud, woven branches, and mud (Figure 17).

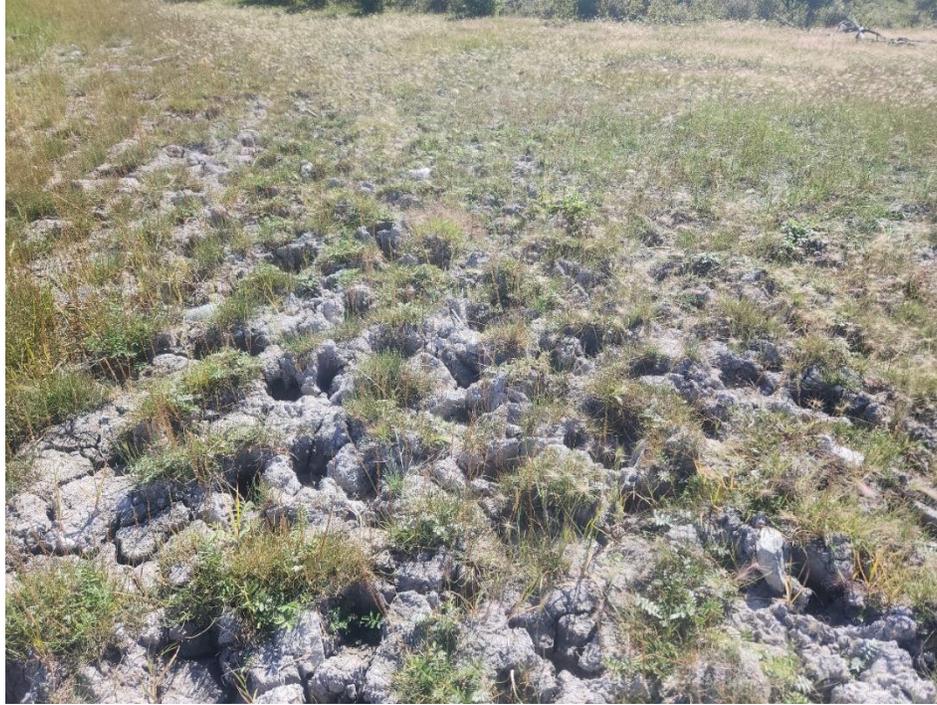
Figure 37. This image displays the negative impact and disturbance from cattle trampling on wetland soils.

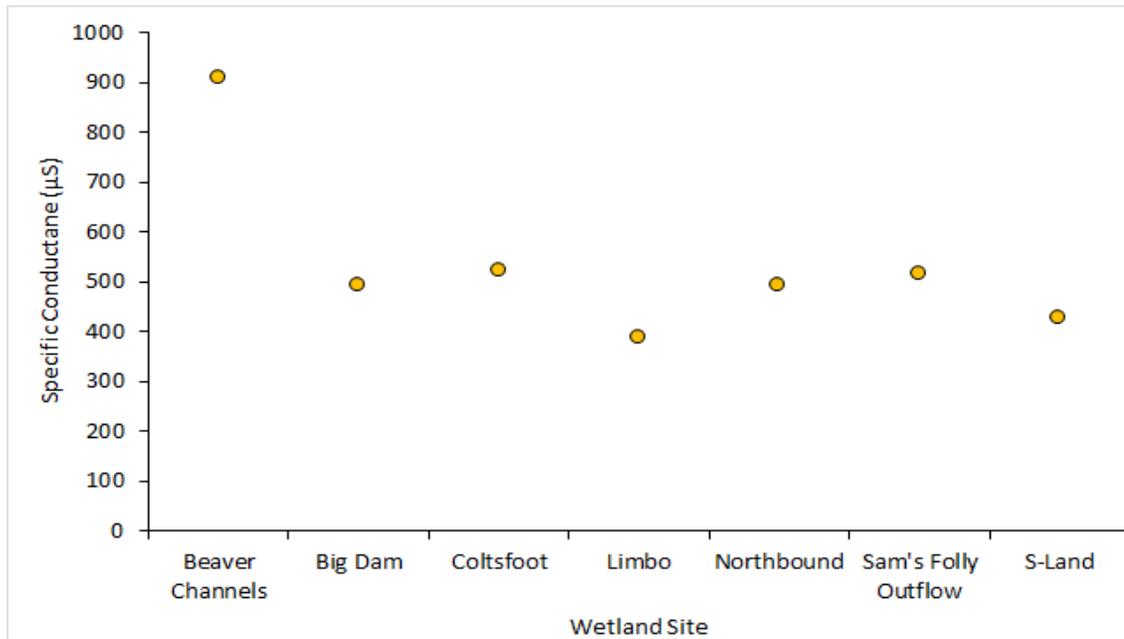
Figure 38. Specific conductance (μS) levels at the 7 wetland sites, with values ranging from 400 to 900 μS .

Specific conductance is a measurement of electrical conductance in water, which therefore indicates the presence of inorganic dissolved ions. Stream conductivity is primarily affected by the geology of the area through which the water flows; areas with clay soils tend to have higher conductivity due to the presence of materials that ionise when washed into water (EPA, 2012). Specific conductance relatively high among all restoration sites (Figure 38), with Beaver Channels having the highest specific conductance of over 900 μS . In comparison, conductivity of the Columbia River at a similar time (August 2024) was 224 μS . This indicates relatively higher inorganic dissolved ions and thus high mineralisation, suggesting that groundwater flow and stream flow are both through materials that ionise when washed into the water.

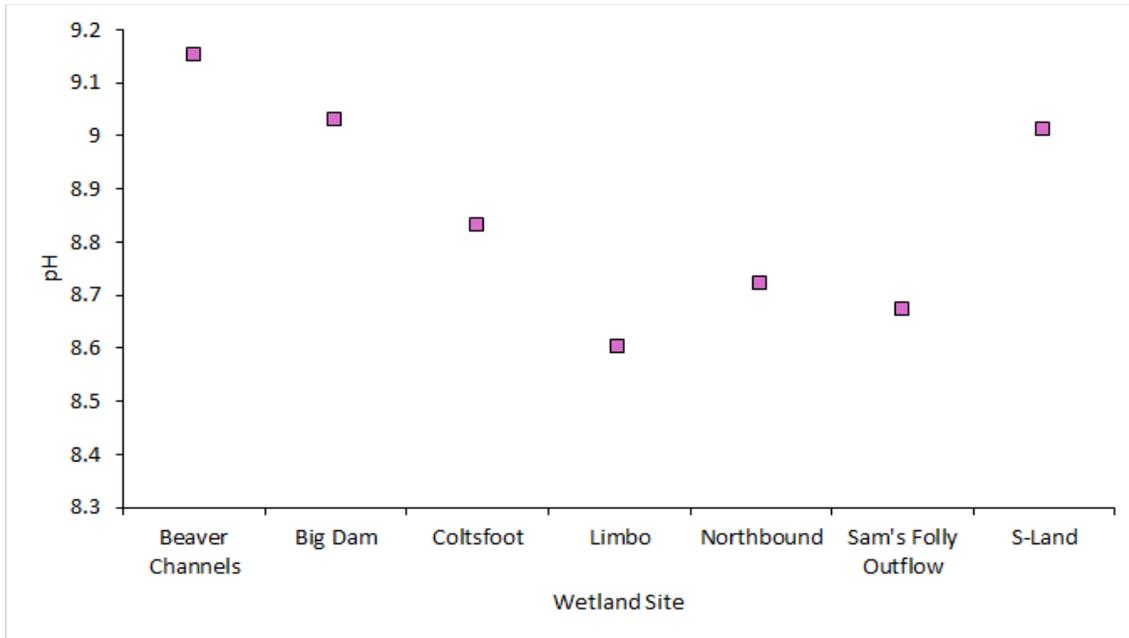
All the restoration wetlands are alkaline, with pH values over 8.6 (Figure 39), with more hydroxide ions than hydrogen ions in the water. A pH of over 8 is generally considered to be a

Figure 39. pH levels at various the 7 upland wetland sites. The plot shows the pH measurements, with each square representing a single pH reading at each wetland.

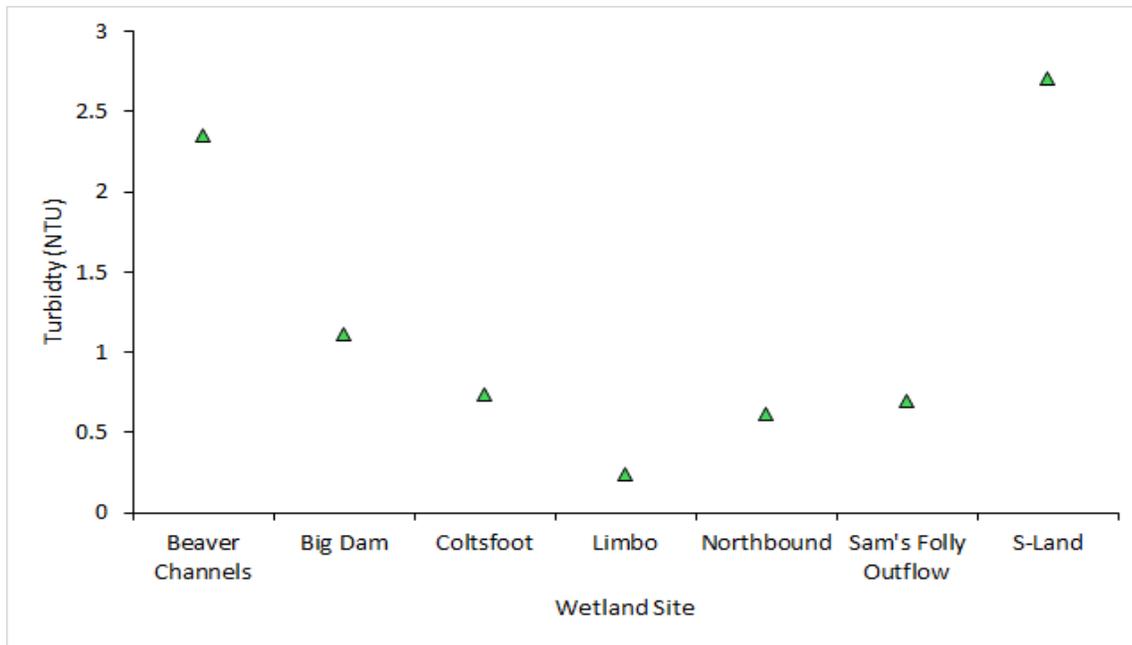
Turbidity in all the restoration wetlands is low, with turbidity ranging between 0.5 and 3 NTU (Figure 40). Low turbidity indicates that the water at these sites has relatively few suspended particles, which is generally a sign of clear water, as well as low levels of sedimentation. Low turbidity is beneficial because it allows for greater light penetration, which is important for the growth of aquatic plants (Austin *et al.*, 2017). Clear water also reduces sediment resuspension and minimizes sedimentation, which can lead to healthier ecosystems. Low turbidity supports better water quality by enabling more effective photosynthesis and supporting plant cover, which in turn stabilizes sediments and improves the overall ecosystem health of the wetland.

Figure 40: Turbidity (NTU) measurements at various wetland sites. This plot graph shows the turbidity levels from across 7 of the wetland sites, with lower values indicating relatively clear water.
