Canada Nature Fund: Community-Nominated Priority Places for Species at Risk

Kootenay Connect: 6CW Columbia Wetlands:

Wetlands West of Columbia Lake

March 31st, 2025. Final Report: Year 6

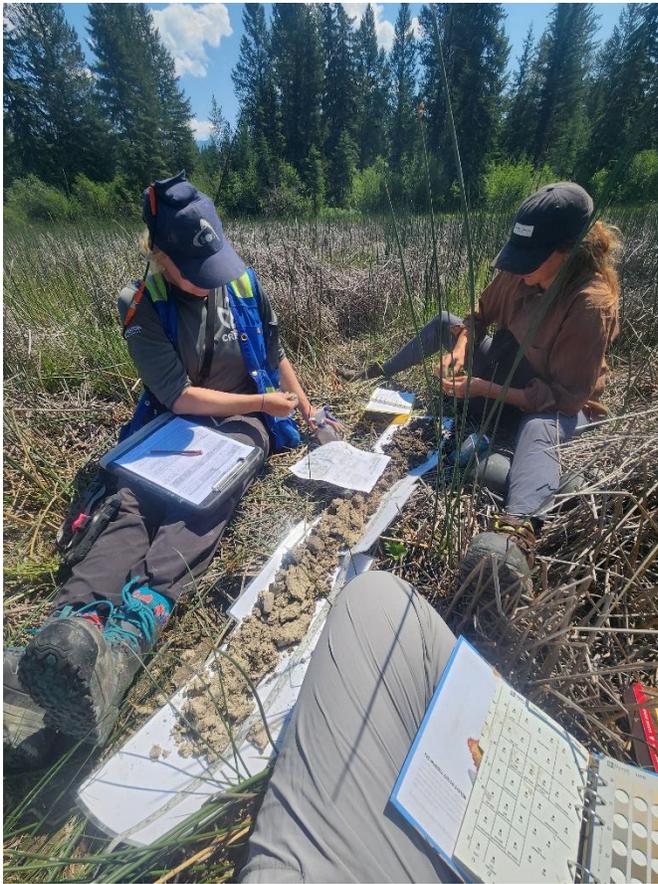
Figure 2: Assessing soil core in Wetland 6.

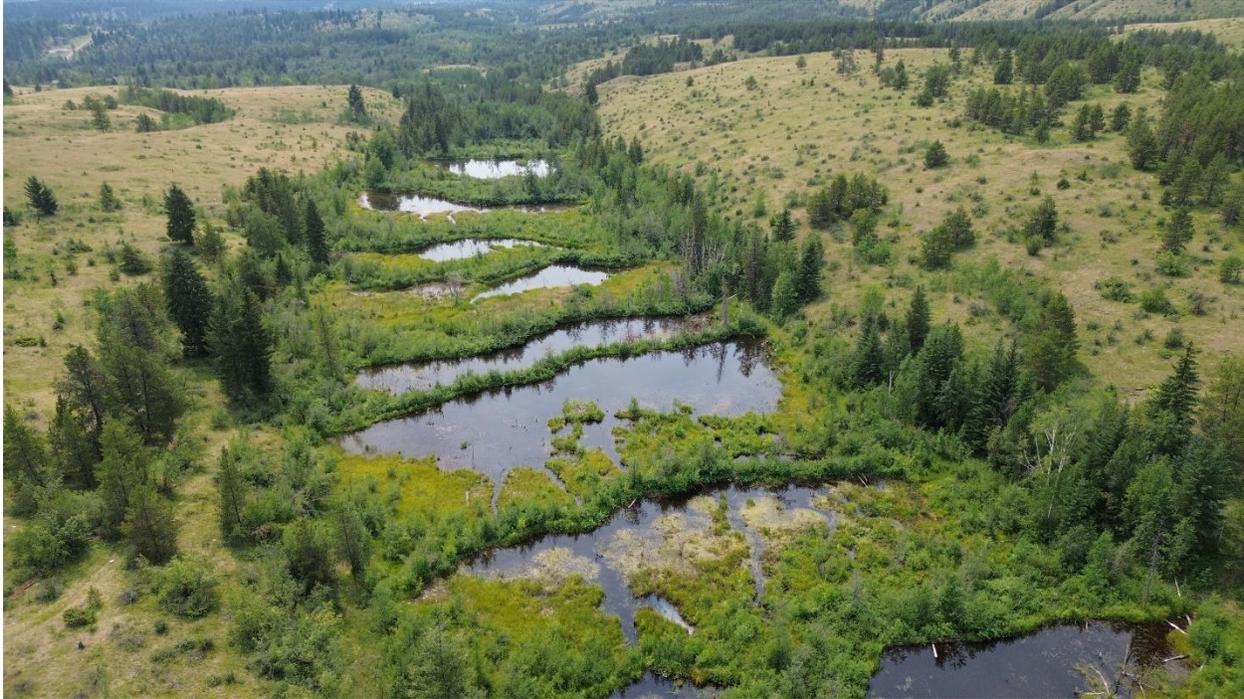
This wetland is a complex of wetlands created along Marion Creek by both active and inactive beaver dams. In this initial survey, we surveyed three plots within Wetland 9, two of which were classified as swamp and one as marsh. Both swamps were palustrine with seasonal hydroperiods, while the marsh was riverine and semi-permanent, with a surface water depth of 0.02m. We later returned to Wetland 9 and surveyed the beaver dams present in detail; this work can be found in Section 4 of this report.

Figure 9: Photograph showing series of beaver dams and associated wetlands along Marion Creek.

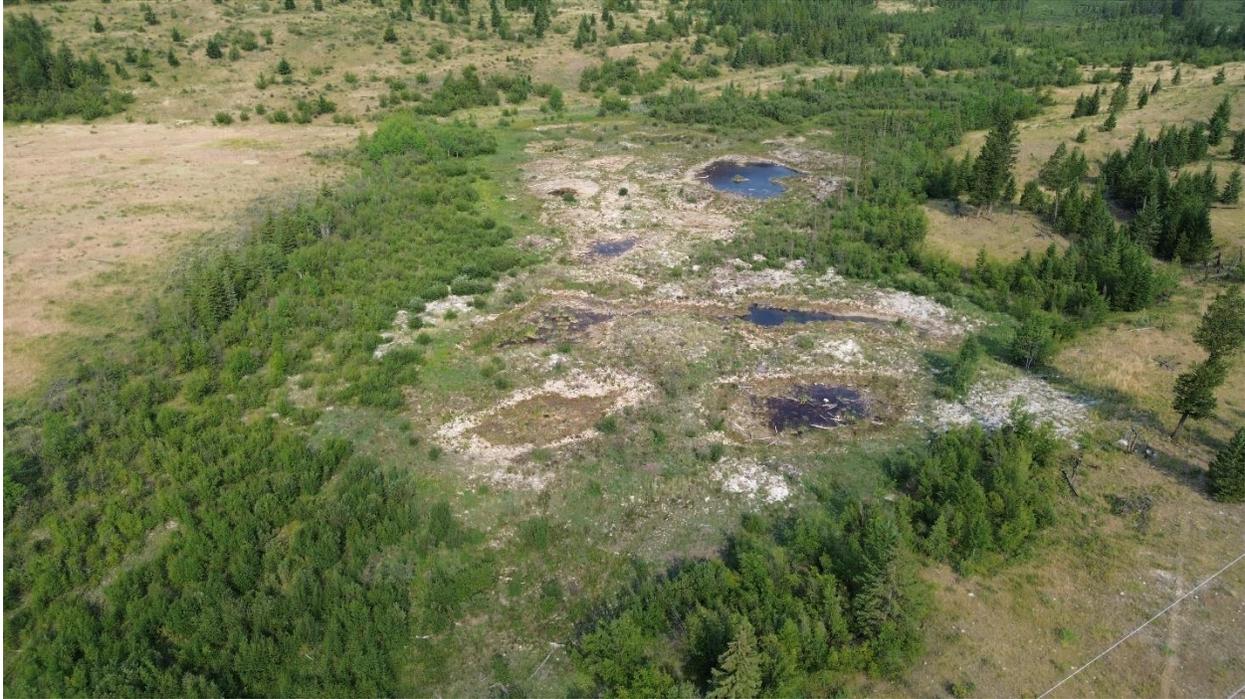
Figure 12: Drone photo of wetland.

We surveyed six plots at this site, two of which were swamp, two of which were marsh, and two of which were classified as non-wetland. Hydroperiod varied from seasonal to ephemeral, and open water was present in the marsh areas in ponded areas that were dug as part of the restoration project. The depth of water in these areas ranged from 0.05 m to 0.60 m deep. We noted invasive species such as Canada Thistle *Cirsium arvense* growing on the soil mounds that had been excavated from these areas, and suspect that drying due to climate change and water demands for ranching is adversely impacting this wetland, as a portion of Sun Creek is diverted upstream of this wetland to an artificial dam holding water for cattle.

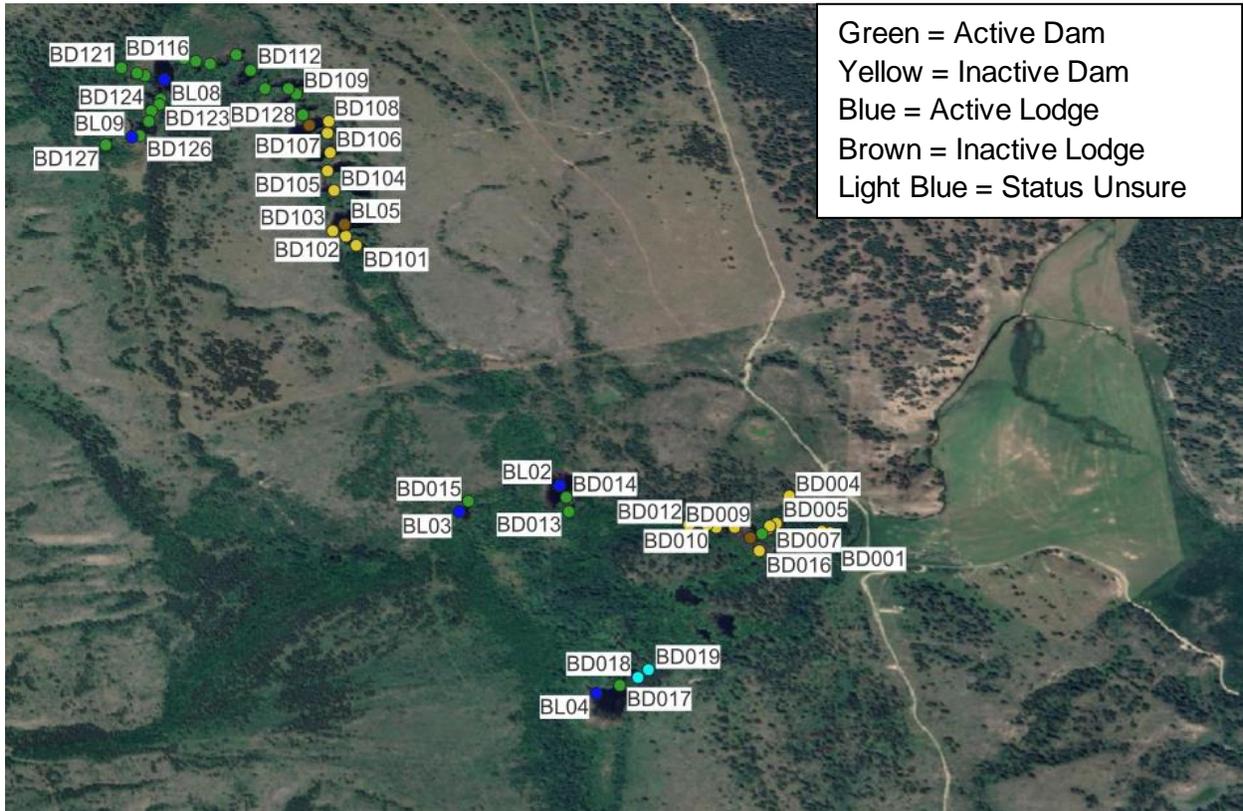
We surveyed 47 beaver dams and nine beaver lodges, and determined that 24 dams and five lodges were active (Figure 17). This means we observed fresh mud and stick repairs to dams and cached vegetation by lodges (Figure 18), indicating that beavers were actively maintaining dams and storing food for the winter in these locations.

Figure 17: Overview map of the 46 beaver dams surveyed in September 2024 in the Marion Creek West wetlands area.

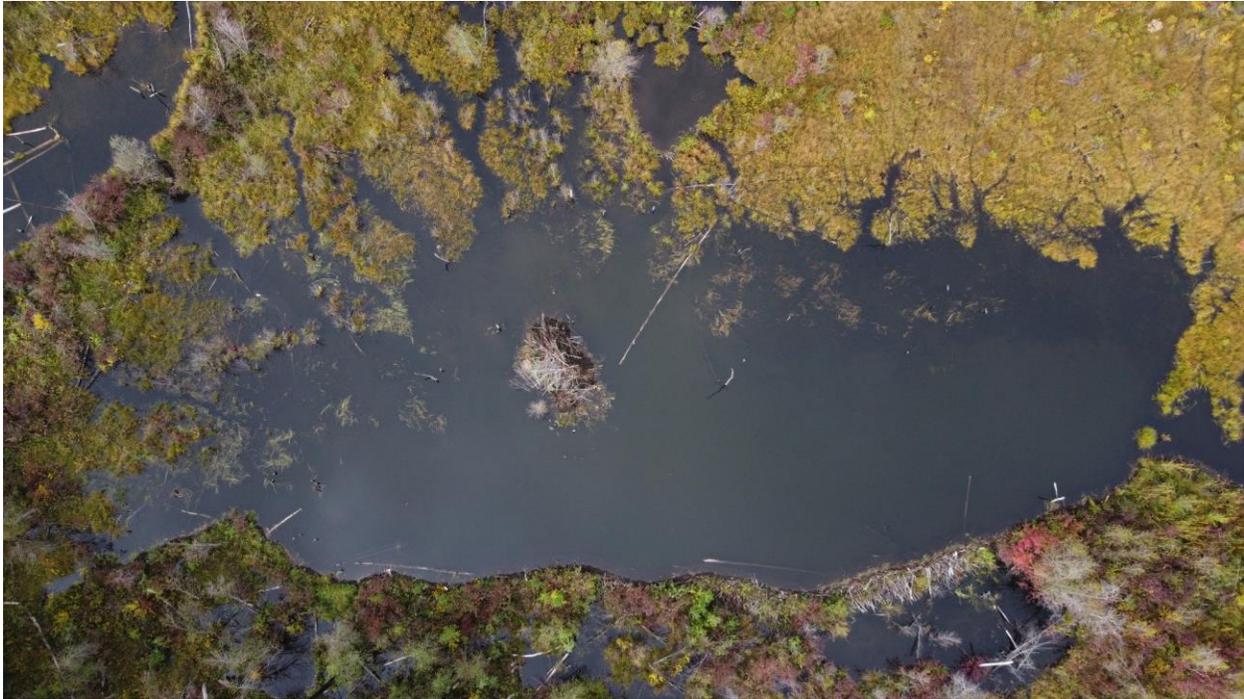
Figure 18: Drone footage showing a beaver lodge with branches cached beside it, indicating that beavers are living in the lodge and preparing for winter. Photo shows Dam 118 and Lodge 08.

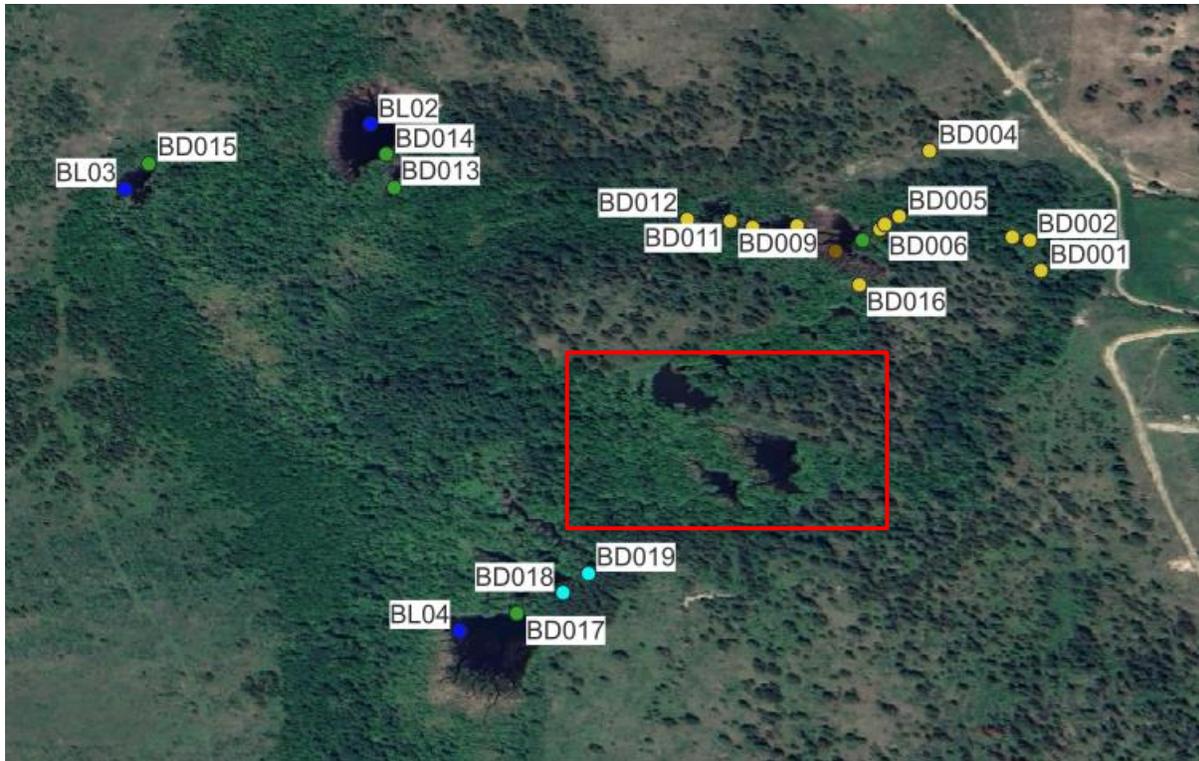
There were two distinct areas of beaver dams within the Marion Creek West Wetlands, as can be seen in Figure 17. The more southerly region contained 19 dams, five of which are active, 11 of which are inactive, and two of which we do not know the status of (Figure 19). There were three active lodges in this region, indicating that the beavers in each lodge were maintaining only one or two dams. This region was predominantly wooded, with many small inactive dams built across Marion Creek which were not holding water or maintaining any wetland area. We found both the longest and the shortest dam in this area, at 122m and 1m in length, respectively. The wetlands associated with active beaver dams were dominated by open water, with a marsh fringe. Plants observed include *Nuphar variagata* and various *Potamogeton* species in the open water, and sedges such as Water Sedge and Beaked sedge in the marsh areas. The wetland associated with Dam 15 was entirely open water, with deciduous forest close to the edge of the wetland area, and no marsh fringe.

Figure 19: Map of the 19 beaver dams in the southern part of the Marion Creek West wetlands. Green indicates active dams, Blue active lodges, yellow inactive dams, and brown inactive lodges. Light blue indicates two dams whose status we have not confirmed. The red box is the area where beaver dams remain to be assessed.

Some dams in this area remain unsurveyed, due to time constraints, and we plan to return to this area next year to complete this work. These unsurveyed dams are indicated in Figure 19 with a red box.

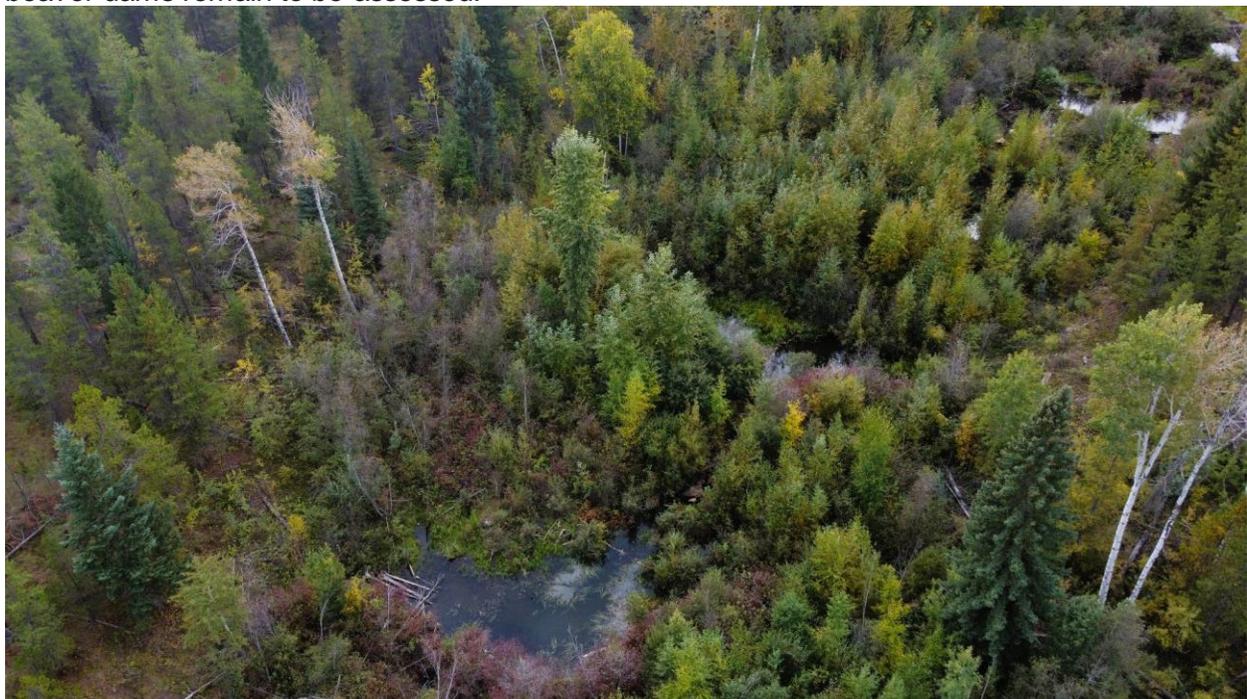
Figure 20: Drone photograph showing the predominantly wooded southerly area of the Marion Creek West Wetlands.

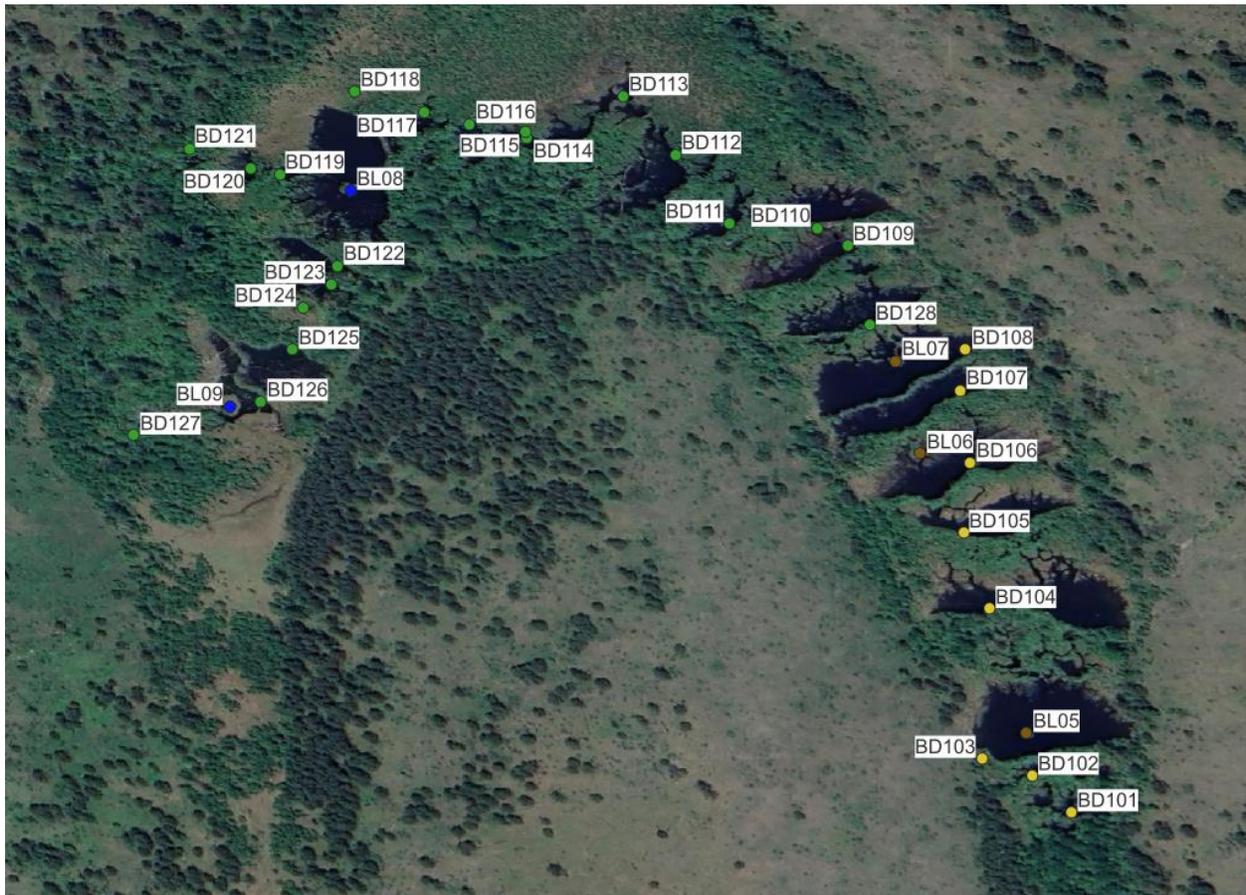
The more northerly area contained 28 dams, 19 of which are active and nine of which are inactive (Figure 21). We observed only two active lodges in this area, indicating that each beaver lodge is sustaining multiple dams, and that each lodge may therefore have a higher population of beavers living inside than in the more southerly region. Dams in this area were between 29m and 115m in length, and created a stepped series of wetland along the creek valley (Figure 22).

Figure 21: Map of the 28 beaver dams in the northern region of the Marion Creek West wetlands. Green are active dams, while blue shows active lodges. Yellow dots indicate inactive dams and brown dots inactive lodges.

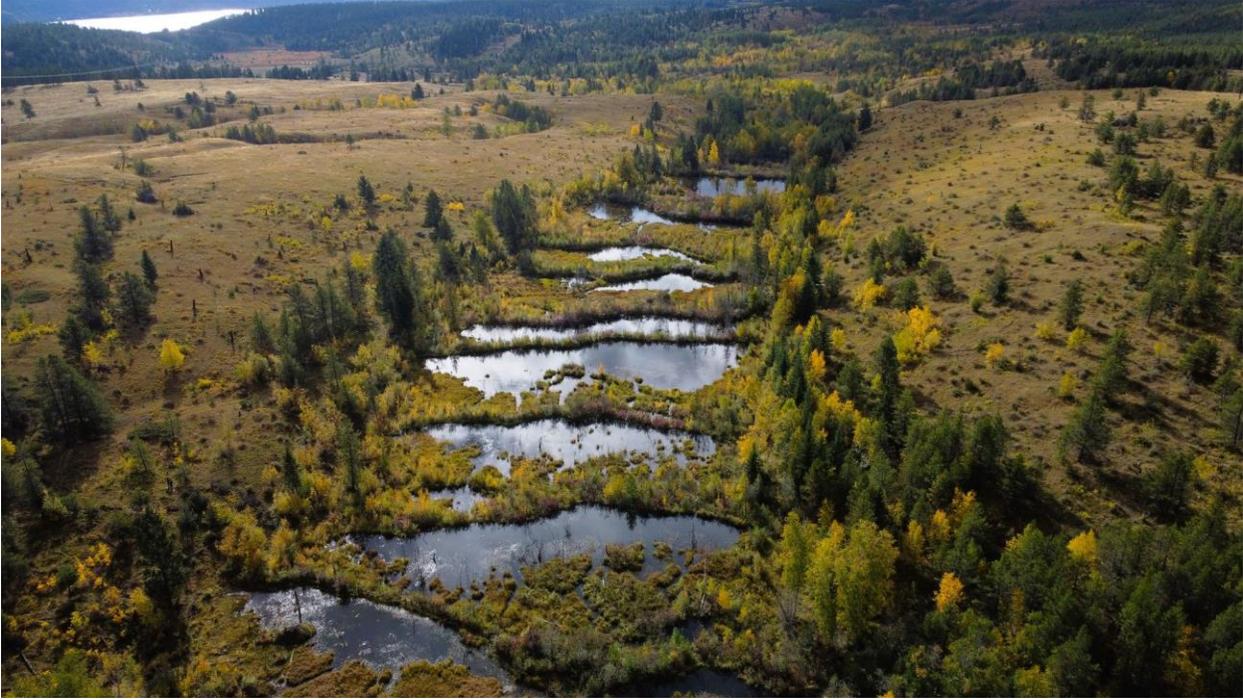
Figure 22: Drone photograph of series of beaver dams in the more northern area of the Marion creek West Wetlands.

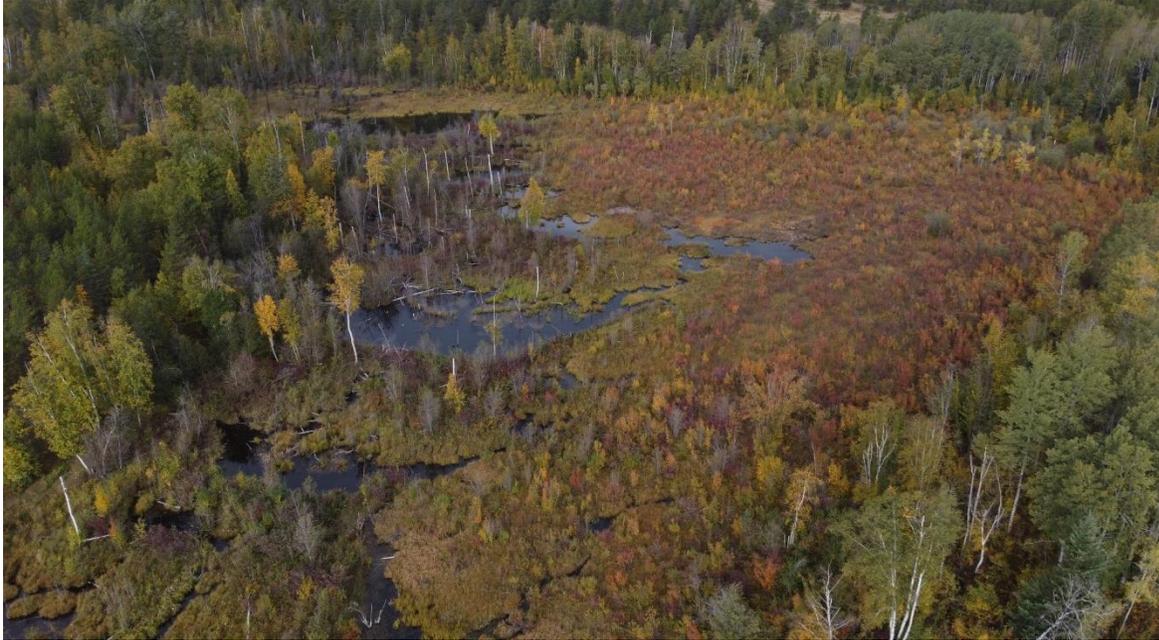
The wetlands maintained by many of the active dams were dominated by open water and marsh vegetation. In the open water areas, plants observed included *Nuphar variagata* and various *Potamogeton* species in the open water. In the marsh areas, plants observed included Water Sedge, Beaked Sedge, Cattail, and Coltsfoot. The wetlands between dams 110 and 118 had fen characteristics, including the presence of Scrub Birch and Labrador Tea. All dams in this area were surveyed.

Figure 23: Drone photo showing wetland area between Dams 110 and 118; note mix of open water, fen, and marsh.
