Summary of Columbia Lake Stewardship Society's 2022 Water Quantity Monitoring Program

Prepared by W. Thompson, M.Sc.

January 2023

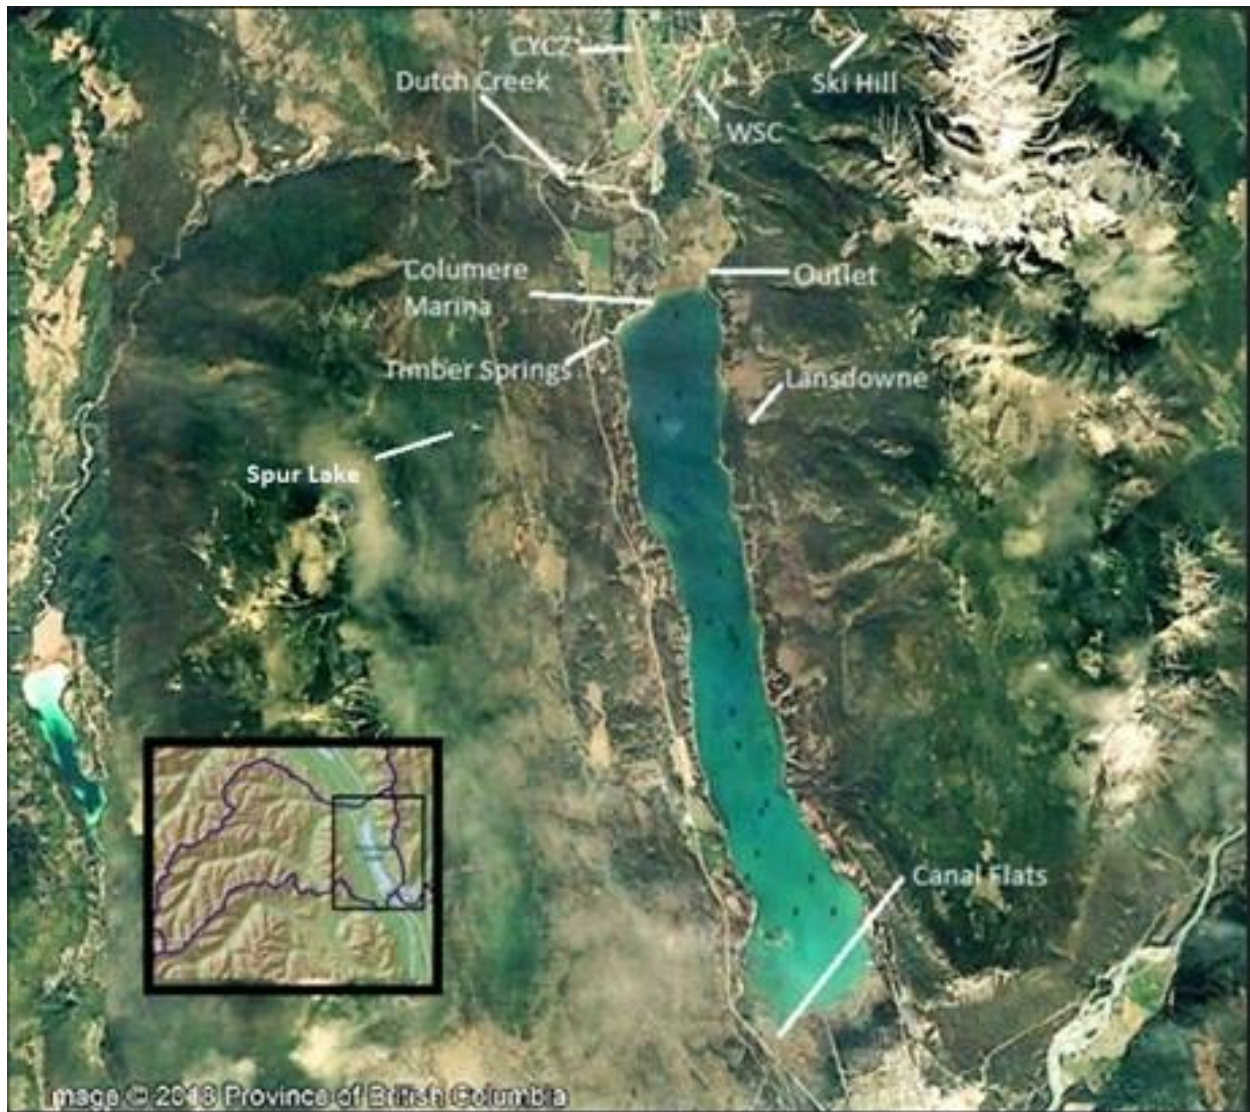
Figure 1 – Map showing station locations. Entire watershed boundary is shown in inset. Site abbreviations are provided in Section 4.1.

Thus, the actual outlet from the lake is not at the Highway crossing but just over three kilometres upstream, except as will be noted during periods of very high water. A series of small creeks enter the Columbia River downstream of the Dutch Creek junction and constitute about nine square kilometres of the entire 881 square kilometre area. The area above the lake outlet is 176 square kilometres. The boundaries of the watershed are shown in the inset of Figure 1.

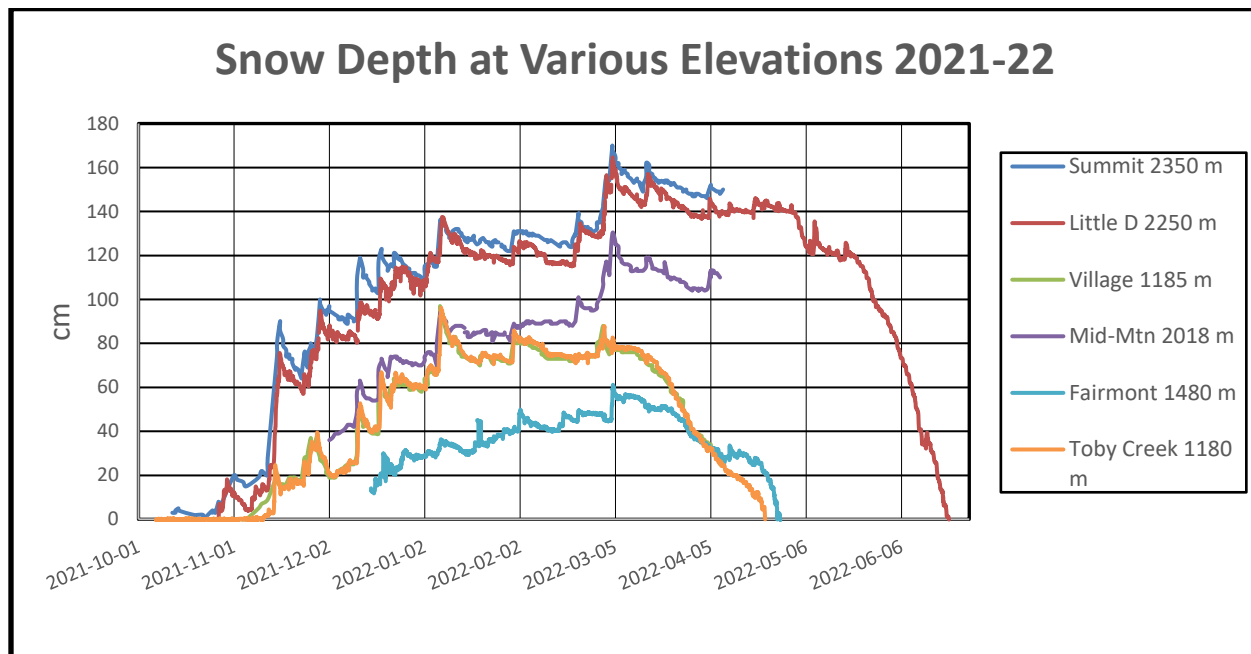
Figure 4 – Snow Depths recorded at stations of varying elevations near Panorama and the Fairmont Ski Hill.

Figure 4 provides insight into the distribution of snow by elevation. As might be expected, snow depths were greater, and the snowpack remained for a longer period at higher elevations than at lower elevations. At the lowest level stations, melt had finished by the end of April, almost two months before the snow had left the Little Dragon site.

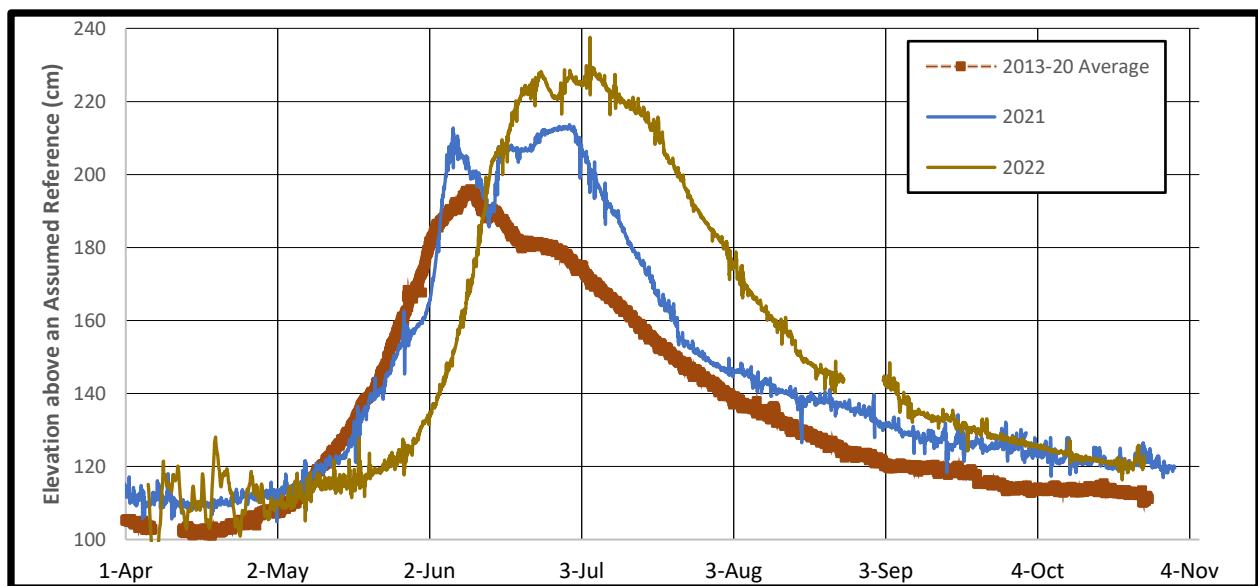
Figure 10 – 2022 water levels compared to the 2014 to 2021 average and 2021 water levels. Levels are above an arbitrarily selected reference.

There were also other factors that will complicate attempts to establish lake water balance. The 2022 water levels recorded on Columbia Lake are compared with the corresponding average levels over the seven-year period 2014 to 2020 and to the water levels of 2021 in Figure 10. Three issues stand out. One is that the rise of the water level trailed its counterparts by nearly two weeks. A second is that the crest level was well above that of previous years, including 2021, a high-water year. The third is that the period of high water extended over a longer period than in previous years. These had on-the-ground consequences. Visual observations during this period indicated that much of the Dutch Creek delta was
